Home Inspection Report

Surrey, BC

Property Address: Surrey, BC
 Date of home inspection: September 4, 2020
 Inspection start time: 9:30 AM
 Inspection end time: 1:30 PM
 Registration BC No: 55167
 Manufacture model No (CSA): 425164
 MLS# not available
 Year Built: 1982
 Construction: Metal / Aluminum
 Furnished: No
 Occupied: No
 Floor Area Total: 964 sq. Ft.

Style: Mobile home
 Stories: 1
 Orientation (Front Facing): West
 Last rain: Last week
 Temperature: +18 Centigrade
 Soil Condition: Dry

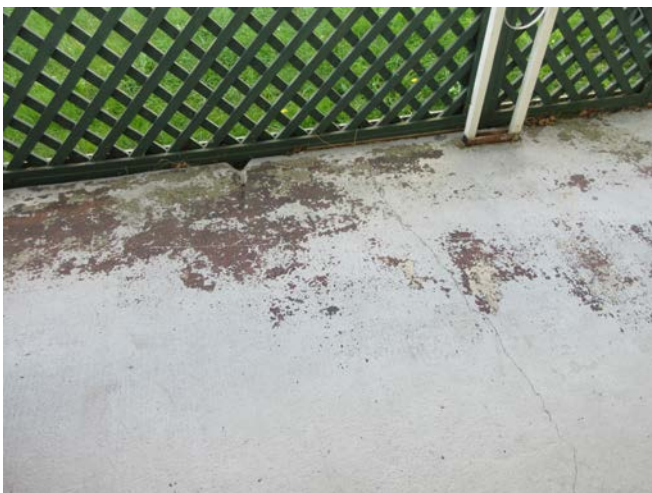
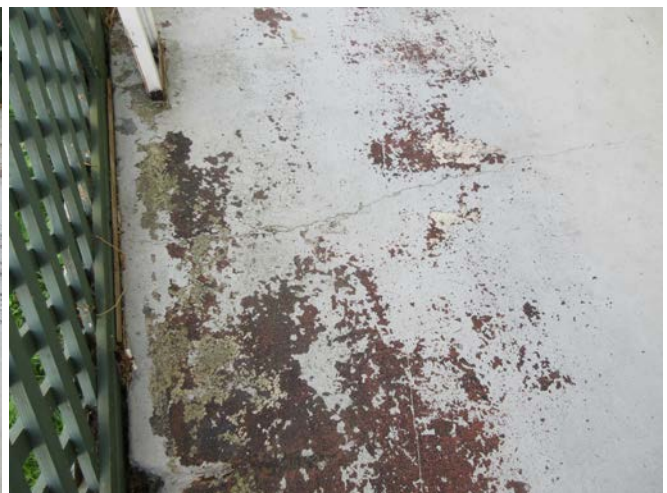
The minor crack was noted on the carport concrete floor. The peeling and missing painting was noted on the concrete slab as well. The crack needs to be monitor for any changes contacting contractor for more action.

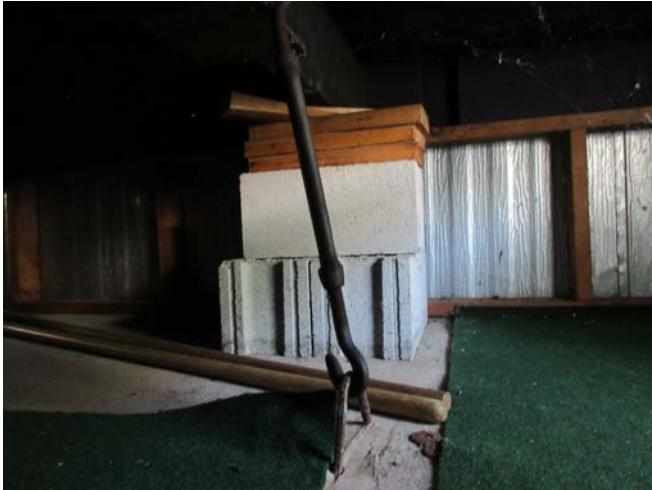
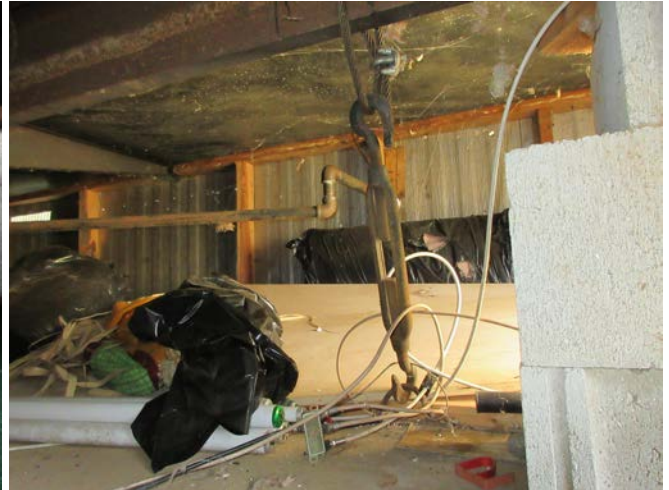
The house base structure was fastened to the ground completely. The foundation seems to be good and is functioning well at the time of this inspection.

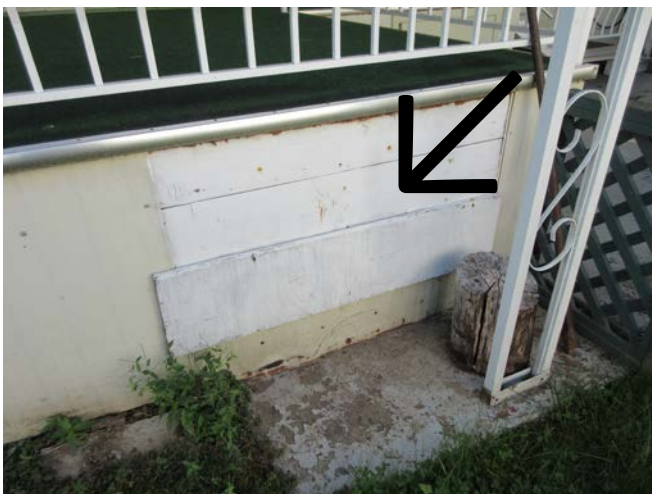
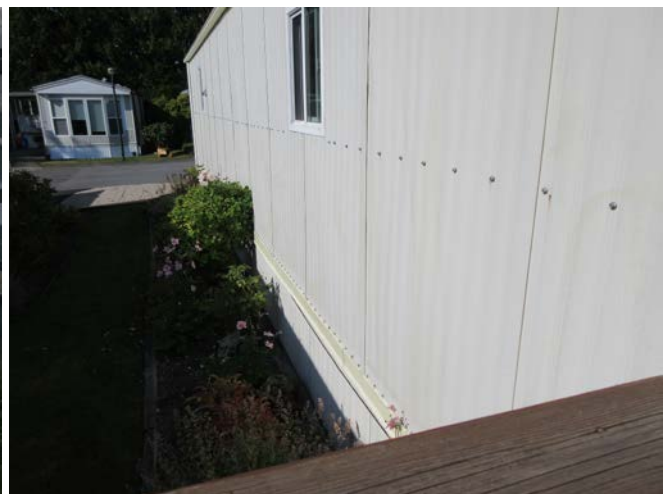
The house has vinyl panel wall cladding and was functional at the time of this home inspection. The wall cladding panel was broken and small portion of the vinyl panel siding damaged. The damaged wall point covered by wood on the north side of the house.

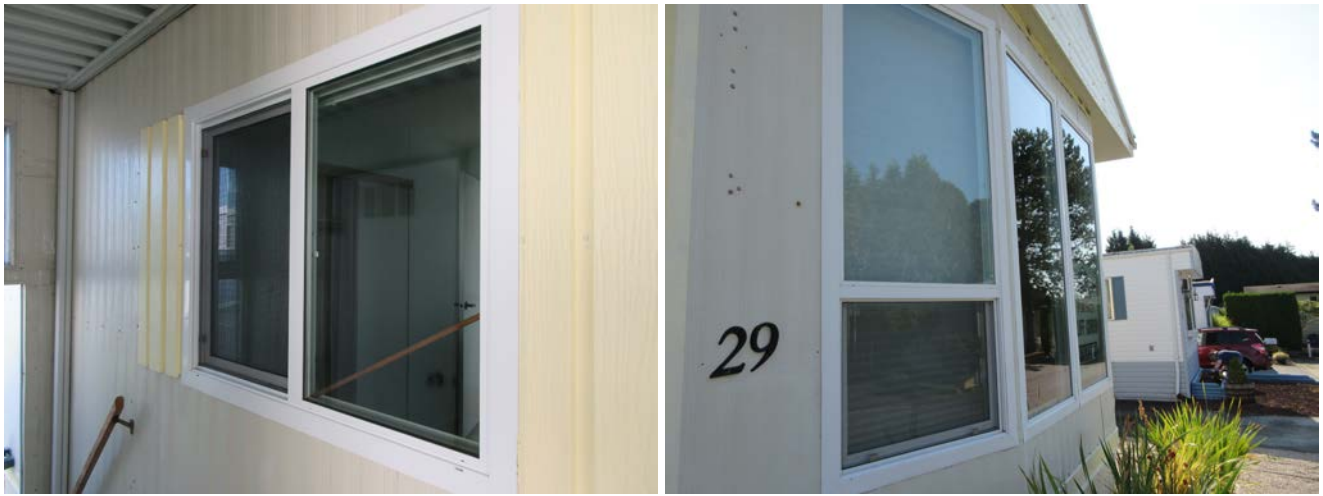
The house has Vinyl windows type with double pane and was functional at the time of this home inspection.

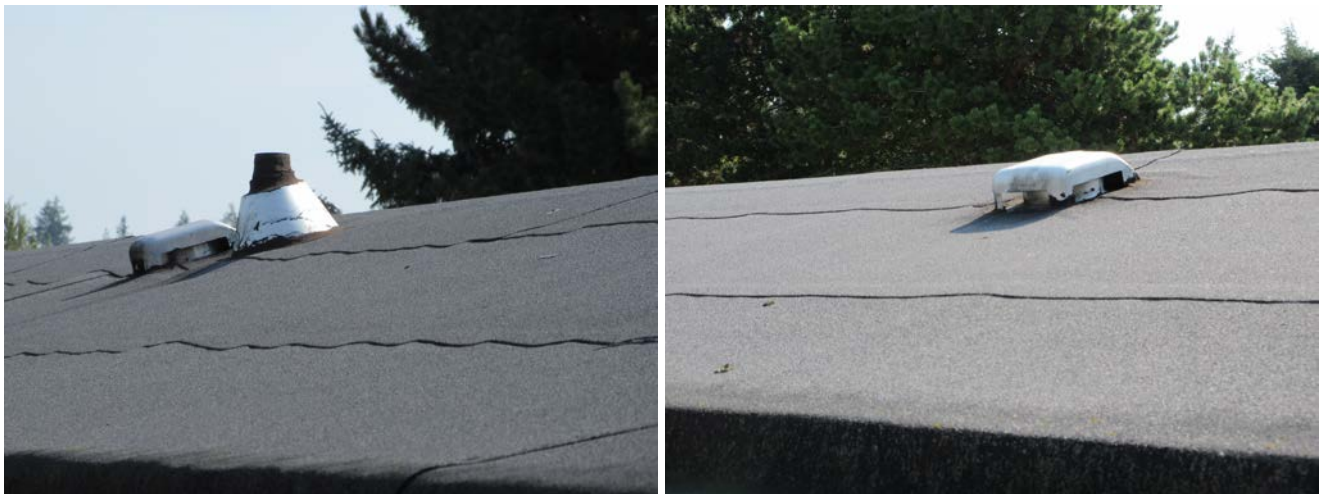
The house roof asphalt rolling coverage. The roof had no leaks and was functioning well at the time of this home inspection.

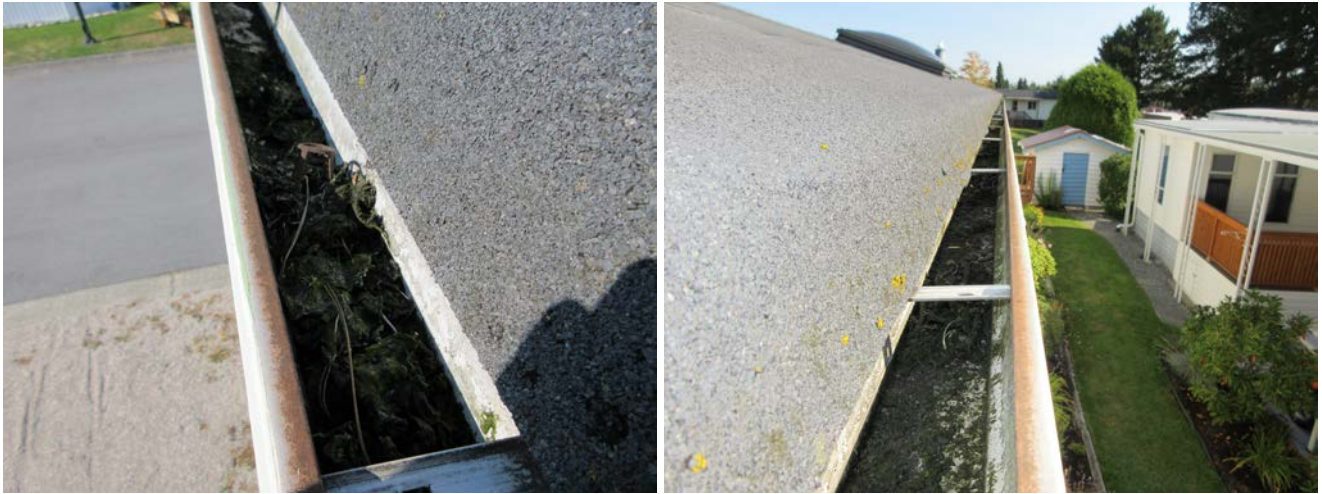
The debris and tree leaves were noted inside of the roof gutter. I recommend clean the gutter to prevent any water leakage to the house.

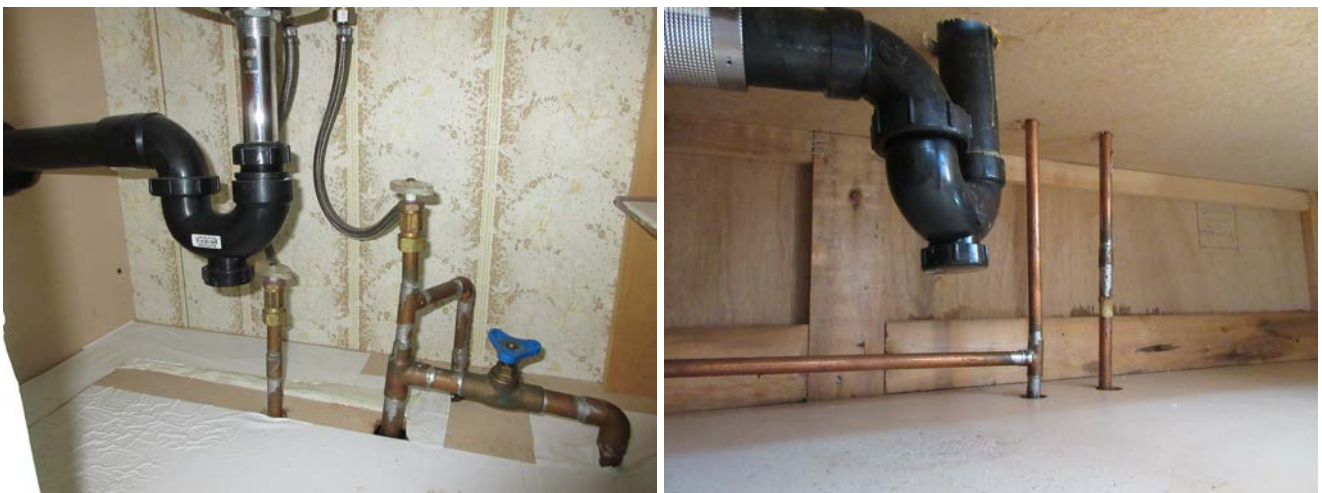
The house original supply pipes is copper. The life expectancy of copper piping is dependent on water condition, it may fail within 20 years. However the copper life expectancy is 40-50 years.

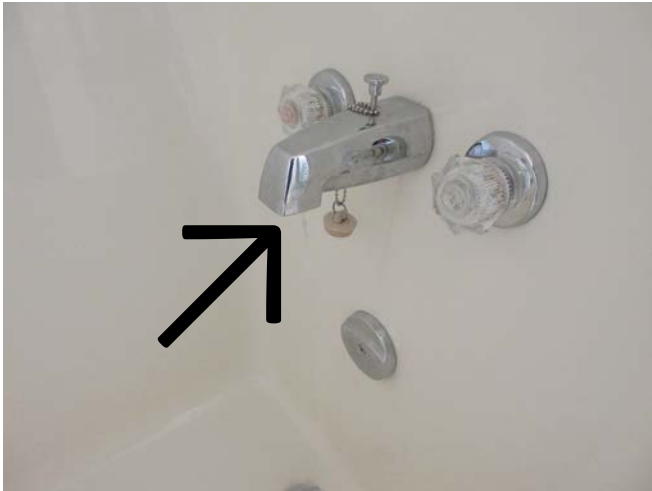
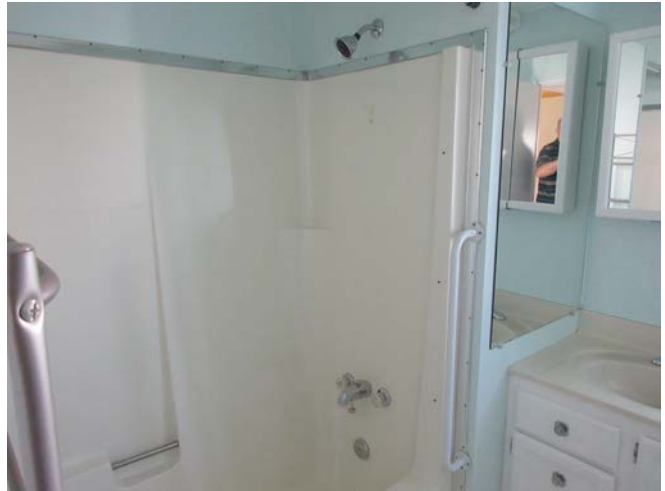
The water leakage was observed on the faucet's spout in the bathroom. I recommend fixing the water leakage.

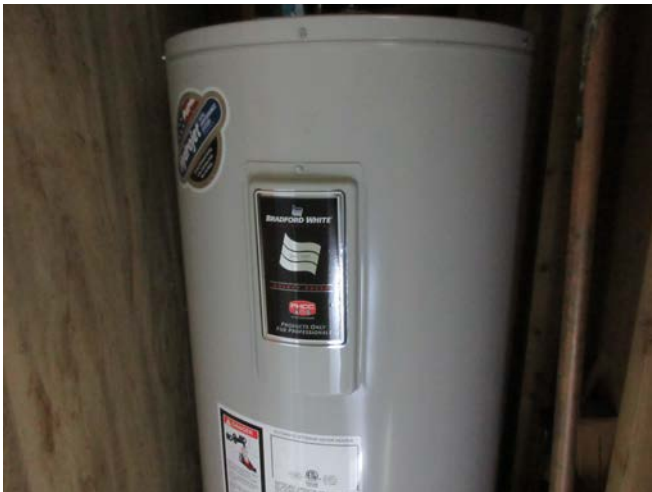
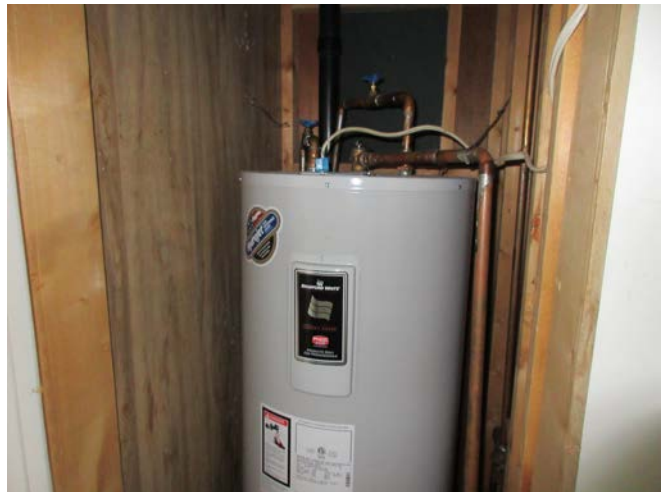
The hot water tank was manufactured dated Feb 2013. The water tank life expectancy is 7-12 years. It has no leaks and is functioning well at the time of this home inspection.

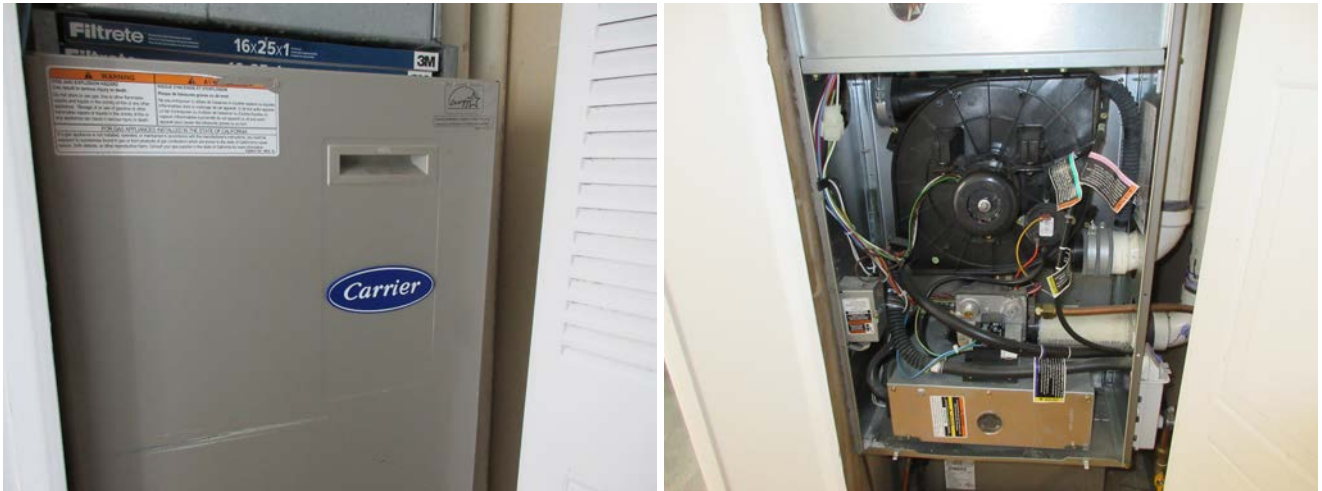
The furnace is a high-efficiency type with input 80000 BTU. The furnace manufactured in dated Apr 2007. The furnace was functional at the time of this inspection.

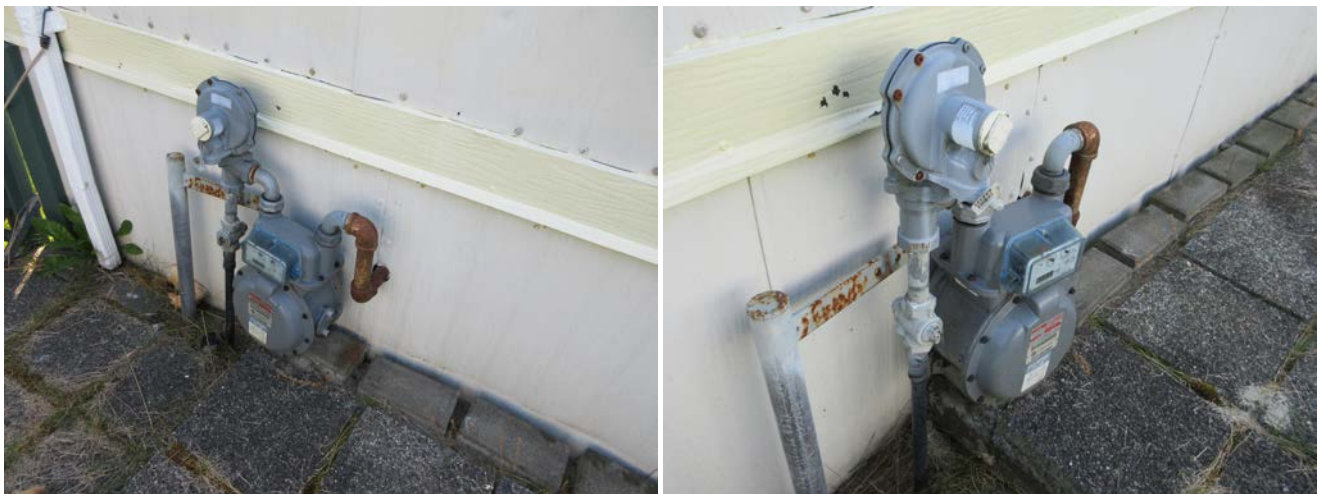
The gas meter was located on the north east of the house. The rust sign was noted on the meter component. I recommend repainting the meter pipe.

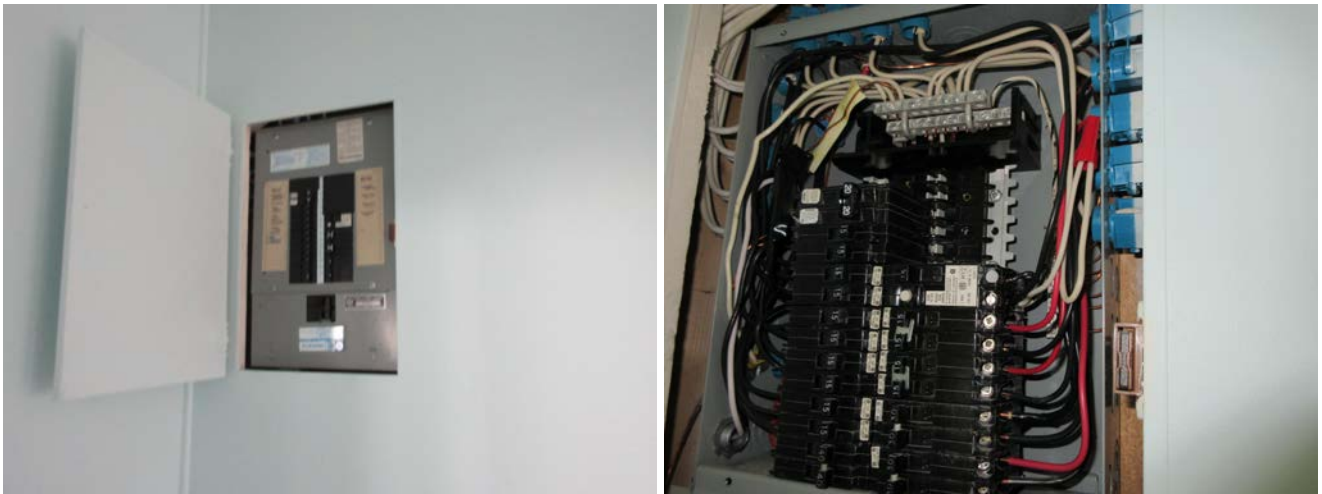
The main panel is located in the northwest corner bedroom and is professionally installed. The electrical panel was 100 Amp and accessible. The wire type of the house was copper. It shows no burnt, damaged, or corroded wires and is labeled. Appropriate circuit breakers and sized wires were used for specific circuits (i.e. 40 amp for the range, 30 amp for the dryer, and 15 amp for general circuitry).

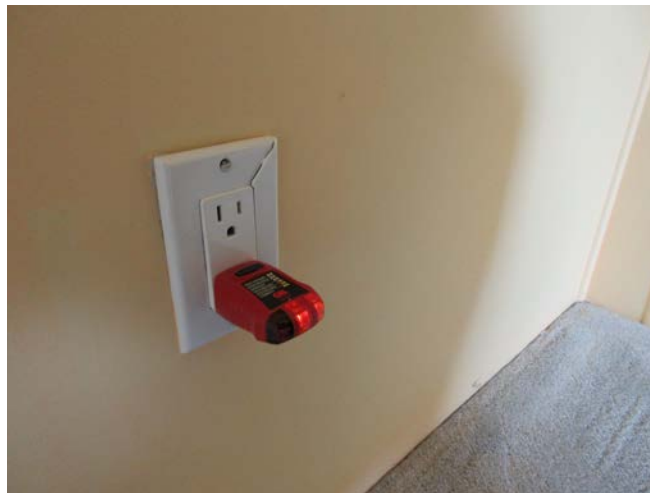
The outlet cover was broken in the master bedroom of the house. I recommend replacing the outlet cover with the new one.

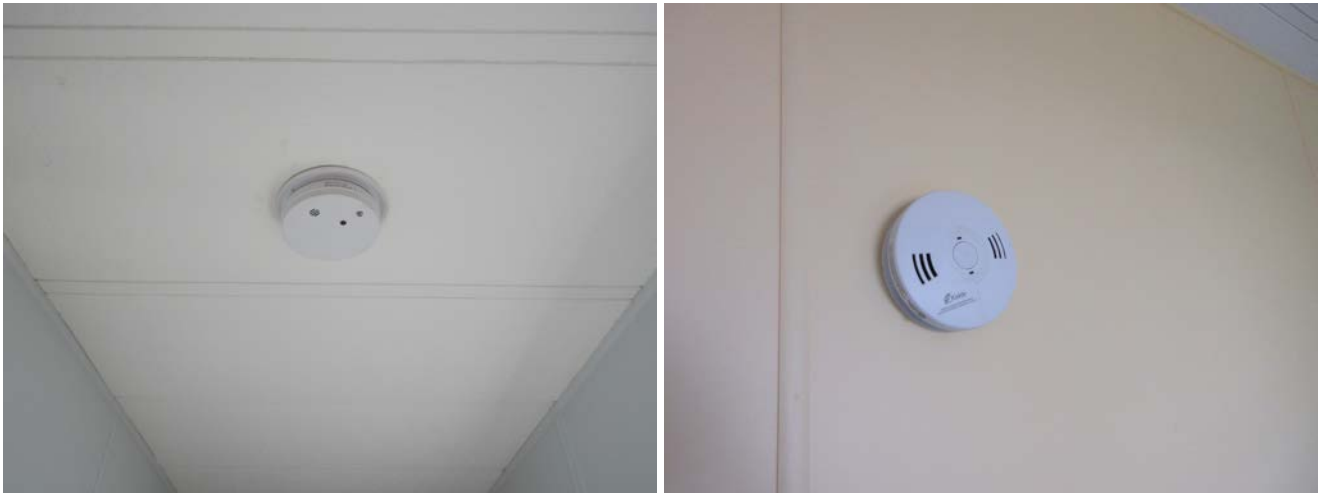
The smoke detector need to be replaced after 10 years and the battery need to be check annually. Replacing smoke detector when moving into a new residence is recommended.

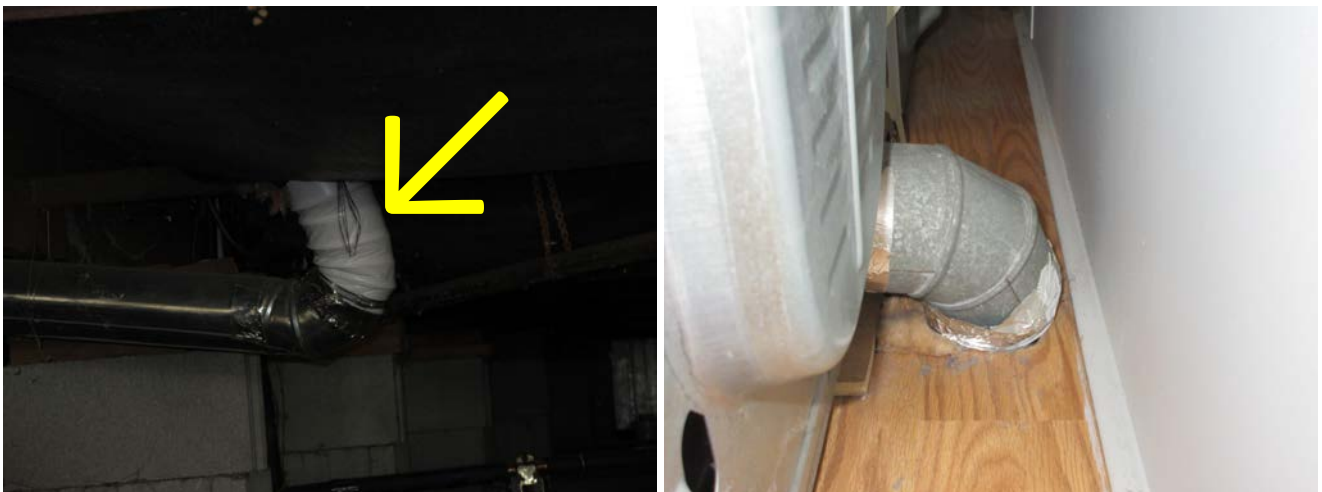
The dryer has small portion of vinyl vent which is not approved for the dryer. The hard metal type vent only is accepted and recommended for dryer. I recommend installing the hard metal duct for the dryer in the laundry room.

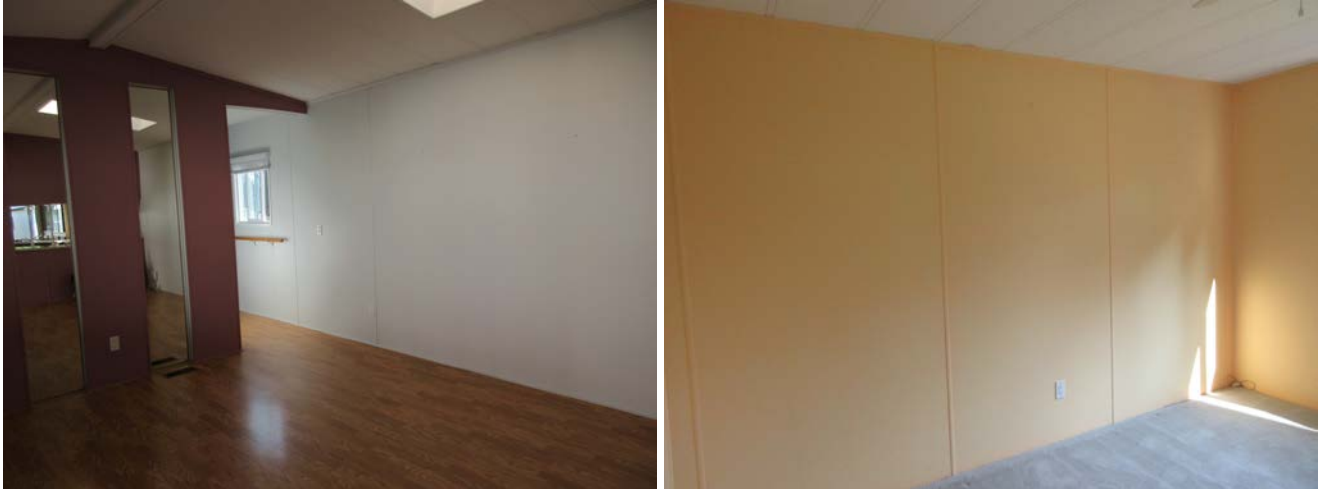
The house had vinyl on gypsum panel. The wall coverage seems to be good and is functioning well at the time of this inspection.

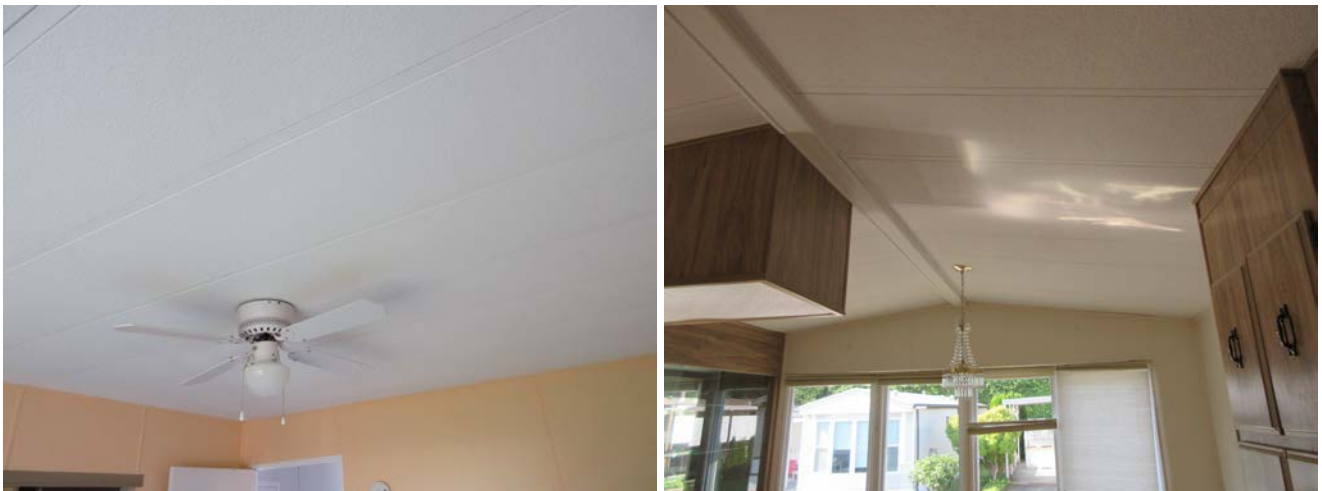
The house ceiling was sheetrock ceilings panel. The ceiling coverage seems to be good and is functioning well at the time of this inspection.

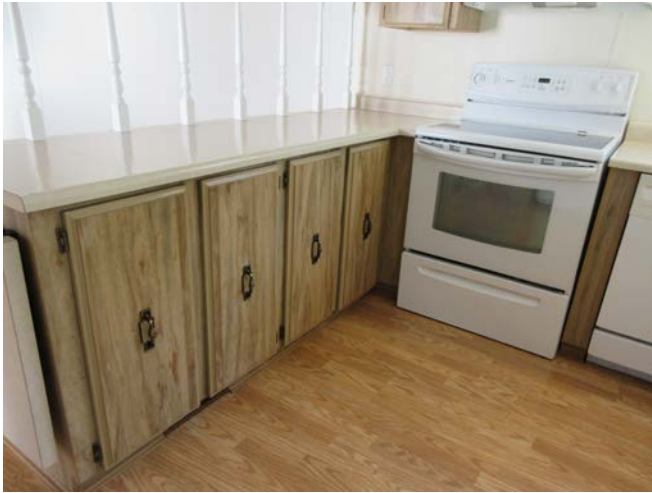
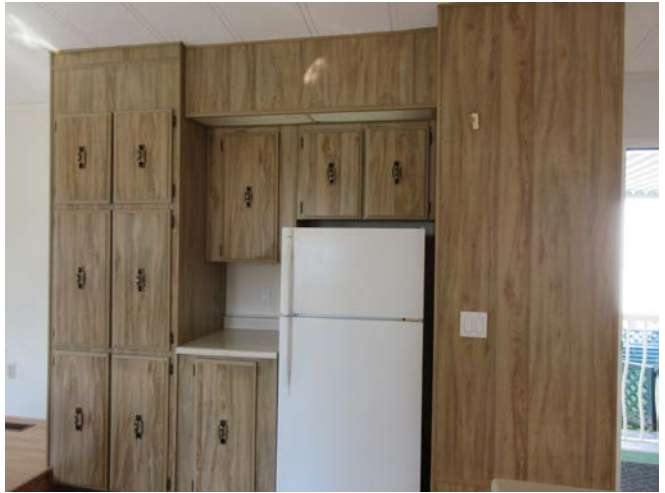
The kitchen cabinet was wood type. The cabinet and counter seems to be good and is functioning well at the time of this inspection.

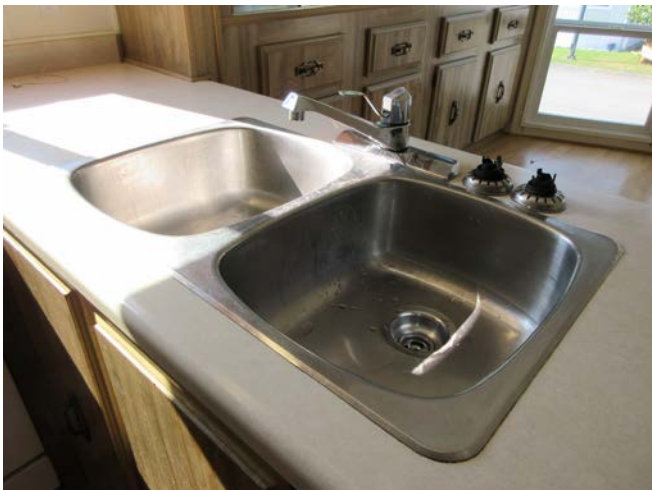
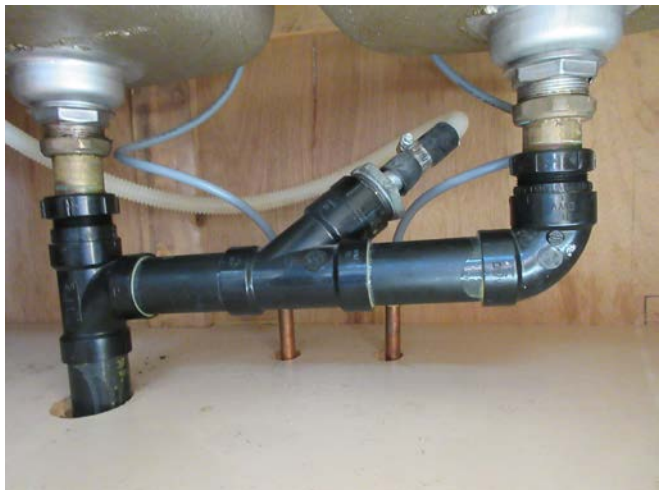
There was no water leakage under the kitchen sink. The sink seems to be good and is functioning well at the time of this inspection.

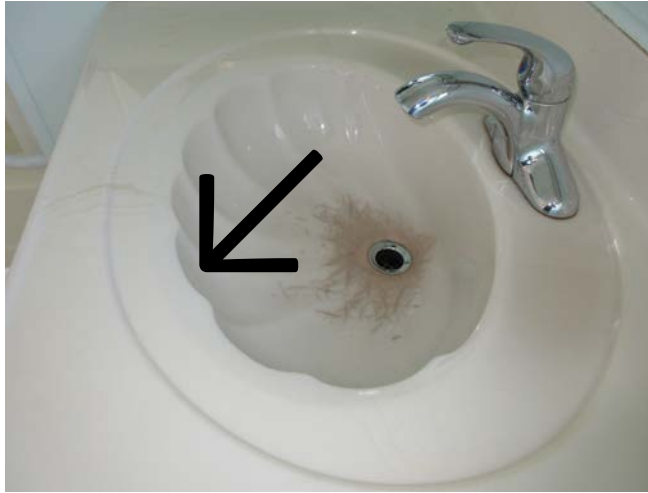
The basin had no hole to discharge overflow water in the basement washroom of the house.

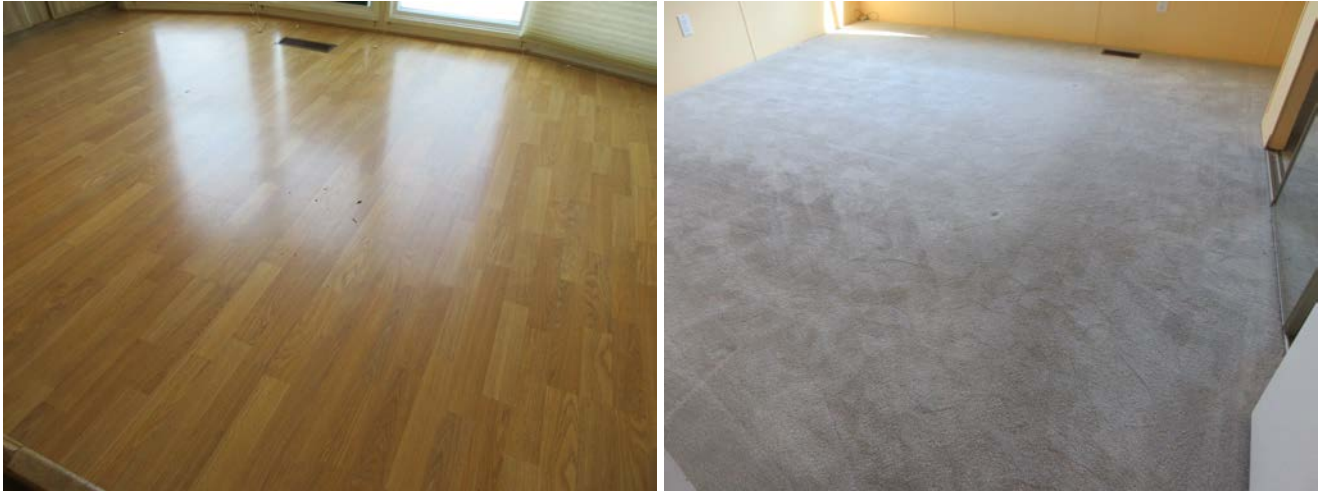
The condo floor was covered by carpet, laminate. The house floor coverage seems to be good and is functioning well at the time of this inspection.
