# Home Inspection Report

New Westminster, BC

Property Address: New Westminster, BC  
 Date of home inspection: September 11, 2020  
 Inspection start time: 9:00 AM  
 Inspection end time: 1:30 PM  
 MLS#: not available  
 Year Built: 2018  
 Construction: Concrete / Wood  
 Furnished: No  
 Occupied: No  
 Floor Area Total: 2341 sq. Ft.

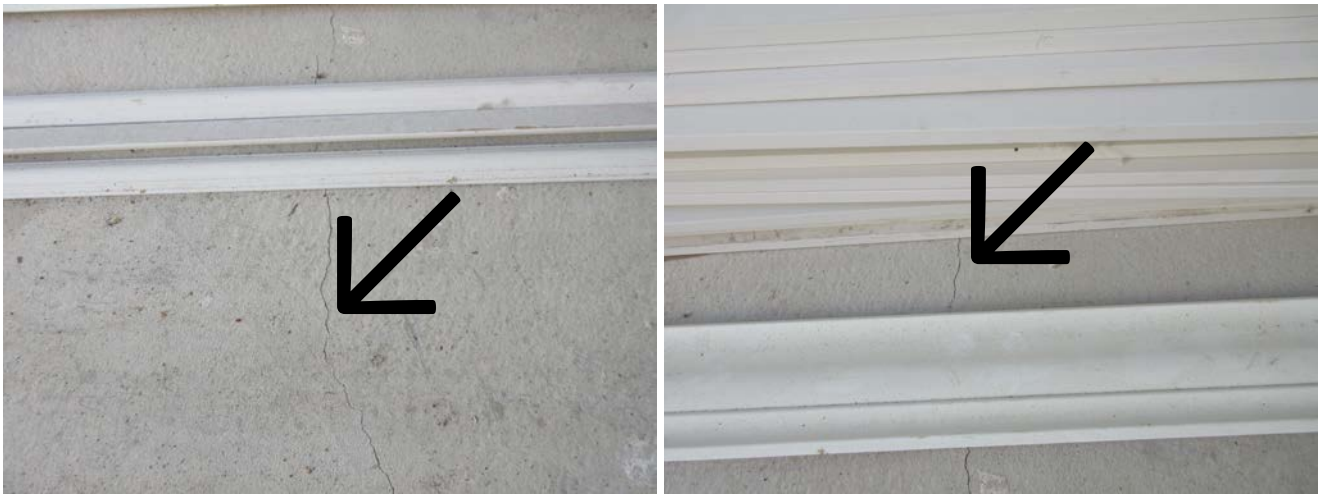
A number of cracks was observed on the garage concrete floor. The crack needs to be monitor for any changes contacting a qualified contractor for more action.

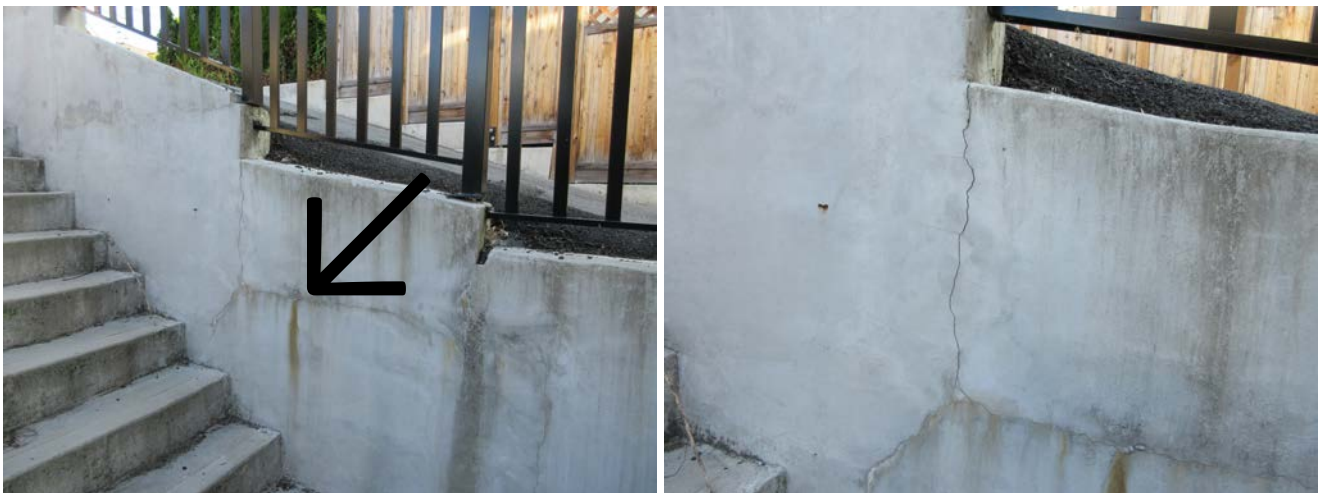
Significant, cracks and bowing were found on the concrete retaining wall in the north-east of the house. Fixing the retaining wall is recommended.

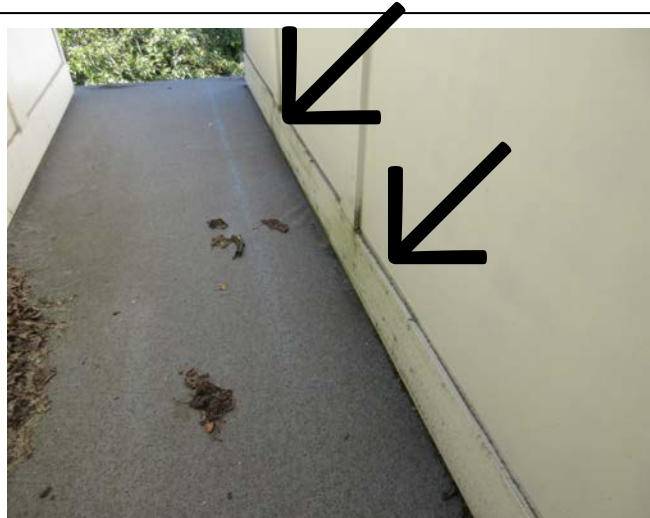
The wood siding was bulged on the south side of the master bedroom. I don't know to what extent the wall component of the wall was damaged. Fixing the wall wood siding and installing step flashing is recommended. To protect the wood, periodic re-painting is important.

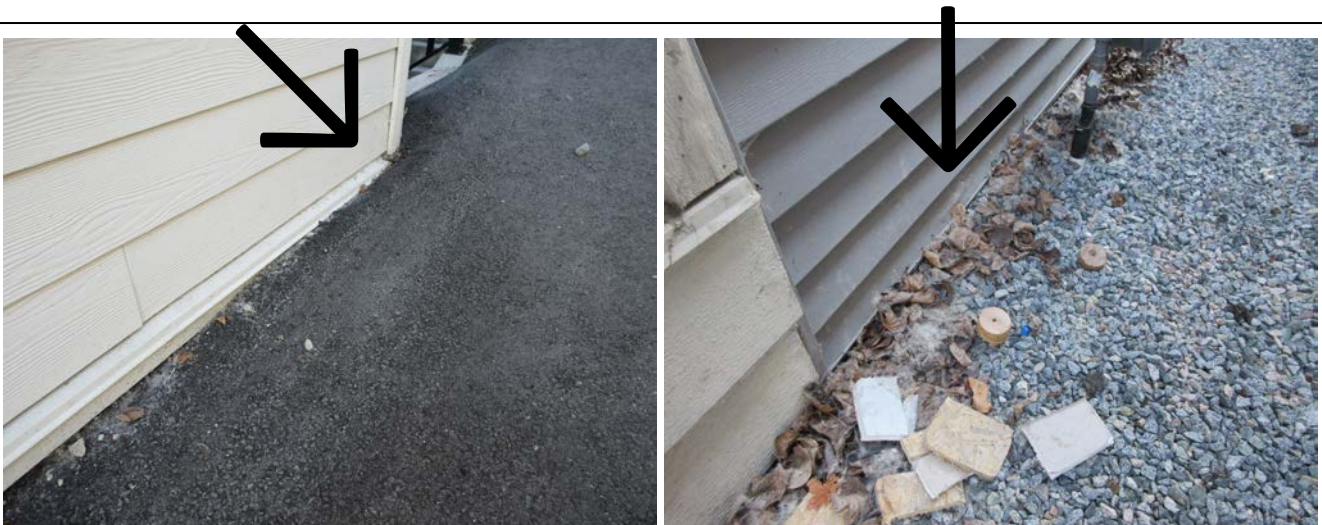
The wall cladding touched the ground in the north east and west side of the house. The wall cladding is needed clearance 6-8" with the ground. I recommend the 6-8" clearance to prevent water entering the wall cladding and component.

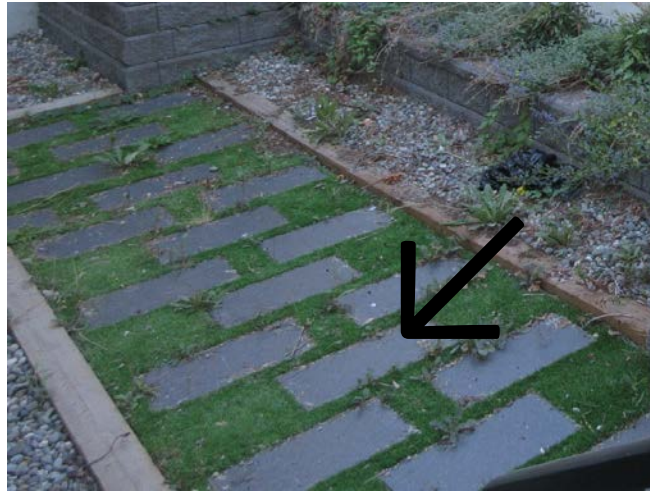
A number of loose floor stone was noted in the yard of the house. Fixing the floor stone is recommended.

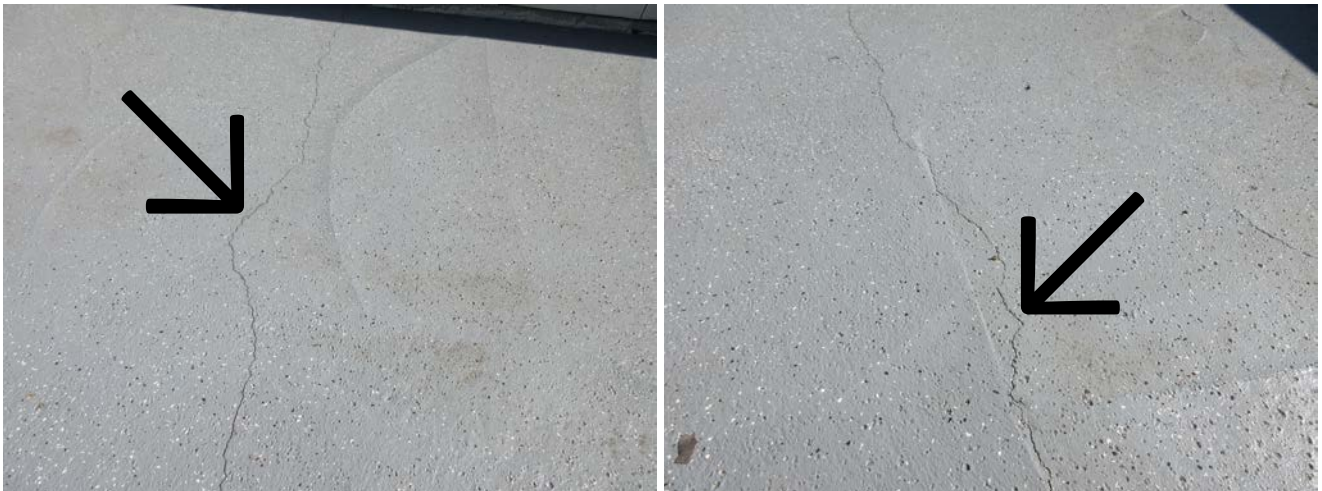
A number of significant cracks was noted on the roof deck concrete floor. The cracks needs to be monitor for any changes contacting the qualified contractor for more action.

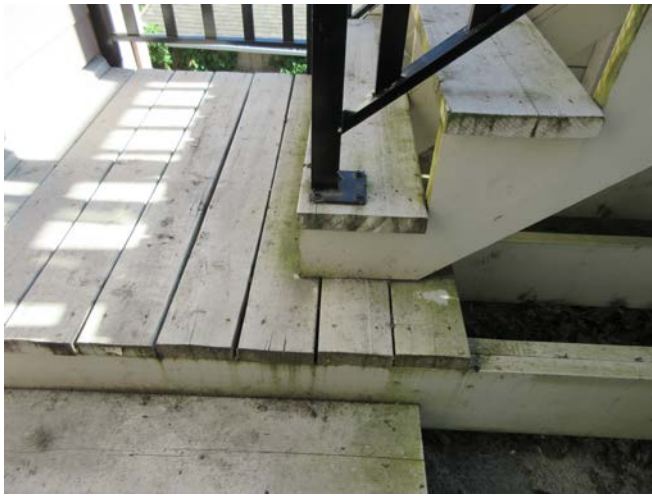
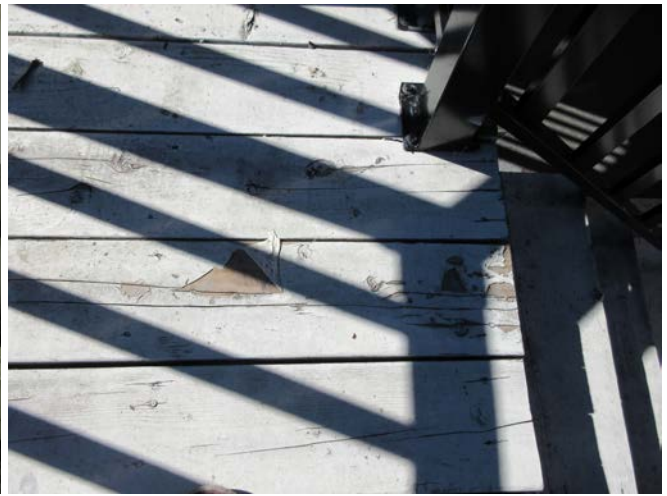
The paint of deck wood stair paint was peeling off in the roof of the house. A number of cracks were noted on the stair wood as well. Fixing the wood stair run is recommended.

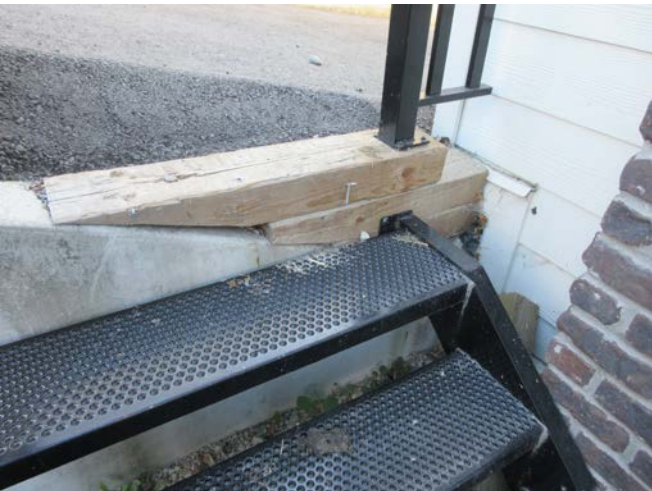
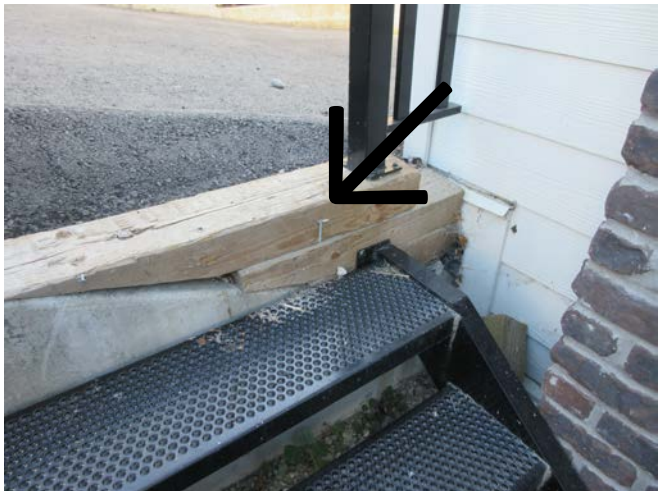
Half part of stair was concrete and half was wood in the yard of the house. The last stair run was implement unprofessionally. The nail was noted on the stair run. The exterior stair's step is unsafe. Do not use the stair until fixing the issue by a qualified contractor.

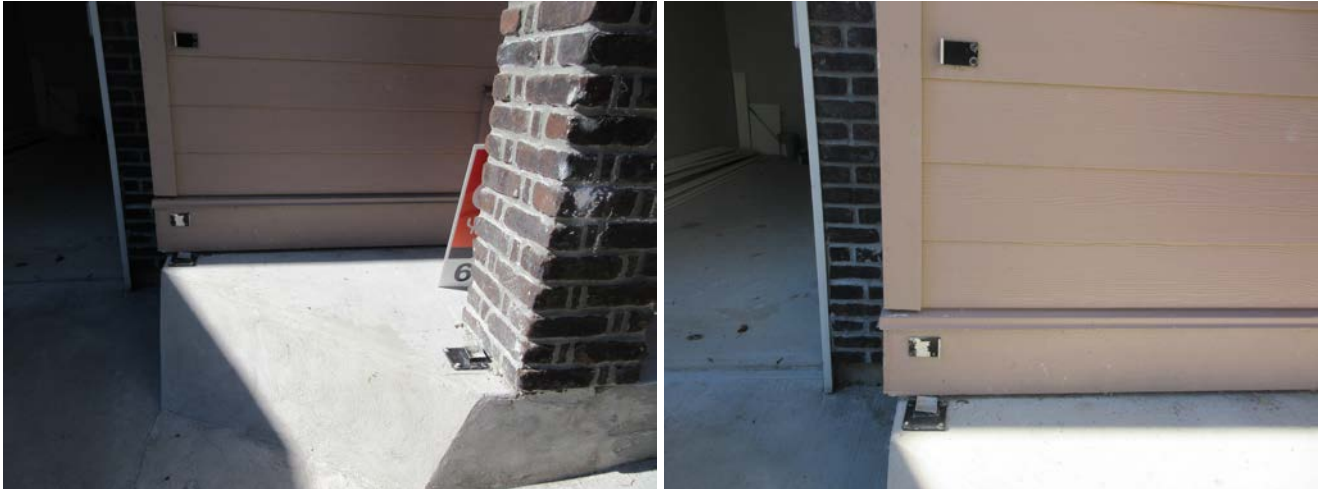
The guard and railing was removed in left side of main entrance of the house. It is a safety concern. I recommend hiring a certified contractor to replace the guard and railing.

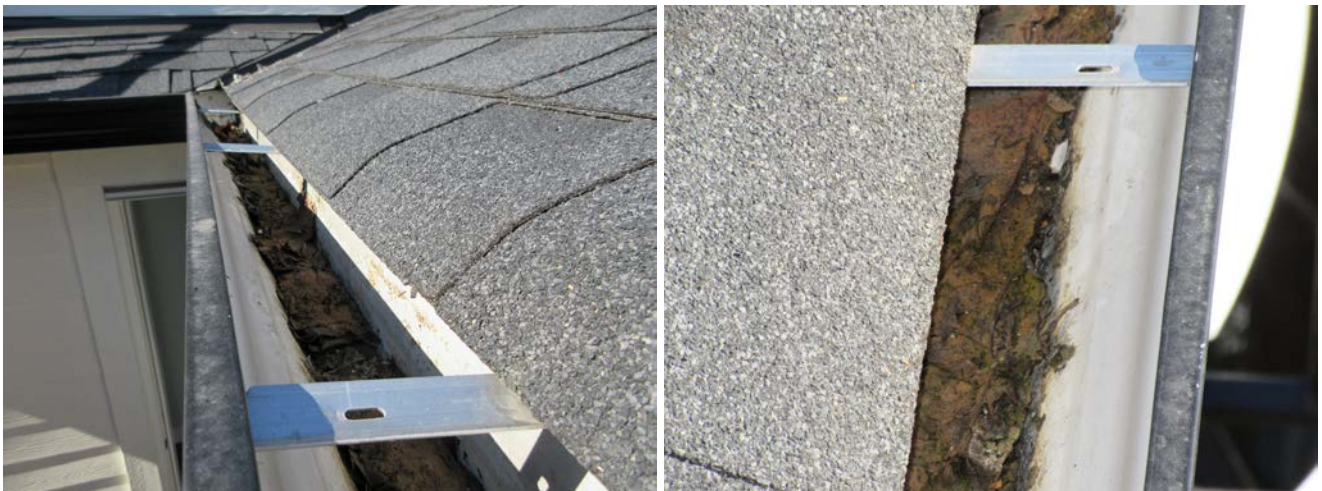
The debris and tree leaves were noted inside of the roof gutter. I recommend clean the gutter to prevent any water leakage to the soffits. Gutters that drain poorly or clogged can lead to many costly problems such as deterioration of fascia, soffit or roof edge. It can also cause gutters to pull loose and lead to possible water intrusion.

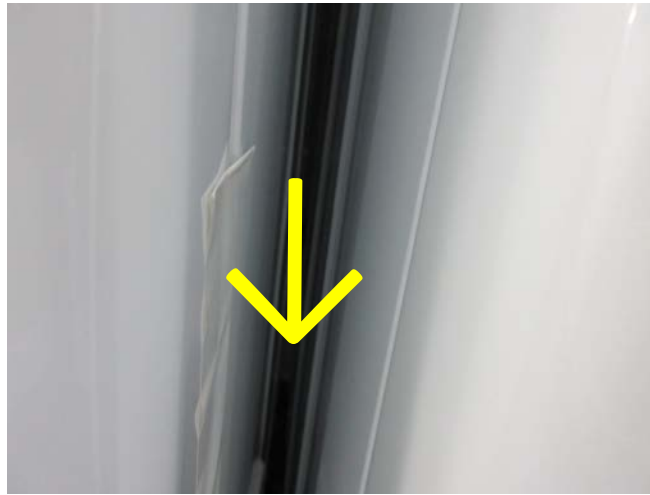
The rubber hose was used for the supply water of washing machine. The water pressure can expand the rubber hose in the long time. The expanded hose may cause the hose has water leakage. I recommend changing the rubber hose type with the (Metal) flexible tap connector type.

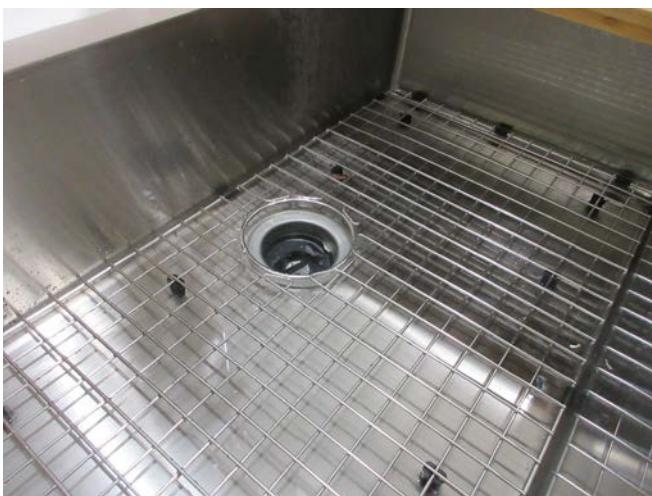
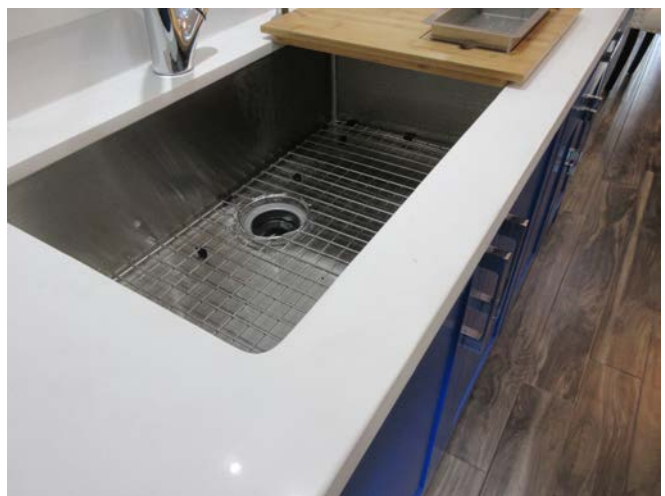
The water was clogged and was discharging slowly from the kitchen sink in the house. Fixing the clogged and discharging water in the sink is recommended.

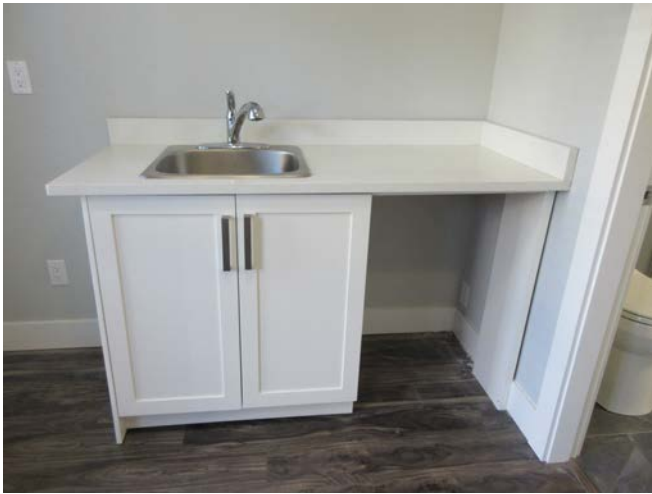
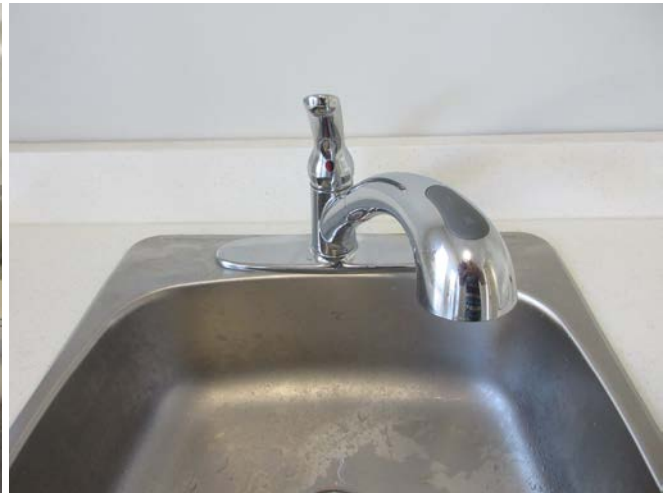
The water pressure was low for the sink faucet in the entrance room. The faucet hot water valve and cold water valve was reversed. Monitor the water pressure change to fix by a qualified plumber is recommended.

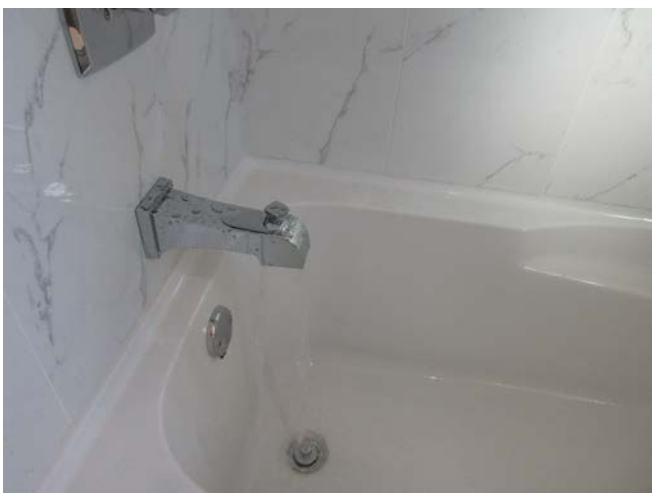
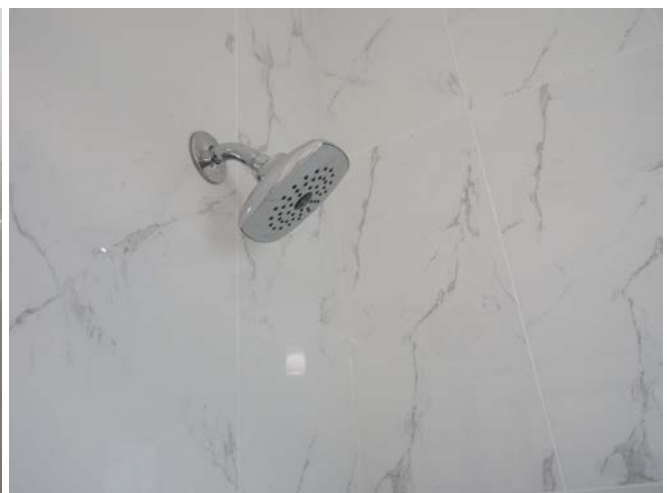
The water pressure looks low for the tub shower and spout. Monitor the water pressure change to fix by a qualified plumber is recommended.

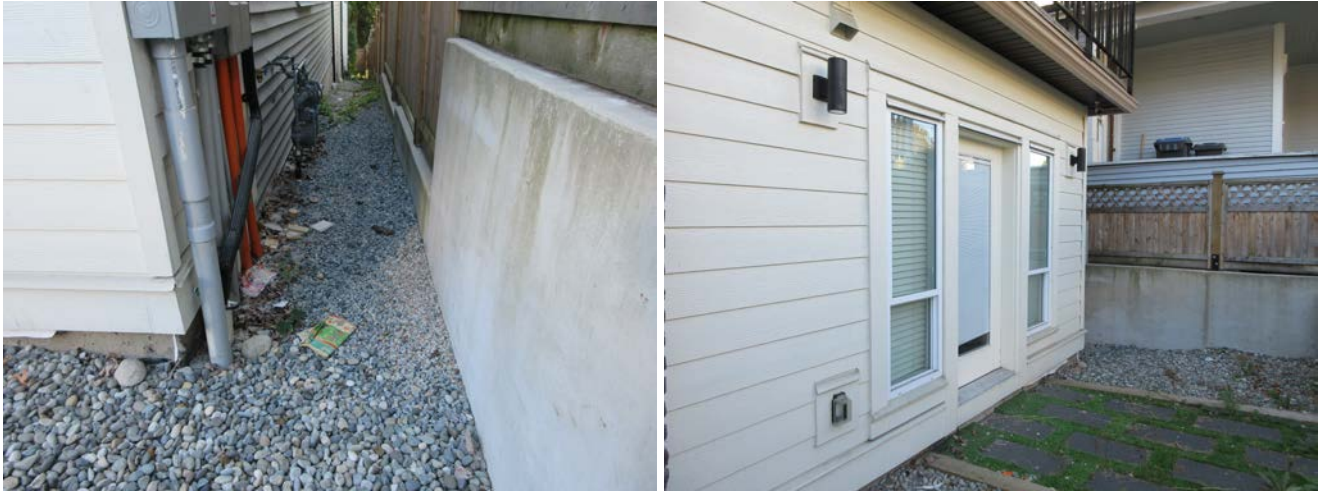
I was not able to find drainage system in the north and west side of the house. The drainage around the house prevent water entering to the crawlspace of the house.

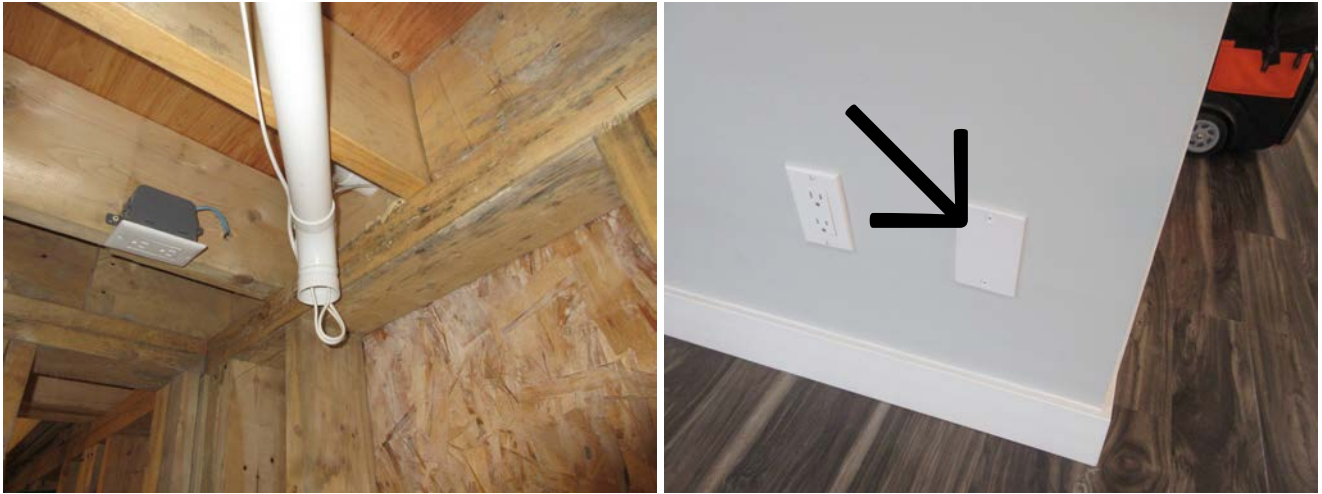
The central vacuum and inlet were not installed in the crawl space and two floors of the house.

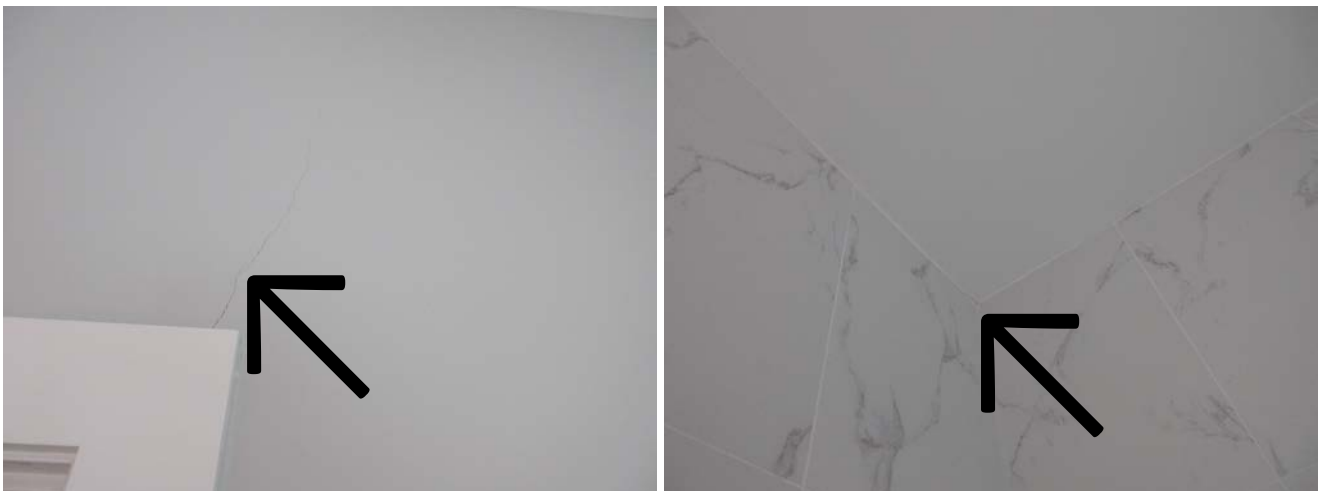
A number of cracks were noted on the wall of the bedroom in the on the ground floor of the house. The cracks need to be monitored for any changes contacting a qualified contractor for more action. I recommend re-painting the wall. T

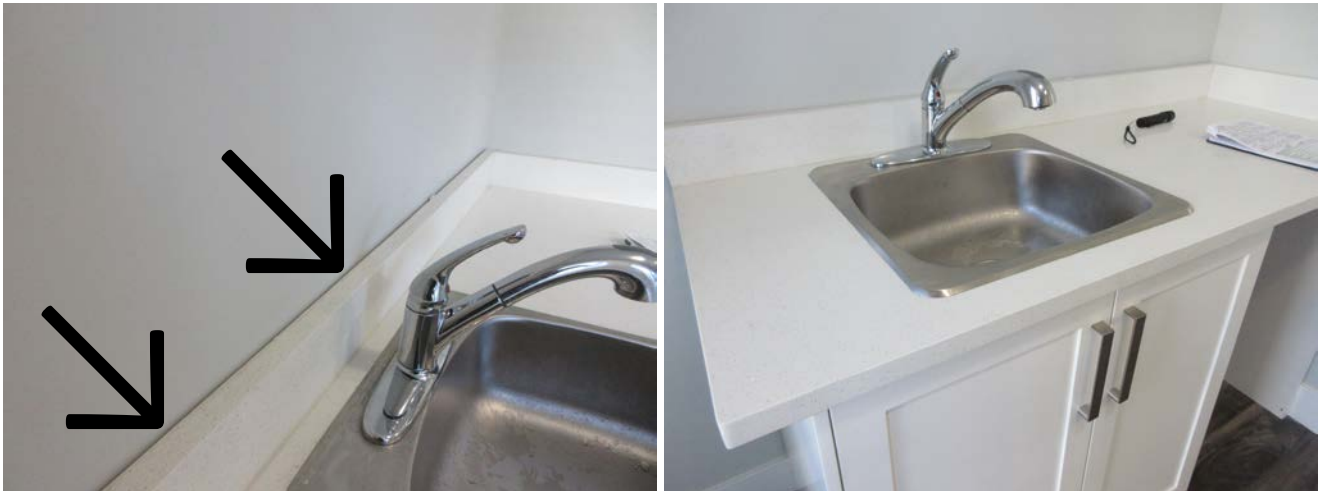
The gap was noted between the counter baseboard and the wall in the entrance room. Fixing the cabinet base board to prevent splashing water entering to the back of cabinet is recommended.

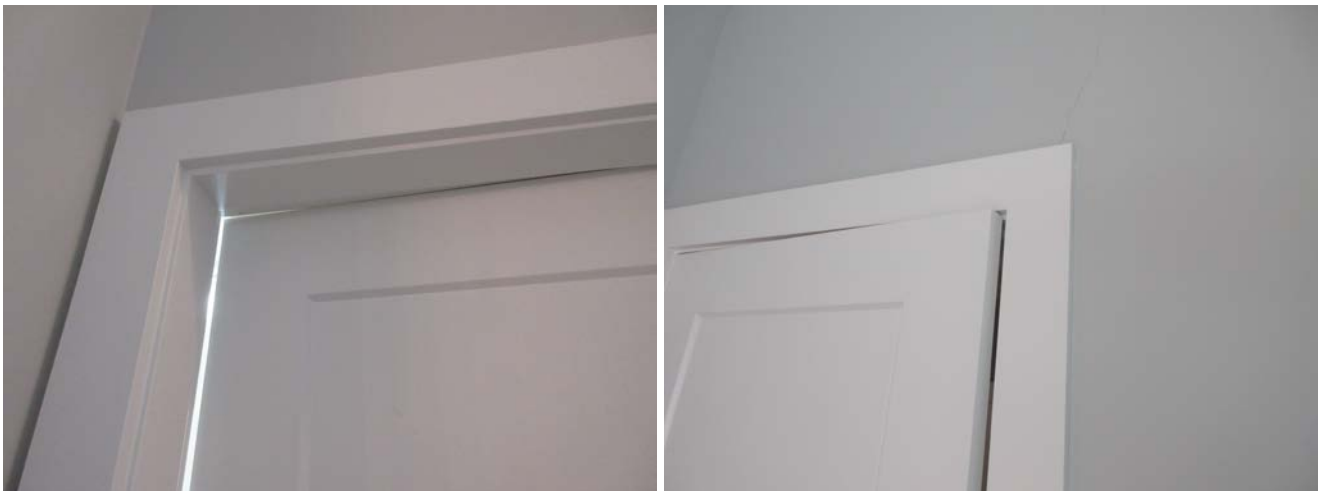
A number of the bedroom and the closet door stuck to the frames in the main floor bathroom, main floor door by dining room, and walk in closet door in top floor. I was not able to keep shut the closet door in the master bedroom of the house. Fixing all stuck room door and closet door in the house is recommended.
