Home Inspection Report

North Vancouver

Property Address: North Vancouver, BC			
Date of home inspection:	June 26, 2020		
Inspection start time:	9:00 AM		
Inspection end time:	12:30 PM		
MLS#	not available		
Year Built:	1978		
Construction:	Concrete / Wood		
Furnished:	Yes		
Occupied:	Yes		
Floor Area Total:	2122 sq. Ft.

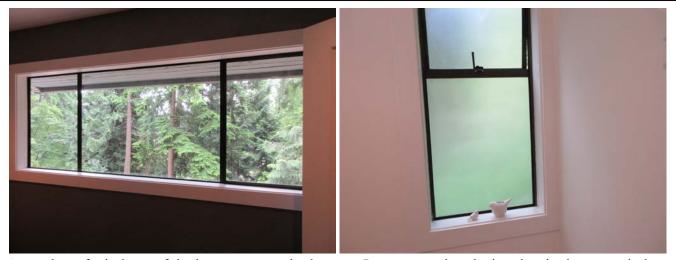
1.1 Windows

A number of windows of the house were a single pane. I recommend replacing the single pane window with the double pane to save the heating of the house.

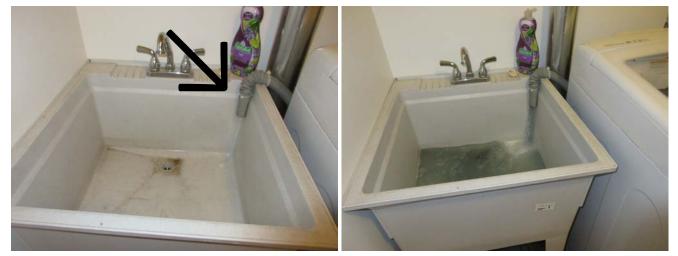
2.2 Washing Machin & Dryer

The washing machine sewage water discharge to the laundry sink. The washing machine sewage hose need to be connected to the sewage system of the house as I recommend.

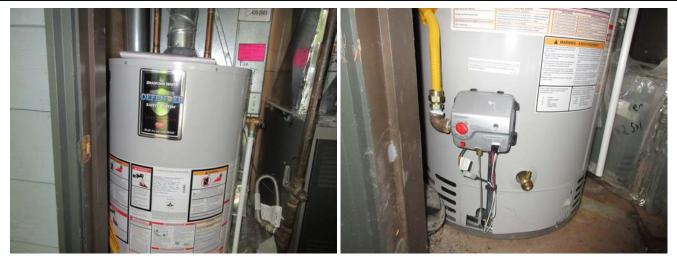
2.3 Hot Water Tanks

The hot water tank was manufactured dated Mar 2017. The water tank life expectancy is 7-12 years. It has no leaks and is functioning well at the time of this home inspection.

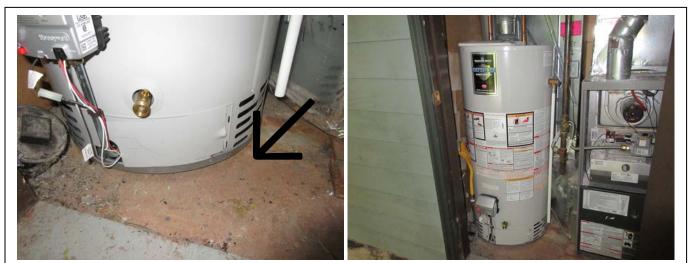
There is no drain pan and no seismic strapping. At present, water of overheating is draining onto the floor and could enter the house and damage the interior. I recommend seismic strapping and a pan drain be installed properly.

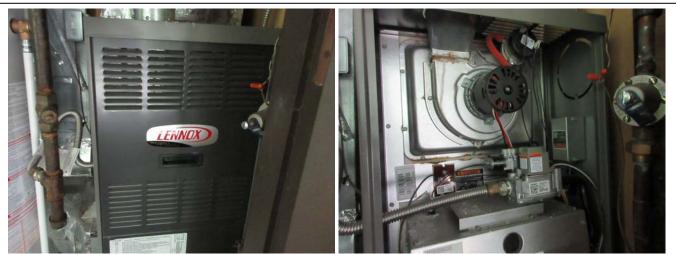
3.1 Furnaces

The furnace is a mid-efficiency type with input 88000 BTU. The furnace manufactured in dated 2009. It is functioning well at the time of this home inspection.

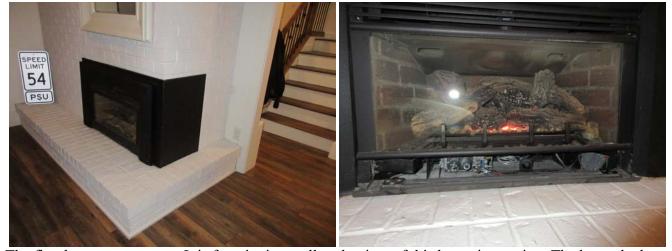
3.2 Fire Place

The fireplace was gas type. It is functioning well at the time of this home inspection. The house had wood burning type fireplace. The wood burning fireplace was replaced with the gas burning type.

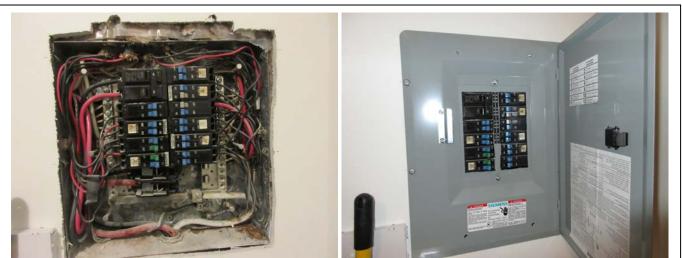
4.1 Main Electrical Panel

The main panel is located in the laundry room and is professionally installed. The electrical panel was 100 Amp and accessible. It shows no burnt, damaged, or corroded wires and is labeled. Appropriate circuit breakers and sized wires were used for specific circuits (i.e. 30 amp for the dryer, and 15 amp for general circuitry).

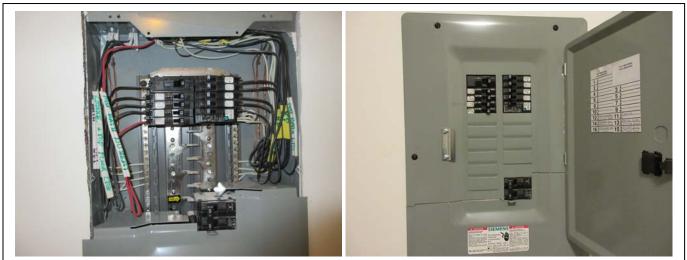
The sub-electrical panel was 60 Amp and the main breaker was 100 Amp. It is functioning well at the time of this home inspection.

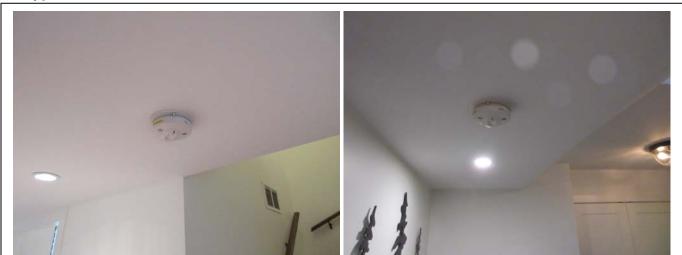
4.2 Smoke Detector & Carbon monoxide

The smoke detector need to be replaced after 10 years and the battery need to be check annually. Replacing smoke detector when moving into a new residence is recommended.

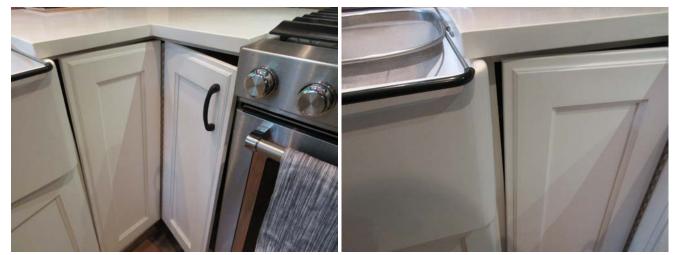
5.1 Counters and Cabinets

The cabinet hinge door was broken and hanged up. The gap was noted around the cabinet door. Fixing the cabinet door is recommended.

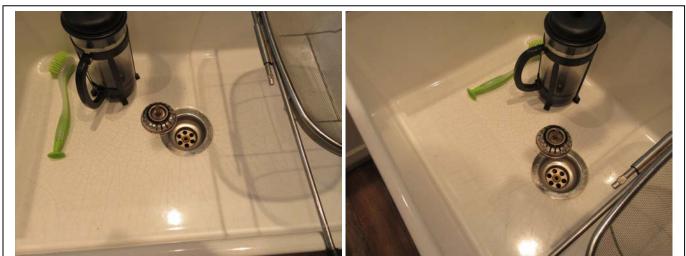
5.2 Kitchen sink & Garbage disposal

A number of surface crack was noted on the kitchen sink. It seems to be the cosmetic crack.

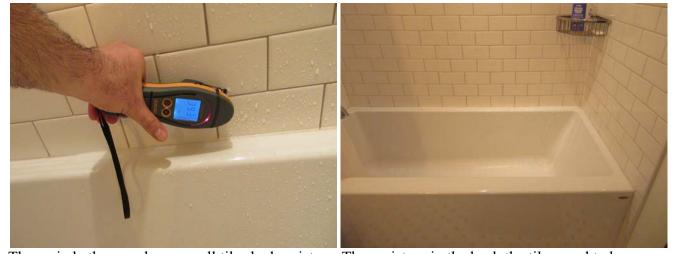
5.3 Bathroom & Washroom

The main bathroom shower wall tiles had moisture. The moisture in the back the tiles need to be monitored for any changes contacting a qualified for more action.
