ABC Home Inspections
Home Inspection Report
Confidential

Prepared exclusively for
87 Nelson St, Vancouver, BC

Property Address: 87 Nelson St, Vancouver, BC
Date of home inspection: Thursday, July 25, 2024
Inspection start time: 10:00 AM
Inspection end time: 12:15 AM
MLS#: not available
Year Built: 2019
Construction: Concrete / Metal
Furnished: No
Occupied: No
Floor Area Total: 534 sq. Ft.

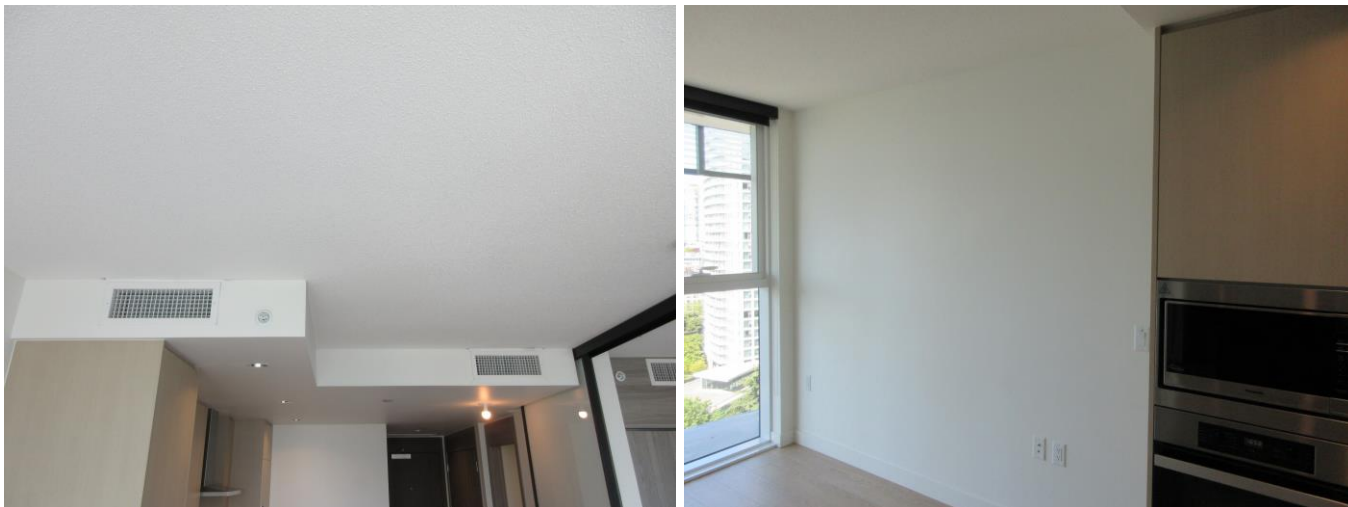
1.1 Main

The house features concrete floors, drywall ceilings, and metal-framed walls. The interior walls, ceilings, and floors showed no signs of defects or structural deficiencies at the time of this inspection.

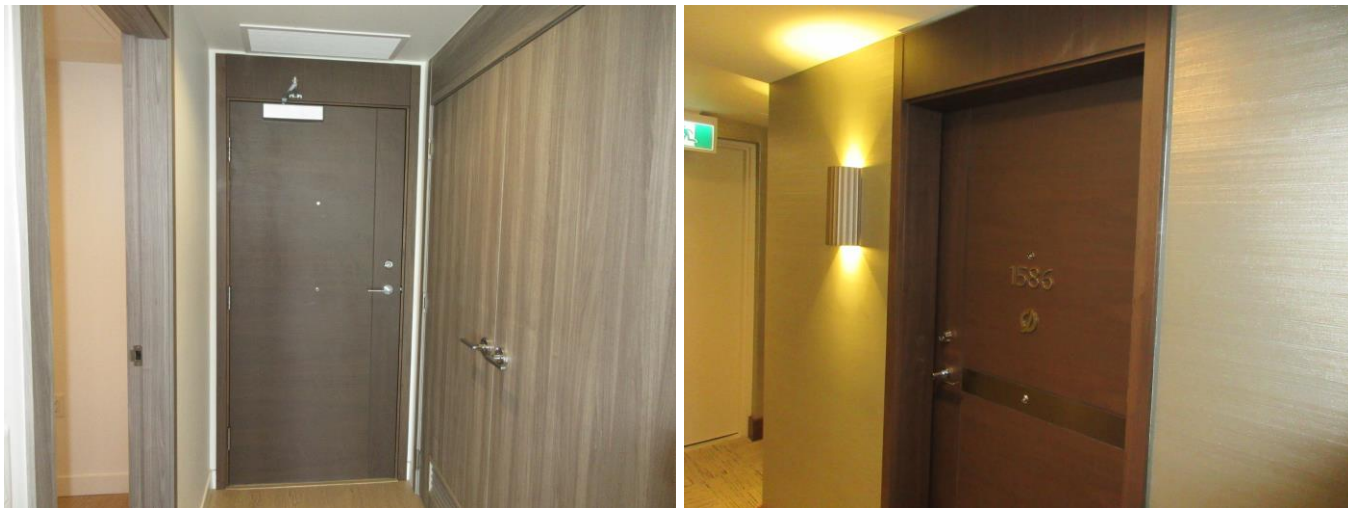
2.1 Exterior Door

The house features a wooden main entrance door. At the time of this inspection, the door was fully operational with no observed deficiencies. All interior doors, closet doors, and associated hardware were functional and in good condition.

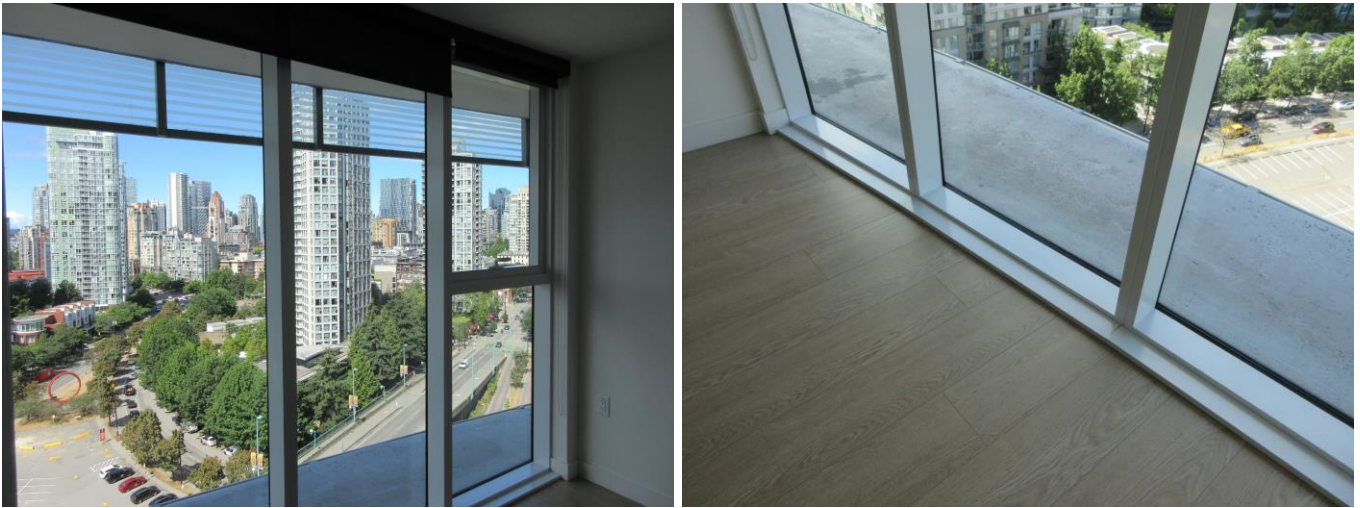
2.2 Window

The house is equipped with aluminum-framed, double-pane windows. At the time of this inspection, the windows were fully functional with no observed deficiencies in their operation or seals.

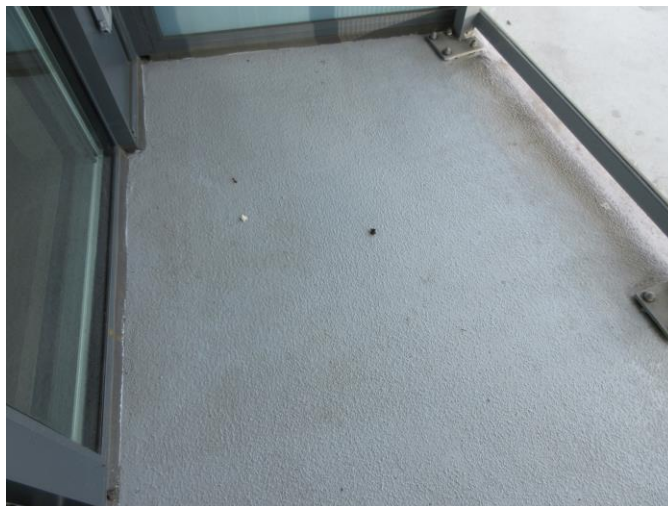
2.3 Balcony

The balcony on the south side of the house features an epoxy floor coating. The balcony showed no visible deficiencies and appeared to be performing as intended at the time of this inspection.

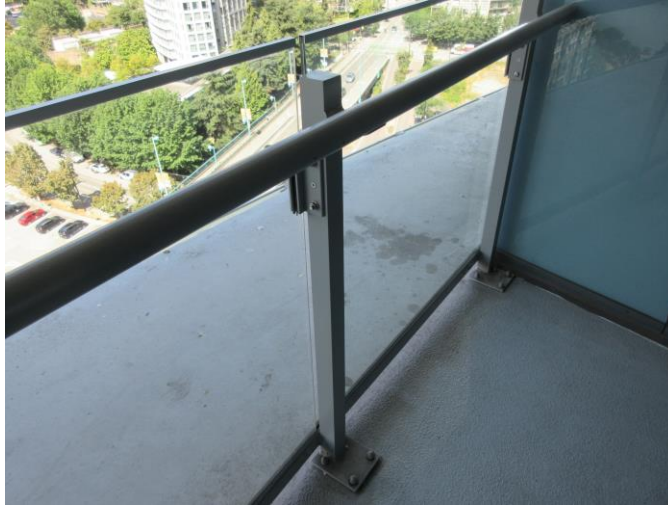
2.4 Guard and Handrail

The balcony features a metal-framed glass guard system. Both the handrail and the guard were found to be securely anchored and functional, with no observed deficiencies at the time of this inspection.

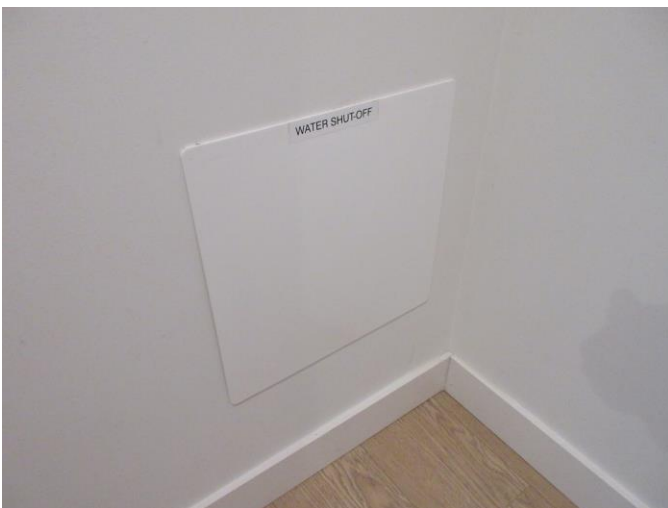
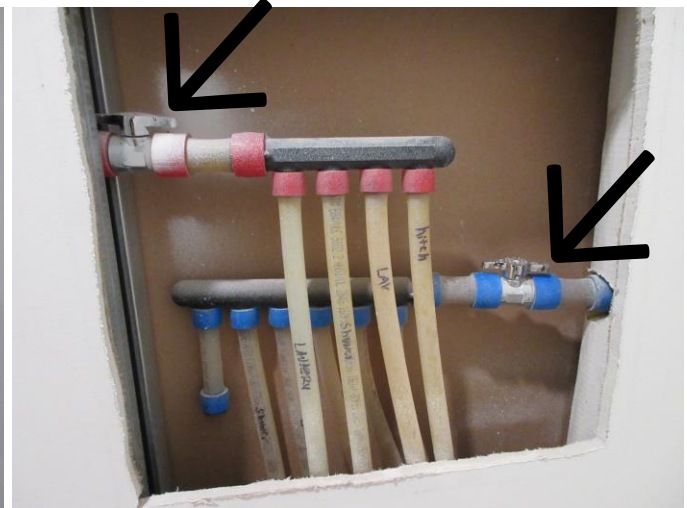
3.1 Water Supply System

The original water supply lines are Uponor PEX piping. The system was functional with no observed deficiencies at the time of this inspection. The typical life expectancy for PEX piping is 40 to 50 years. The main water shut-off valve is located in the den.

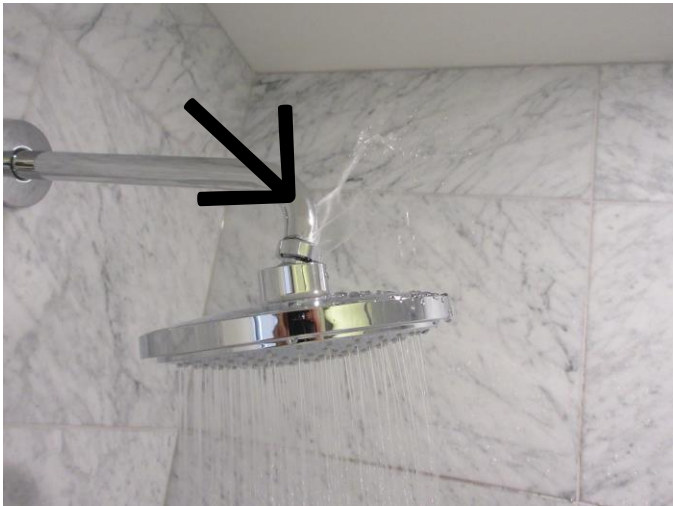
3.2 Bathtub

Active leakage was observed at the master bathroom shower head. It is recommended that a qualified individual repair or replace the fixture to prevent water waste and potential moisture issues.

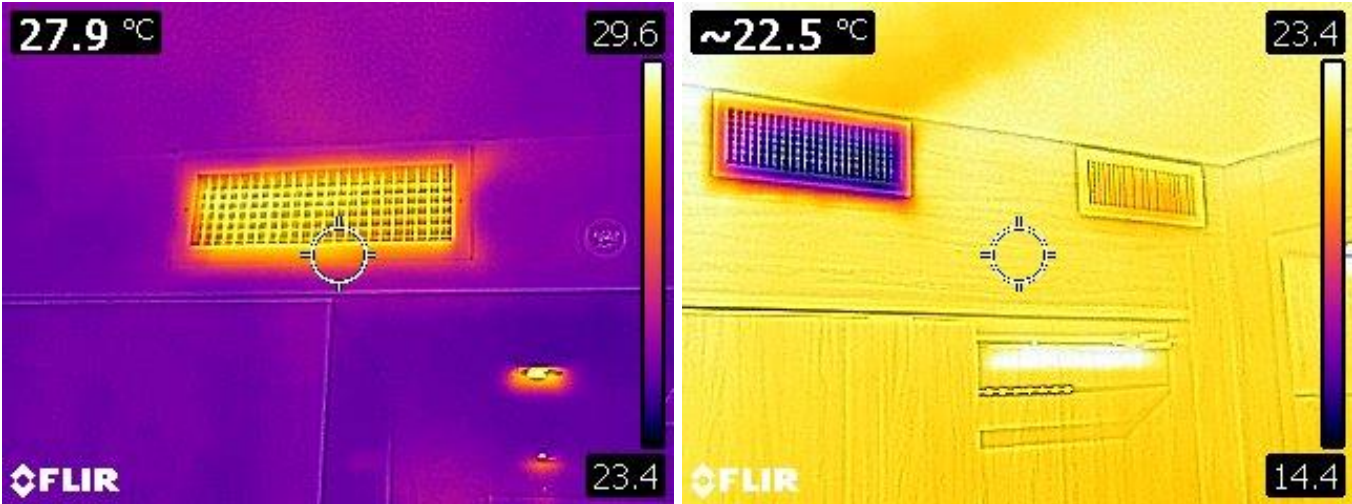
4.1 Fan coil

The property is equipped with a fan coil unit (FCU) connected to the central heating system. The unit was operated and tested; it was found to be fully functional with no observed deficiencies at the time of this inspection.

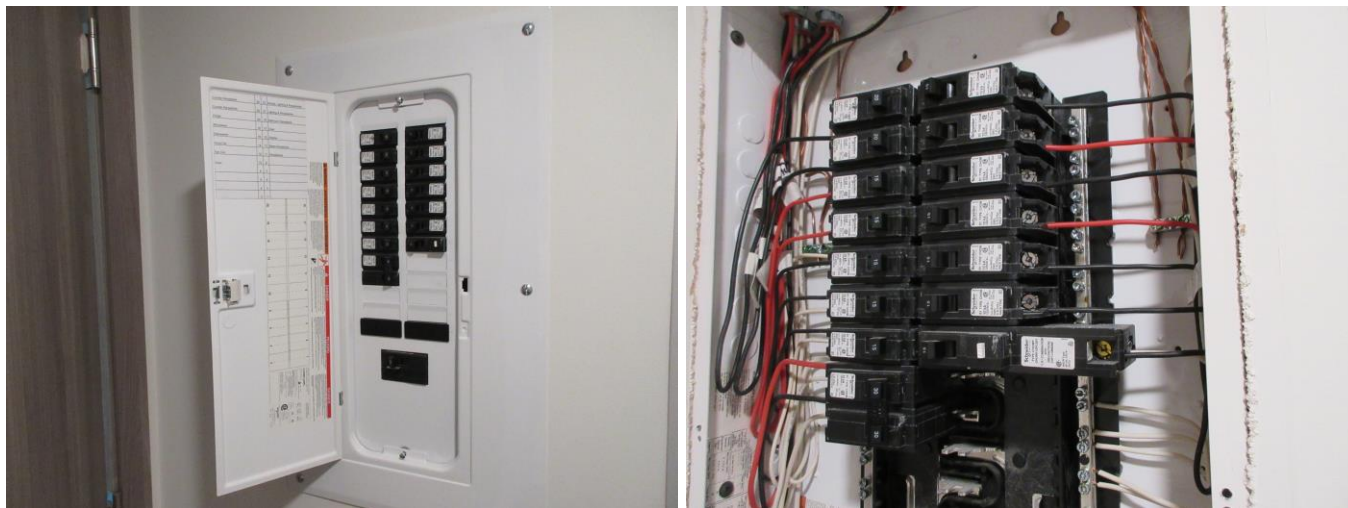
5.1 Main Electrical Panel

The 100-amp main electrical panel is located in the den and was professionally installed. The house is wired with copper, and no signs of burnt, damaged, or corroded wiring were observed. All breakers were clearly labeled. Appropriate circuit breakers and wire gauges were used for specific circuits (e.g., 30-amp for the dryer and 15-amp for general circuitry).

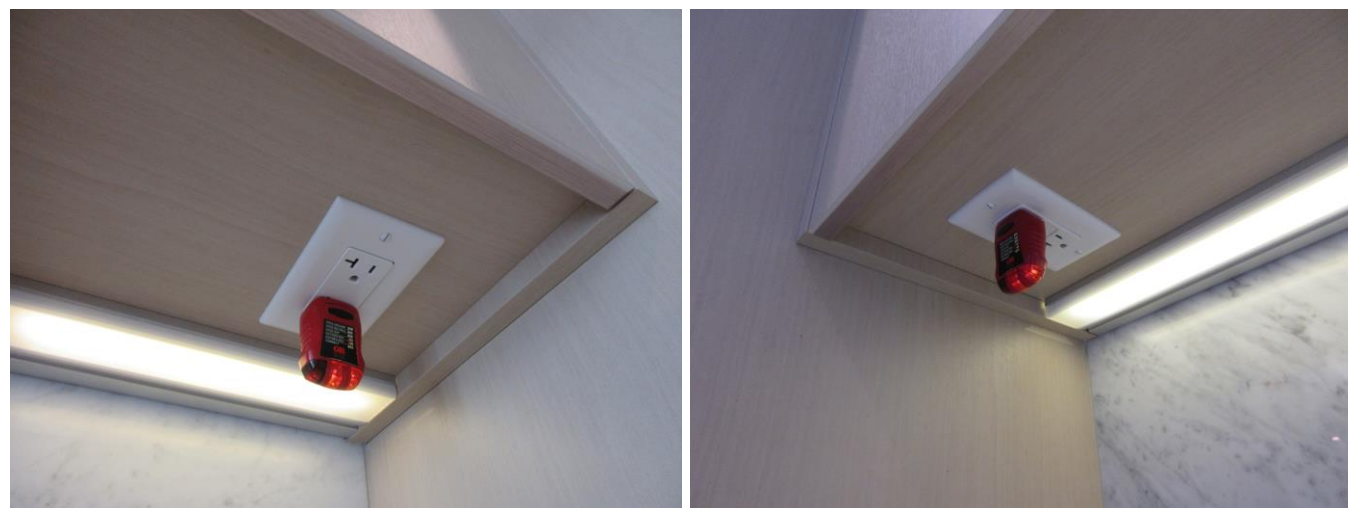
5.2 Outlet and Switch

GFCI-protected outlets were located in the kitchen. The units were tested and appeared to be in serviceable condition at the time of inspection.

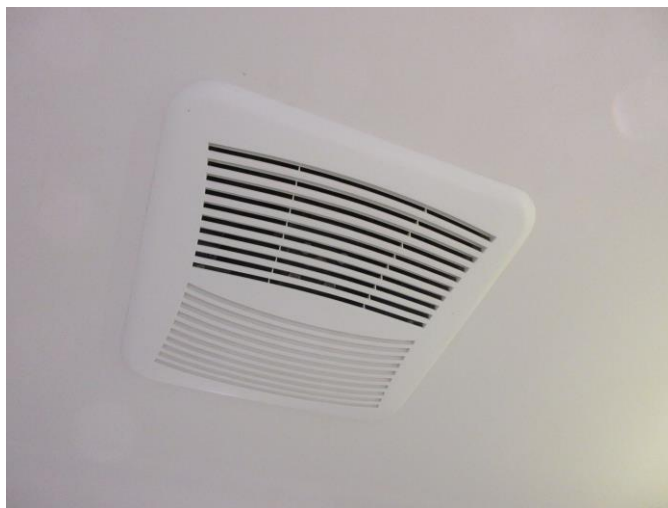
6.1 Bathroom & Washroom

Electrical exhaust fans were located in the bathrooms. These units were tested and found to be fully functional with no observed deficiencies at the time of inspection.

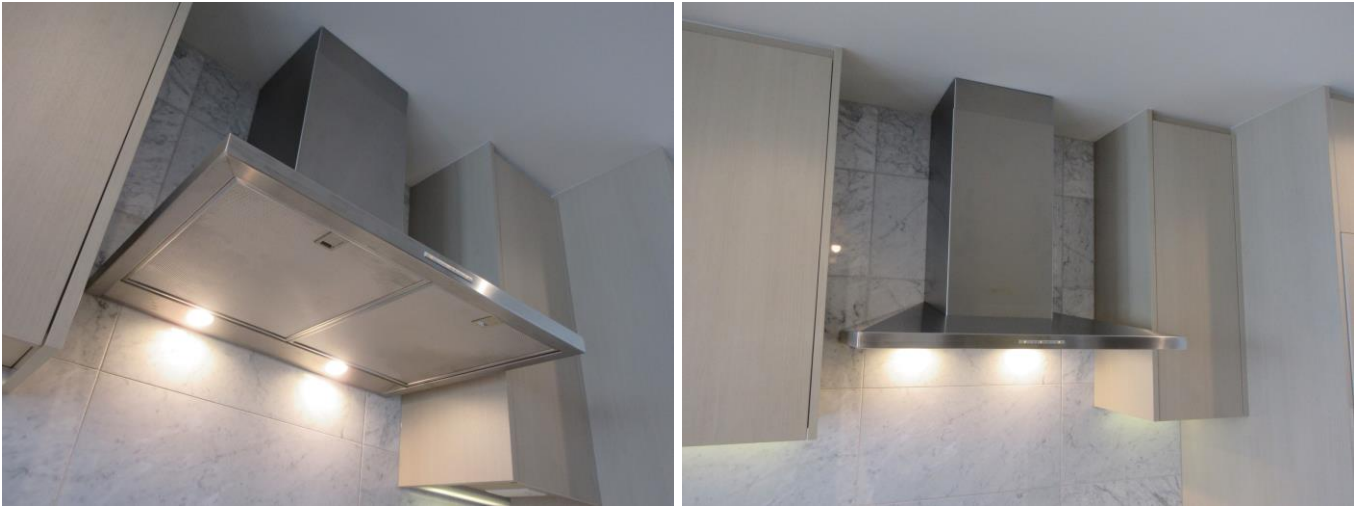
6.2 Rang Hood

The kitchen is equipped with an electric range hood. The exhaust fan and light were tested and found to be fully functional with no observed deficiencies at the time of inspection.

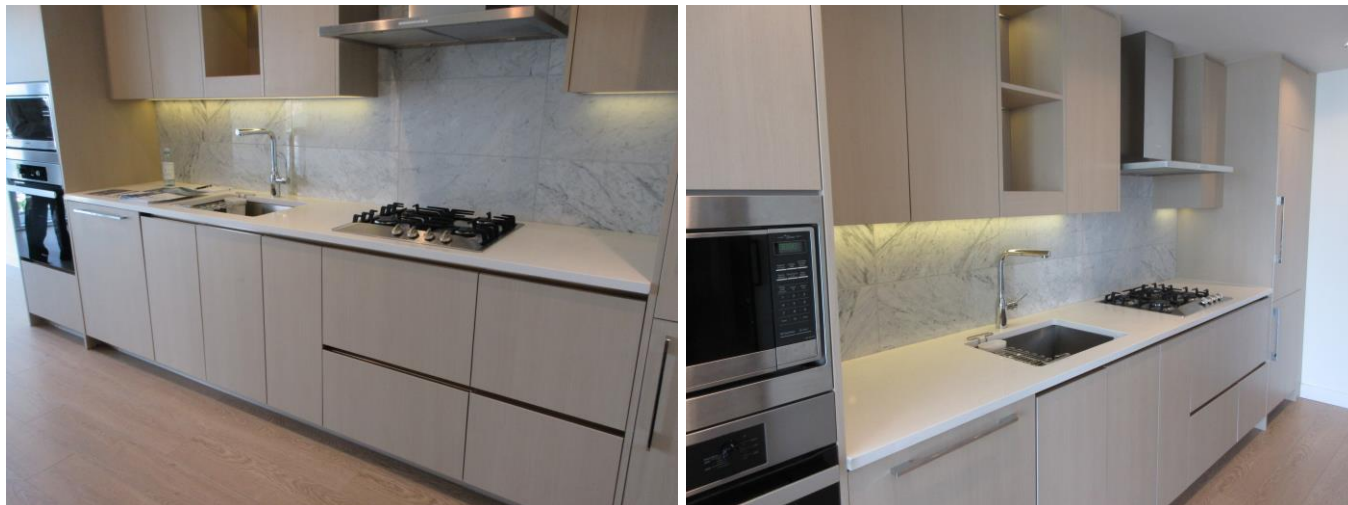
7.2 Counter and Cabinet

The kitchen features quartz countertops and MDF-core cabinet doors. Both the cabinetry and the countertops were inspected and found to be in serviceable condition, with no observed deficiencies in alignment or finish at the time of inspection.

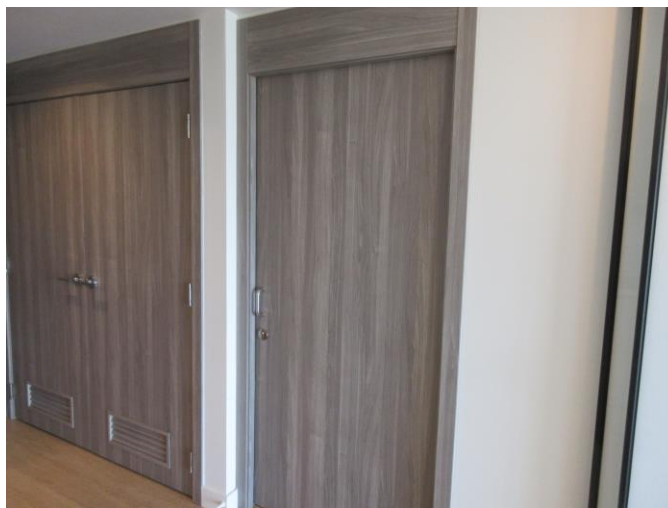
7.3 Door & Closet door

The interior features MDF-core doors for all rooms and closets. The doors and their associated hardware were tested and found to be fully operational and in good condition, with no observed deficiencies at the time of this inspection.

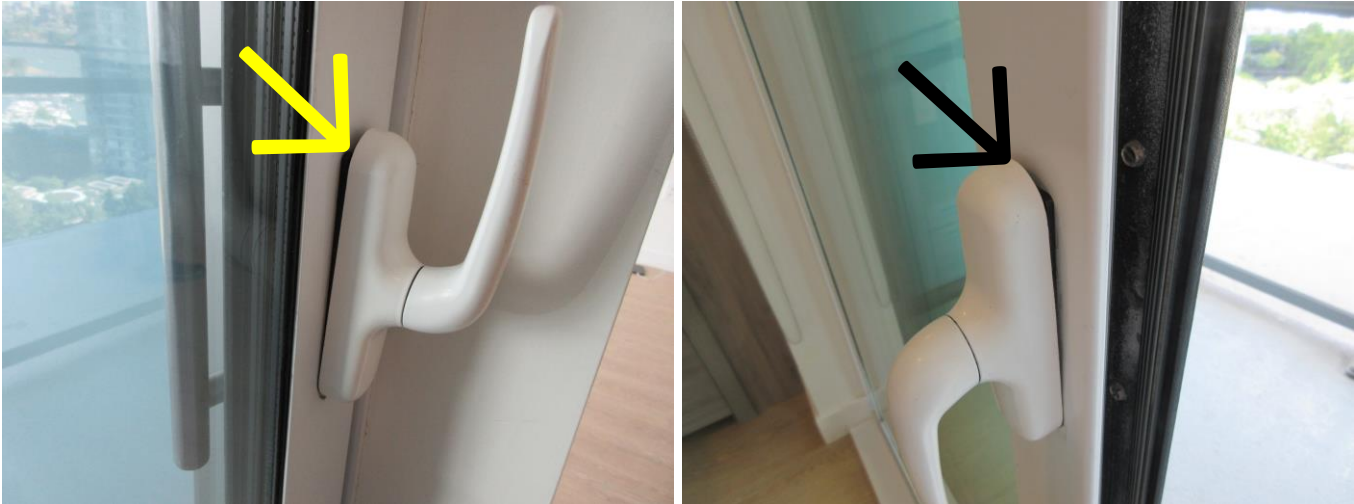
The balcony is equipped with an aluminum-framed door. During the inspection, the door handle was found to be loose. It is recommended that the hardware be tightened or repaired to ensure proper operation and security.

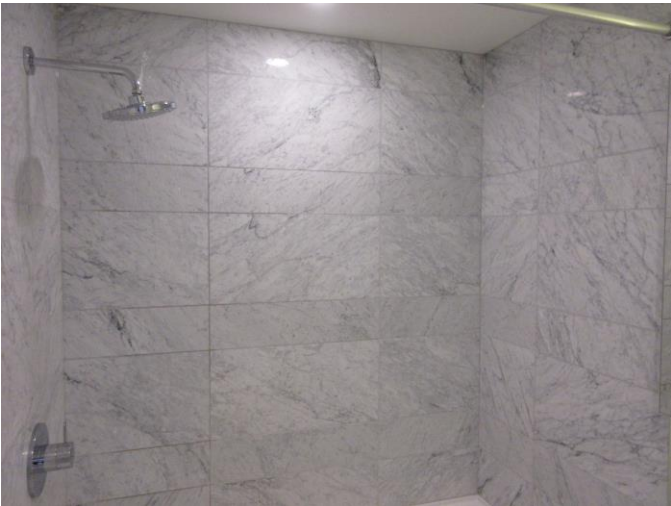
7.4 Bathroom

The bathroom shower wall tiles and grout were inspected and appeared to be in serviceable condition. The grout lines are intact and no visible deficiencies or moisture-related concerns were noted at the time of inspection.

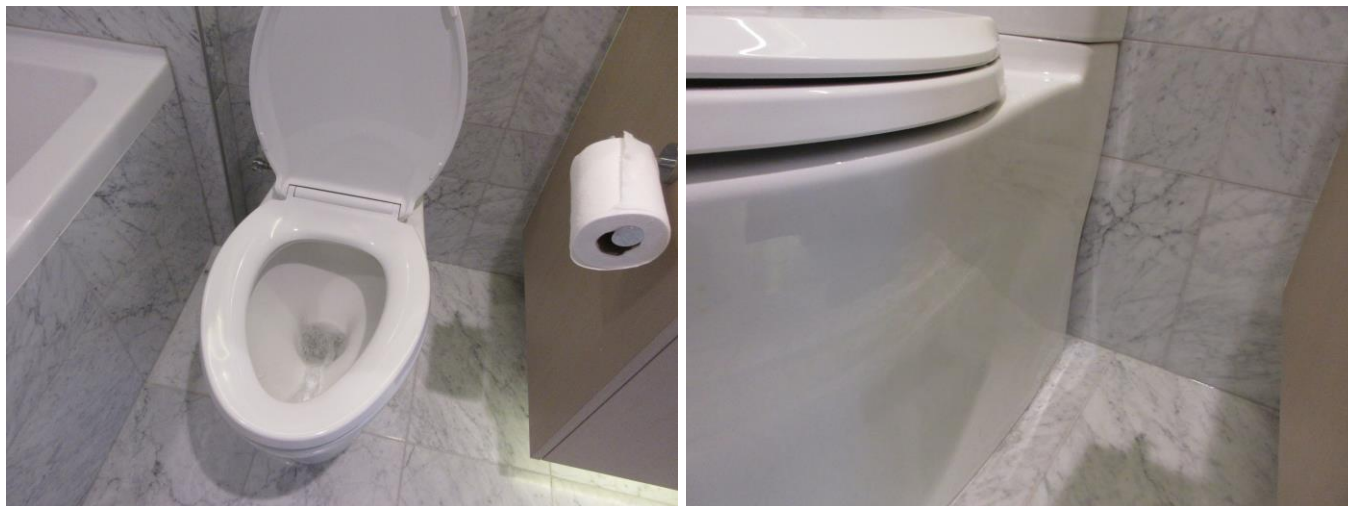
7.5 Washroom

All toilets were tested throughout the home. They were found to be properly installed and fully functional, with no observed deficiencies. The units were firmly secured to the floor, and no cracks or active leaks were noted at the tanks or bowls at the time of inspection.

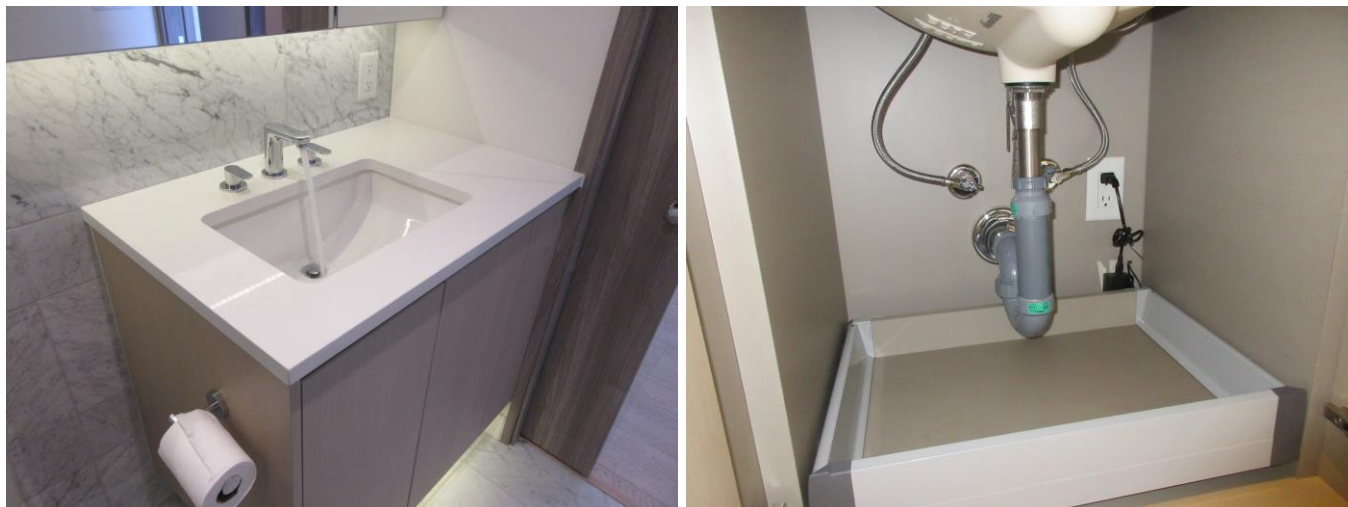
The bathroom lavatory and faucet were tested. The basin was securely mounted, and the faucet was fully functional with no observed deficiencies. Water pressure and drainage were both adequate and performing as intended at the time of this inspection.

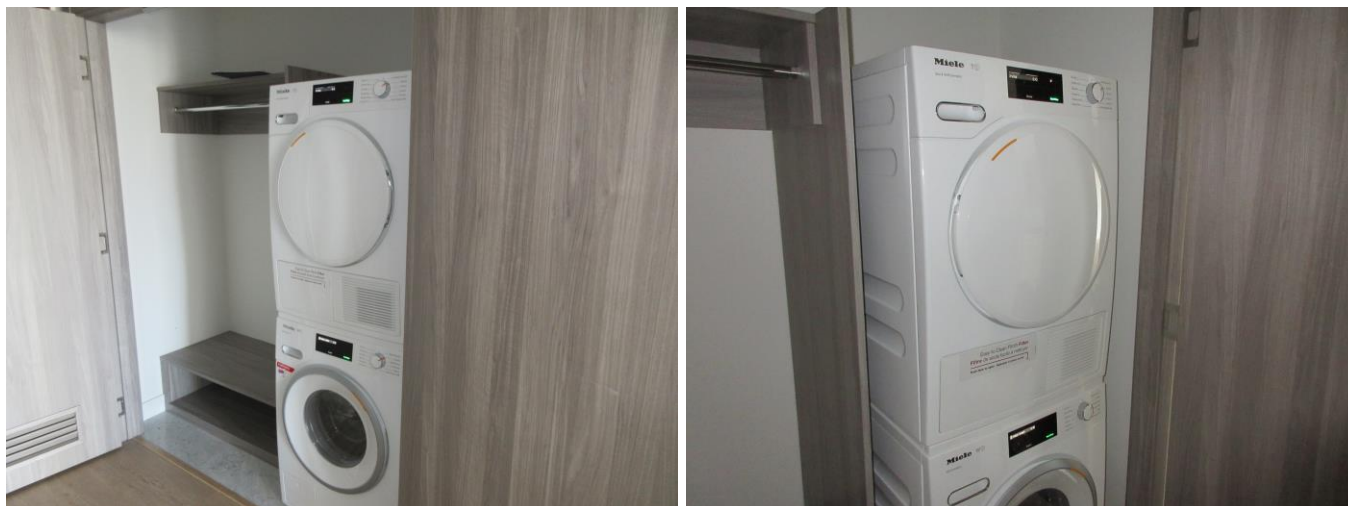
7.6 Washing machine & Dryer

The washing machine and dryer were tested in the laundry room and found to be fully functional at the time of inspection. No active water leaks were observed at the washer's supply or drain lines. Both appliances appeared to be in serviceable condition.

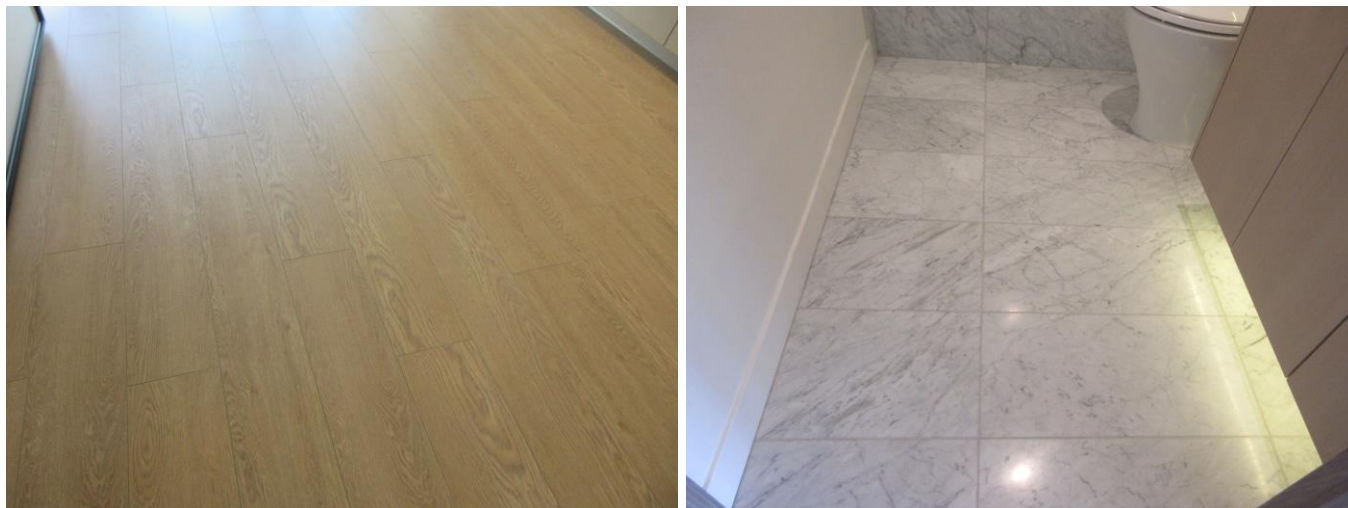
7.7 Floor cover

The home's flooring consists of laminate and stone surfaces. The flooring was inspected throughout and found to be in serviceable condition with no observed deficiencies in installation or finish at the time of this inspection.

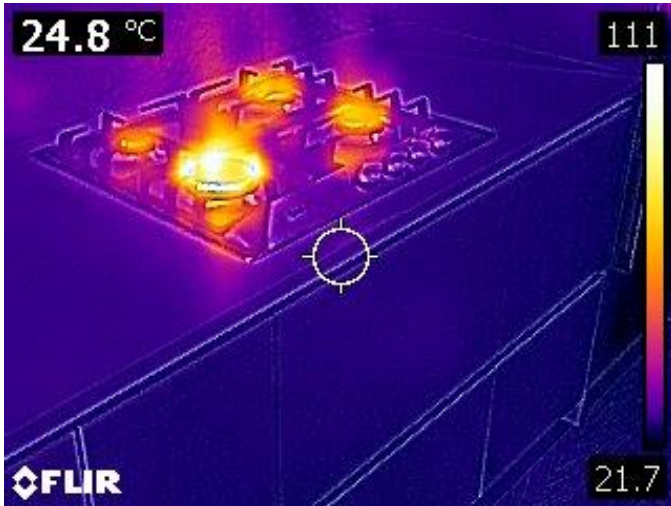
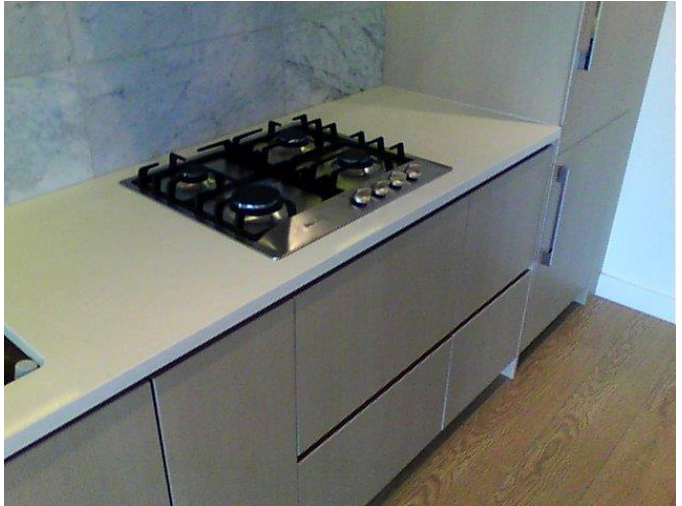
7.8 Range & Oven

The house is equipped with a gas range. The unit was operated and tested; all burners and the oven were found to be fully functional and in serviceable condition with no observed deficiencies at the time of inspection.

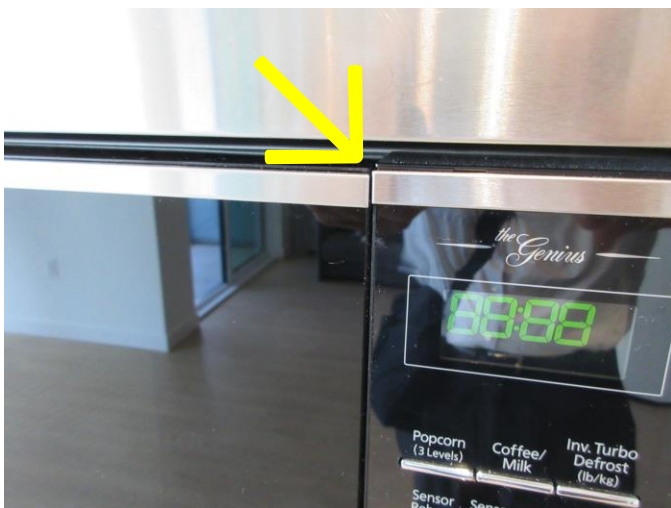
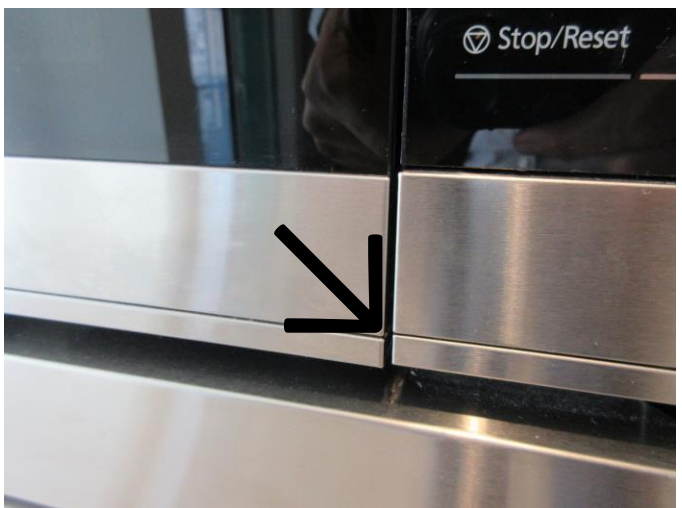
The microwave door was observed to be misaligned with the surrounding trim panel, showing a minor sag. This appears to be a cosmetic issue and did not affect the unit's ability to latch or operate at the time of inspection. Adjusting the door hinges is recommended for aesthetic uniformity.

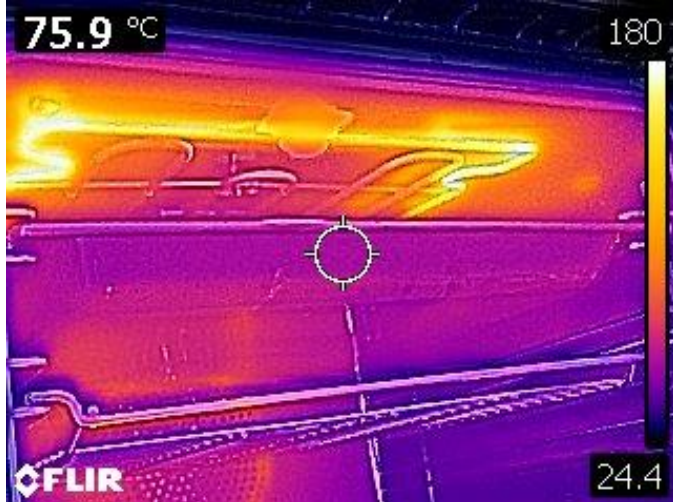
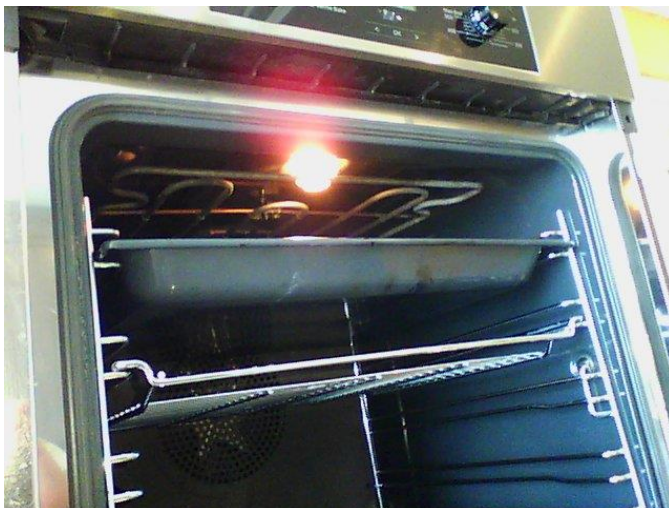
7.9 Wall oven

The kitchen features a gas-fired oven with an electronic ignition system. The unit was tested and found to be fully functional, reaching target temperatures during the heating cycle with no observed deficiencies at the time of inspection.

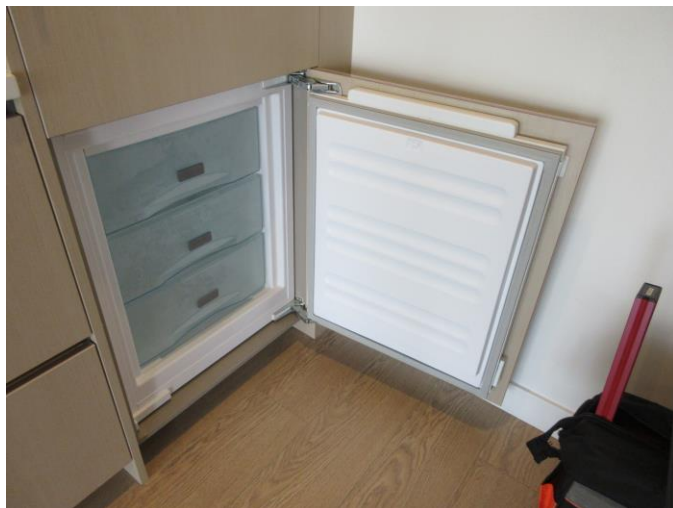
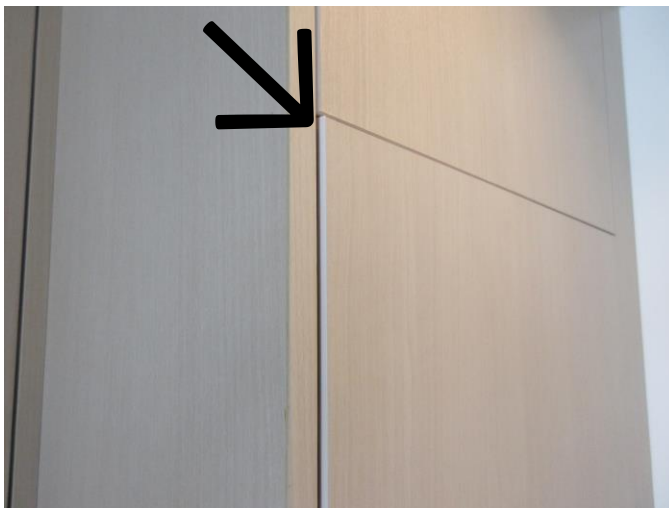
7.10 Fridge

The refrigerator and freezer doors were observed to be misaligned with the left cabinet side panel (gable). This appears to be a cosmetic issue related to the leveling of the appliance or hinge adjustment and does not affect the unit's seal or function. Adjustment is recommended for aesthetic uniformity.
