ABC Home Inspections
Home Inspection Report
Confidential

Prepared exclusively for
Surrey, BC

Property Address: Surrey, BC
 Date of home inspection: Tuesday, September 6, 2022
 Inspection start time: 5:00 PM
 Inspection end time: 7:30 PM
 Registration BC No: 12893
 Manufacture model No (CSA): 364
 MLS# not available
 Year Built: 1972
 Construction: -
 Furnished: Yes
 Occupied: Yes
 Floor Area Total: 960 sq. Ft.

Style: Mobile_home
 Stories: 1
 Orientation (Front Facing): North

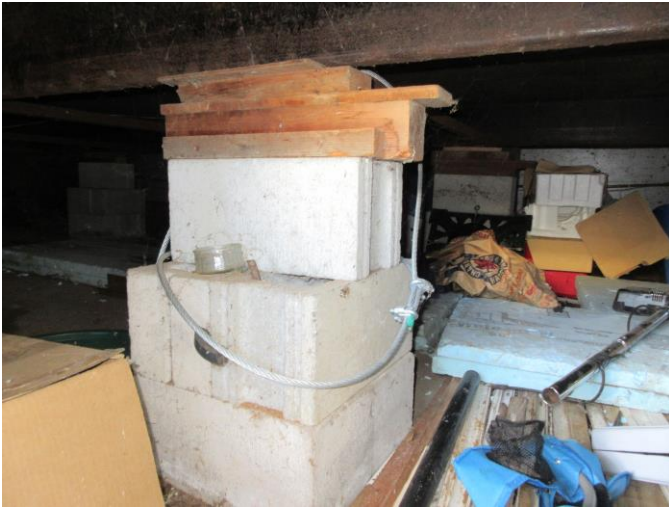
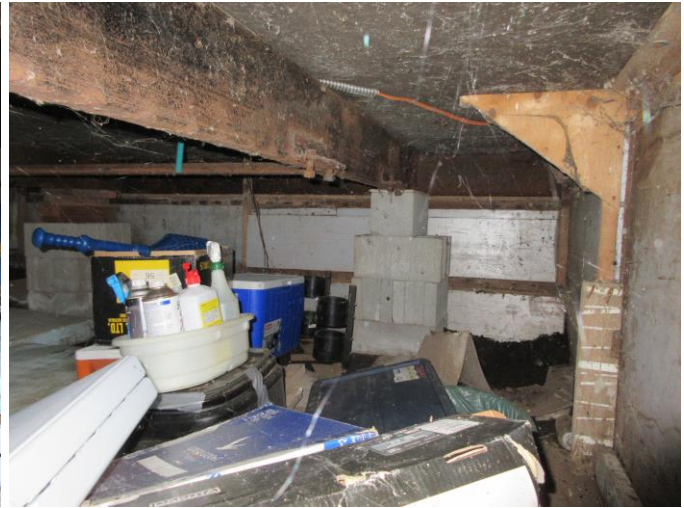
1.1 Foundation

The mobile home is situated on a concrete foundation; however, the unit is not fastened or anchored to the ground. This is a significant structural deficiency, as the home lacks the required stability against wind uplift or shifting. I recommend contacting a qualified contractor immediately for further evaluation and to install a proper anchoring system.

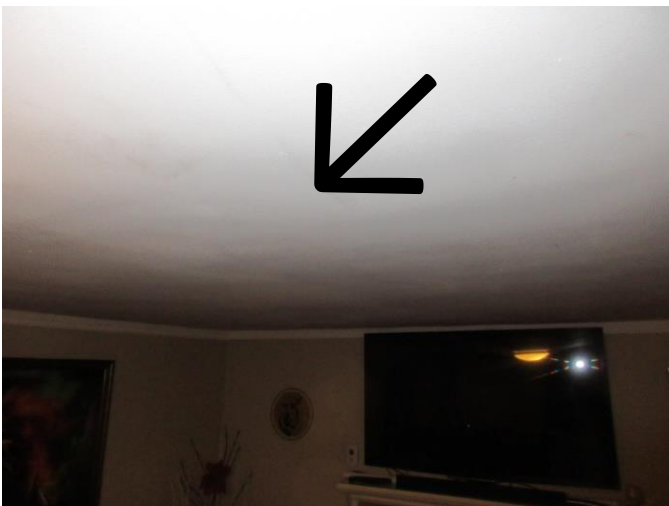
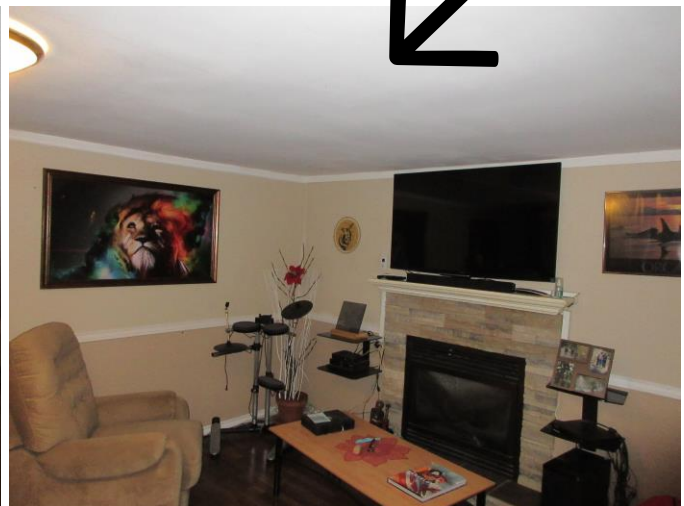
1.2 Ceiling

Visible sagging (deflection) was observed in the living room ceiling. This condition may indicate a structural concern, a failure of the ceiling joists, or moisture-related damage. I recommend that a qualified structural contractor or engineer be consulted to determine the cause and perform necessary repairs.

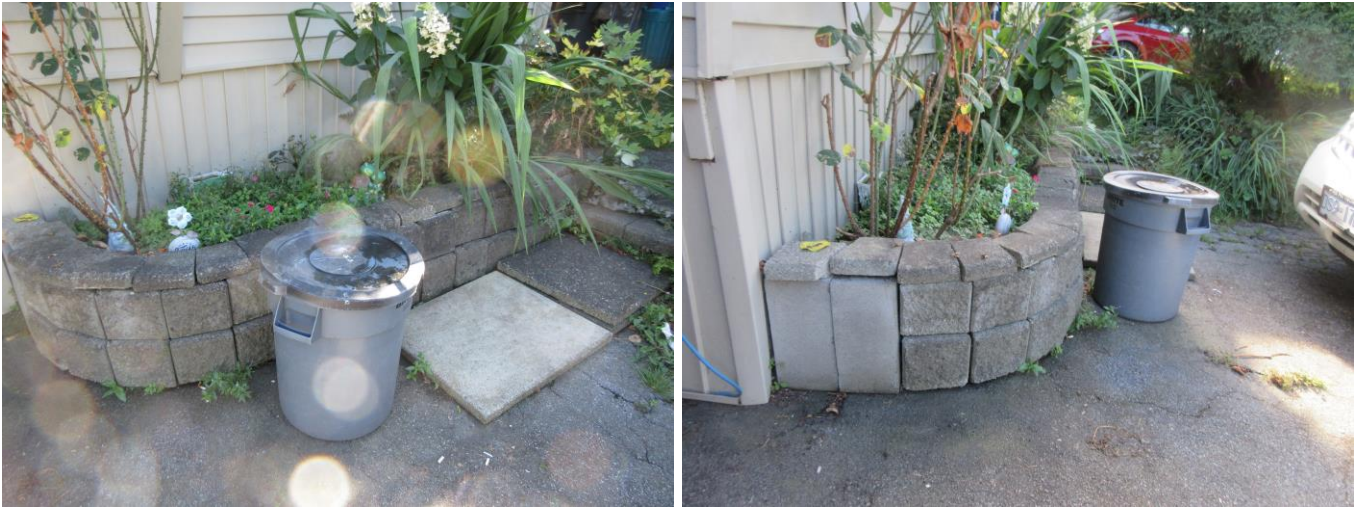
1.3 Retaining wall

A masonry retaining wall is located on the north side of the property. The wall shows signs of structural movement, including uneven surfaces and displaced blocks. This indicates potential soil pressure or drainage issues. I recommend a qualified hardscape or structural contractor evaluate the wall for stabilization and repair.

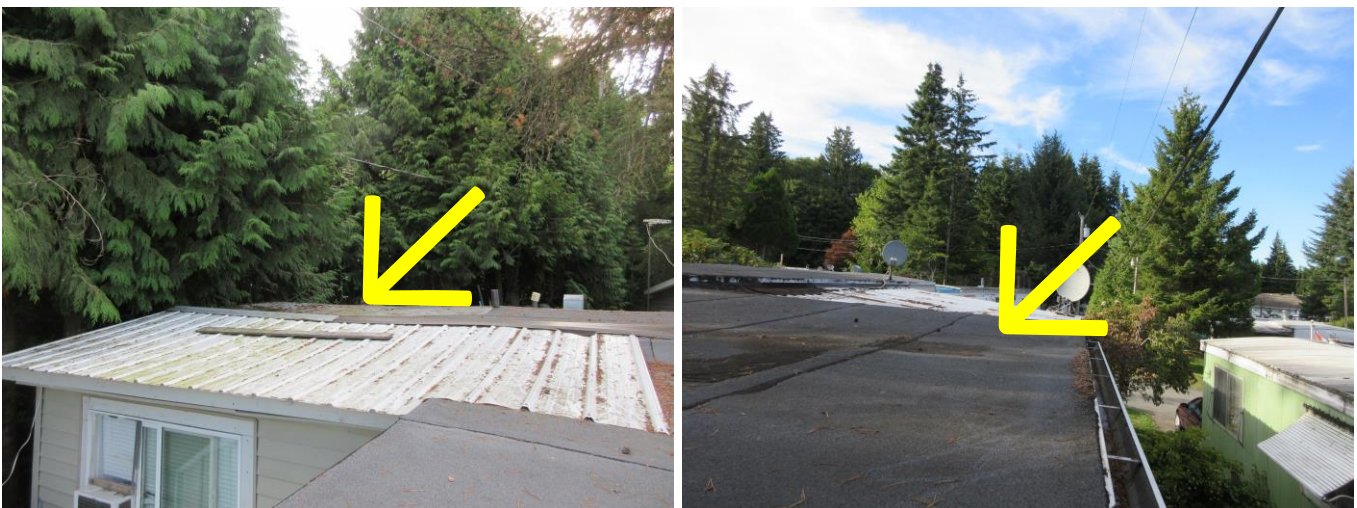
1.4 Roof

A significant sagging and wavy surface was noted on the roof. The sagging and wavy surface of the roof is the significant deficiency and indicate the potential of the moisture entering to the house. The sagging needs to be fixed, and maintained by the qualified contractor as recommended.

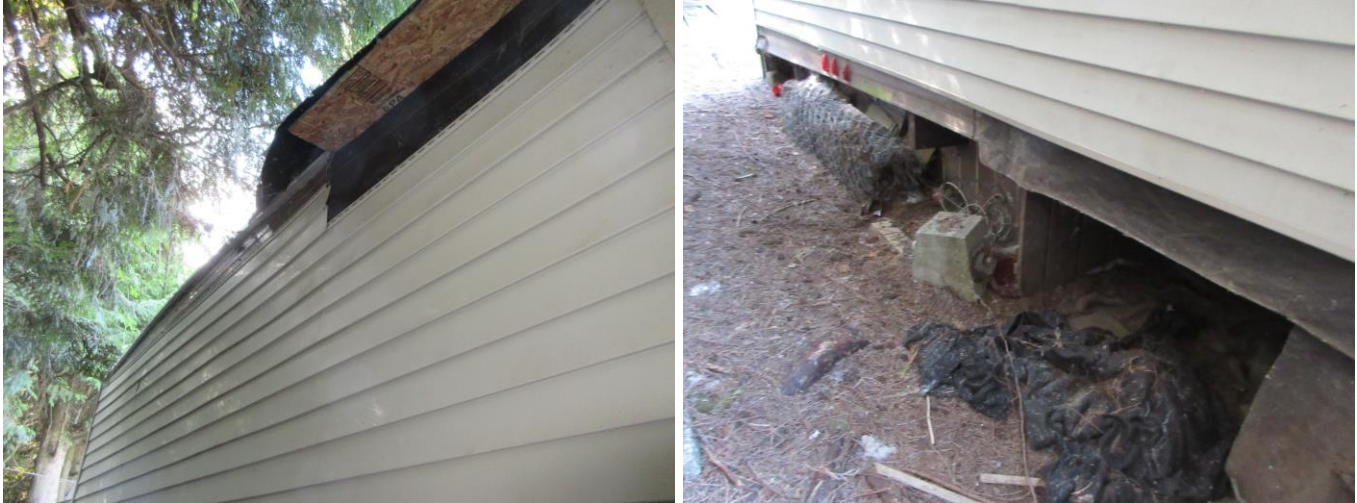
2.1 Wall Cladding

The exterior of the home is finished with vinyl siding. Sections of the siding panels are missing on the South and West elevations, exposing the underlying house wrap and sheathing. To prevent moisture damage and rodent intrusion, I recommend installing matching vinyl panels and ensuring the area is properly sealed by a qualified contractor.

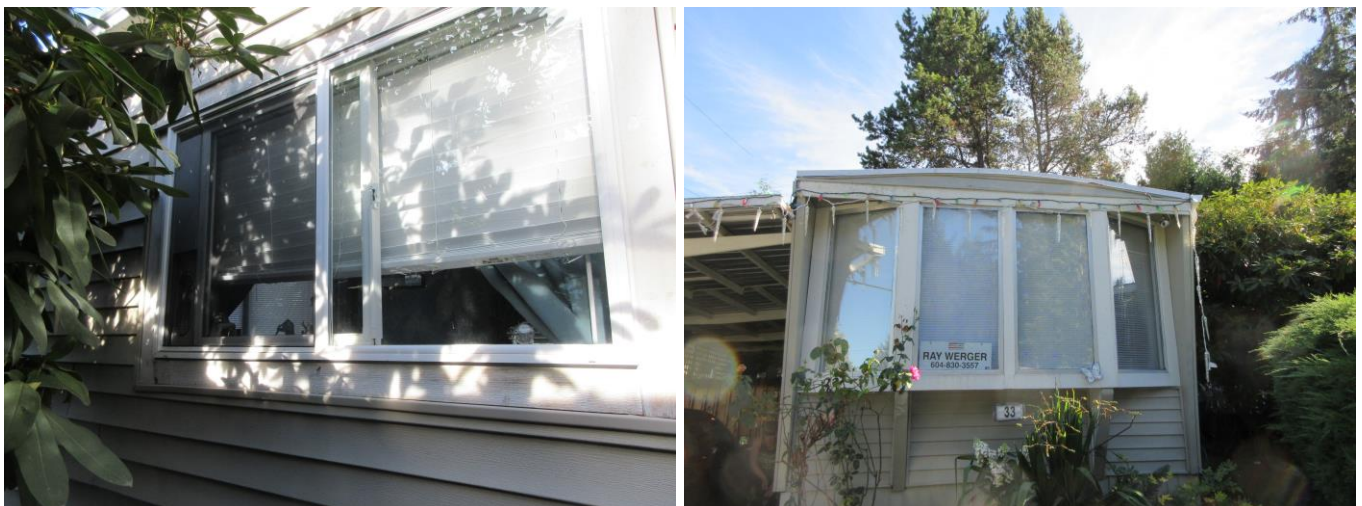
2.2 Window

The home is equipped with a combination of vinyl and aluminum-framed, double-pane windows. All units tested were found to be functional and in serviceable condition at the time of inspection. No deficiencies in the hardware or visible failures of the thermal seals were observed.

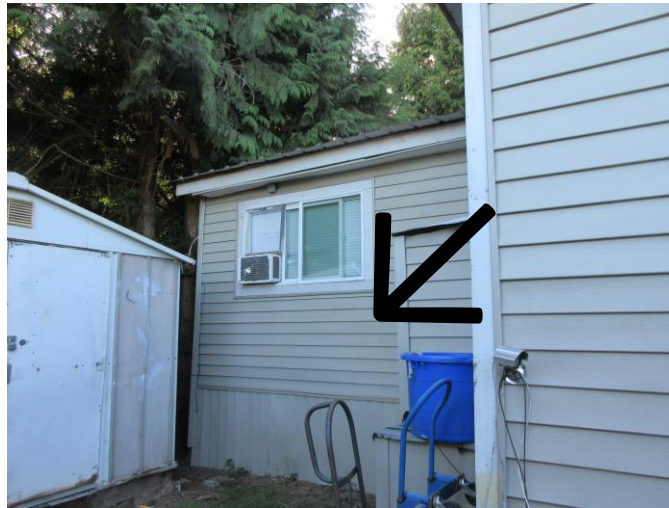
2.3 Added space

An addition was noted at the rear of the property. The permit history and zoning approval for this structure were not verified as part of this home inspection. I recommend the client contact the local building department to confirm that all necessary permits were obtained and that the space meets current building codes.

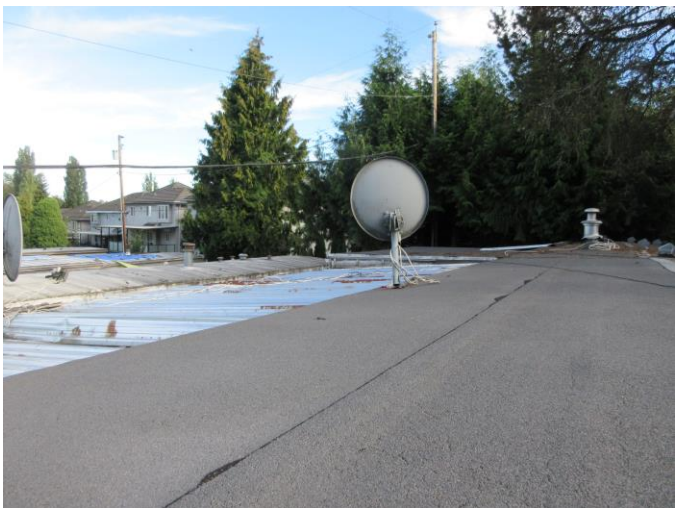
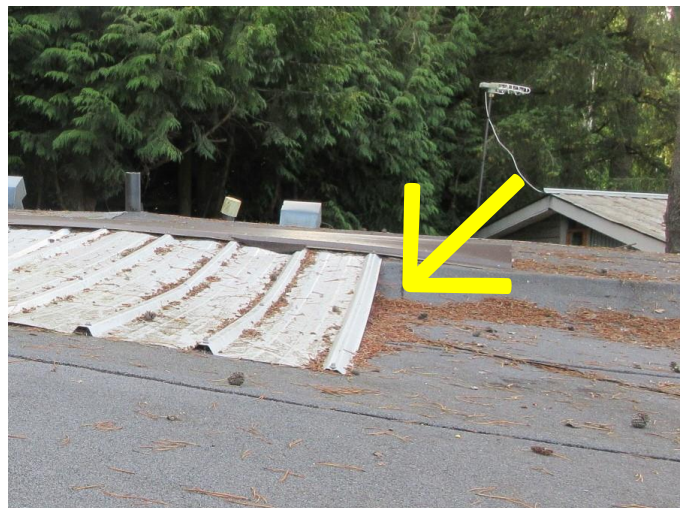
3.1 Roof Covering Material

The roof covering consists of a combination of torch-on membrane and aluminum sheeting. A visible void was noted at the transition point between these two materials. This separation creates a significant potential for water intrusion into the structure. It appears that standard trade practices were not followed at this junction; I recommend immediate repair by a qualified roofing contractor to ensure a watertight seal.

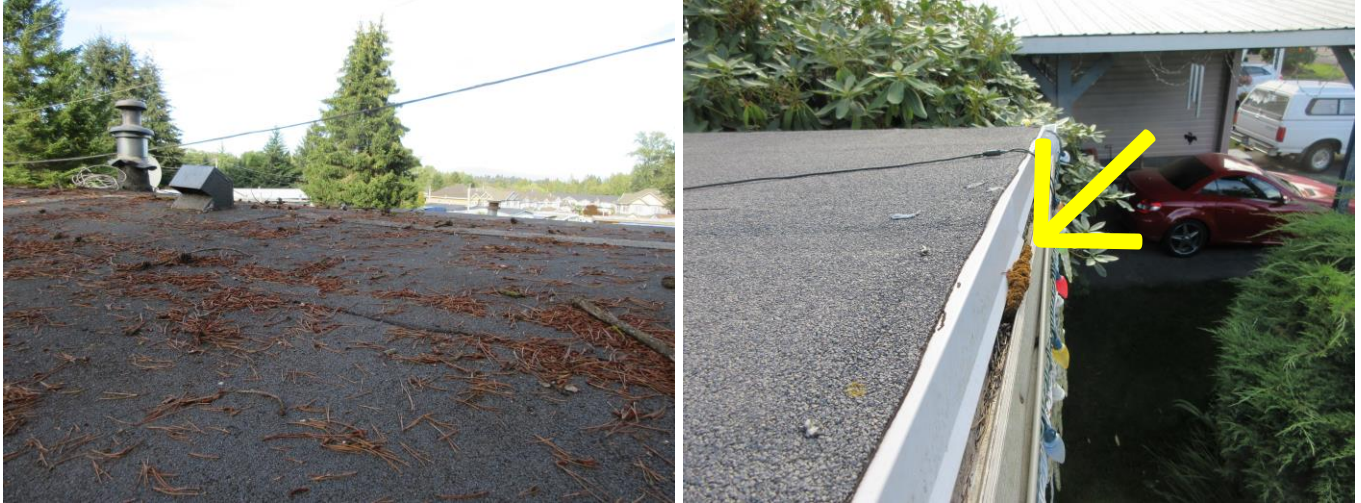
Organic debris (tree leaves) has accumulated across the roof surface. This buildup can trap moisture, promote moss growth, and lead to the premature deterioration of the roofing membrane and metal components. Regular cleaning and maintenance of the roof surface and gutters are recommended to ensure proper drainage and extend the life of the roof.

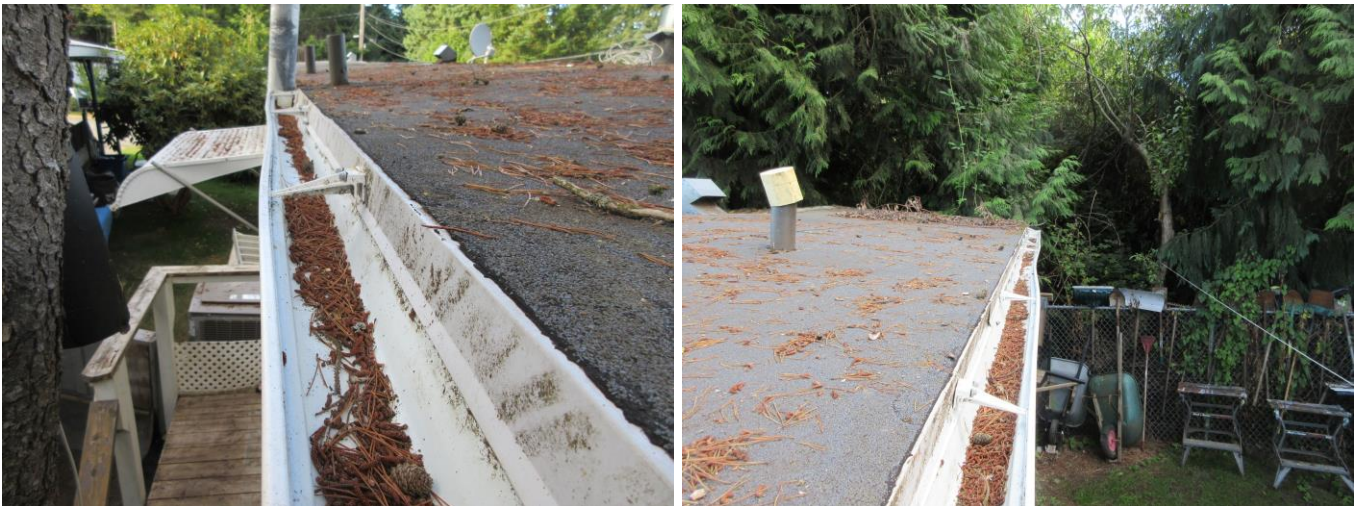
3.3 Gutter and Downspout

The gutter system is significantly obstructed by an accumulation of organic debris and tree leaves. Clogged gutters prevent proper drainage, which can lead to water backing up under the roof edge, damaging the fascia boards, and causing the gutters to pull loose from the structure. I recommend cleaning and flushing the entire gutter and downspout system to prevent potential water intrusion and costly structural repairs.

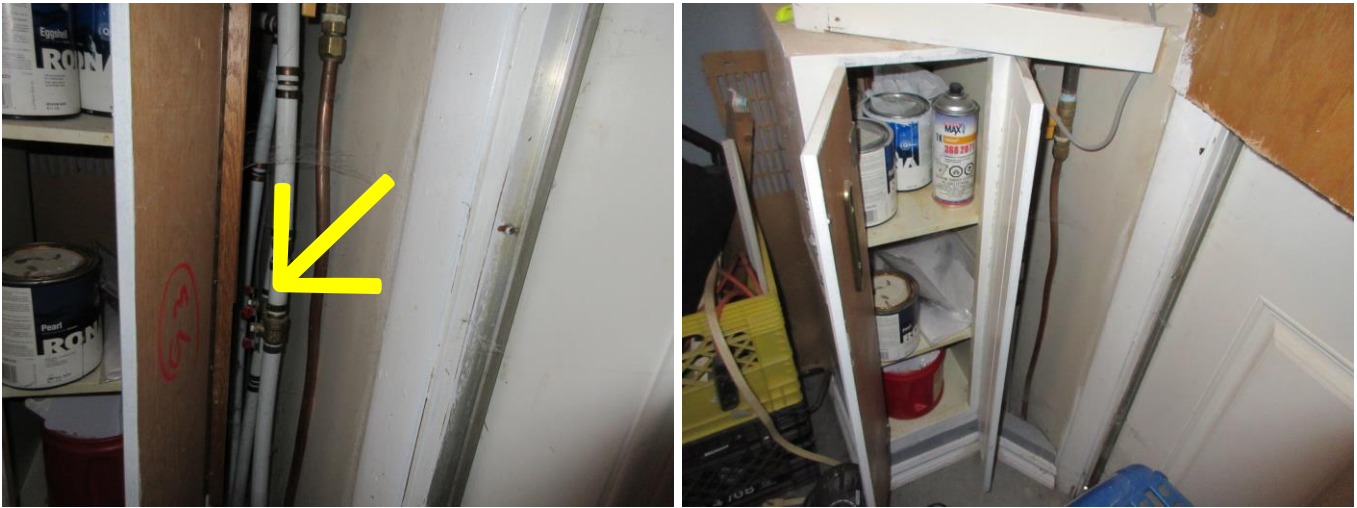
4.1 Water Supply System

The potable water supply piping is PEX (cross-linked polyethylene). The system was inspected and found to be functional and in serviceable condition with no observed leaks or deficiencies at the time of inspection. The main water shut-off valve is located in the laundry room. PEX piping typically has an estimated service life of 40 to 50 years.

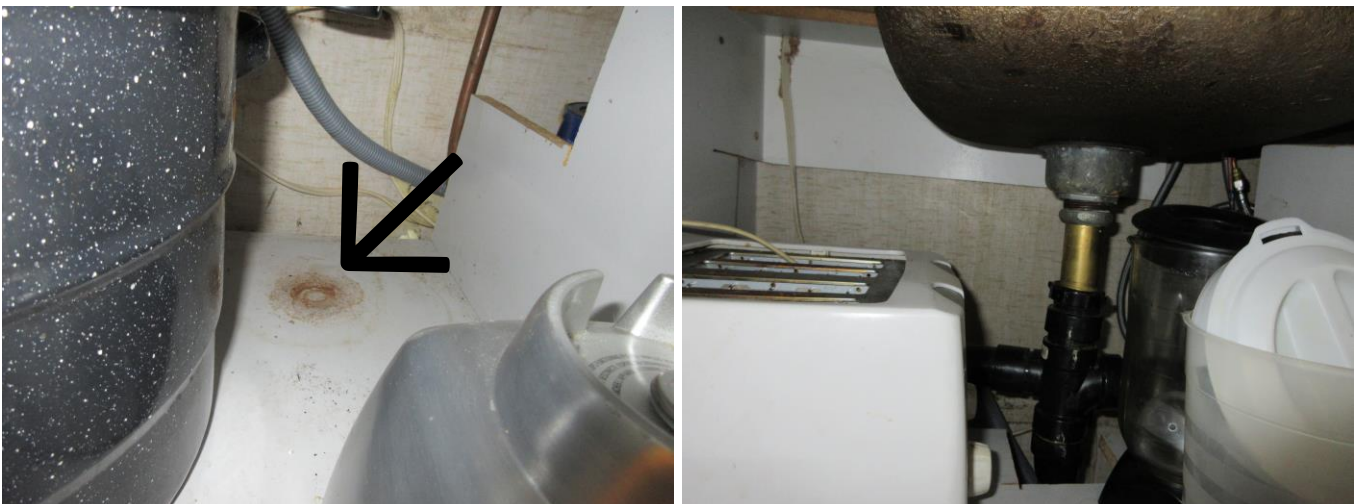
4.2 Kitchen and laundry sink & faucet

Active moisture leakage was observed at the kitchen sink drain assembly (P-trap). Water was noted dripping from the slip-joint connections, which has caused minor staining to the base of the cabinet. I recommend immediate repair or replacement of the drainage fittings by a licensed plumber to prevent further water damage and potential mold growth.

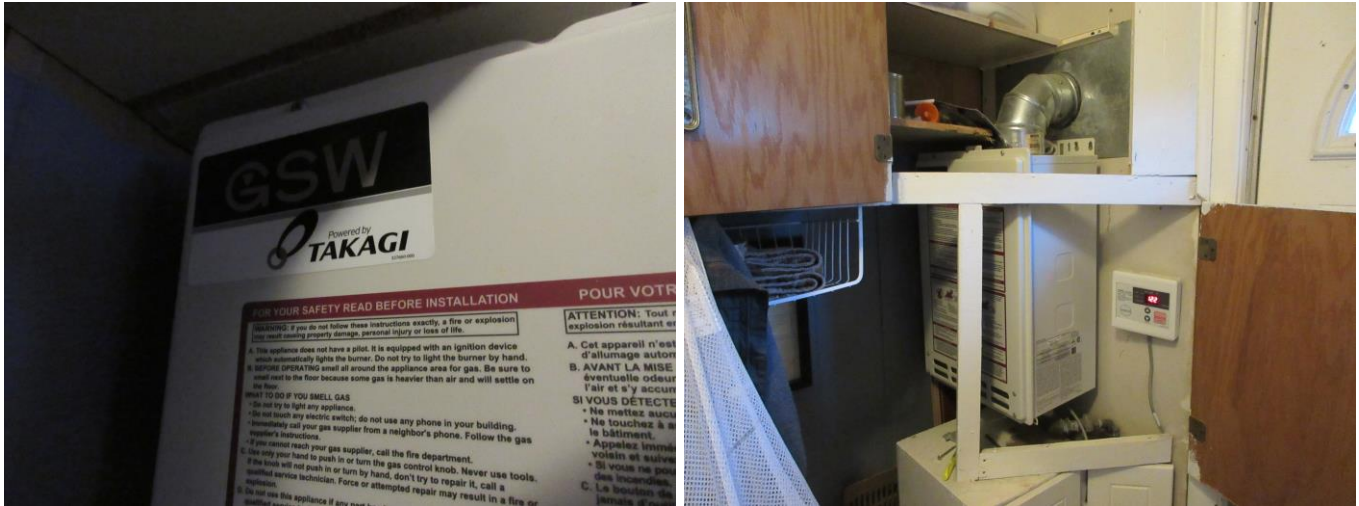
4.3 Hot Water Tank

The home is equipped with a tankless water heater manufactured in 2019. The unit was inspected and found to be performing as intended with no visible leaks or deficiencies at the time of inspection. Tankless units typically have a service life of 20+ years. I recommend regular professional maintenance, including descaling, to ensure the unit reaches its maximum life expectancy.

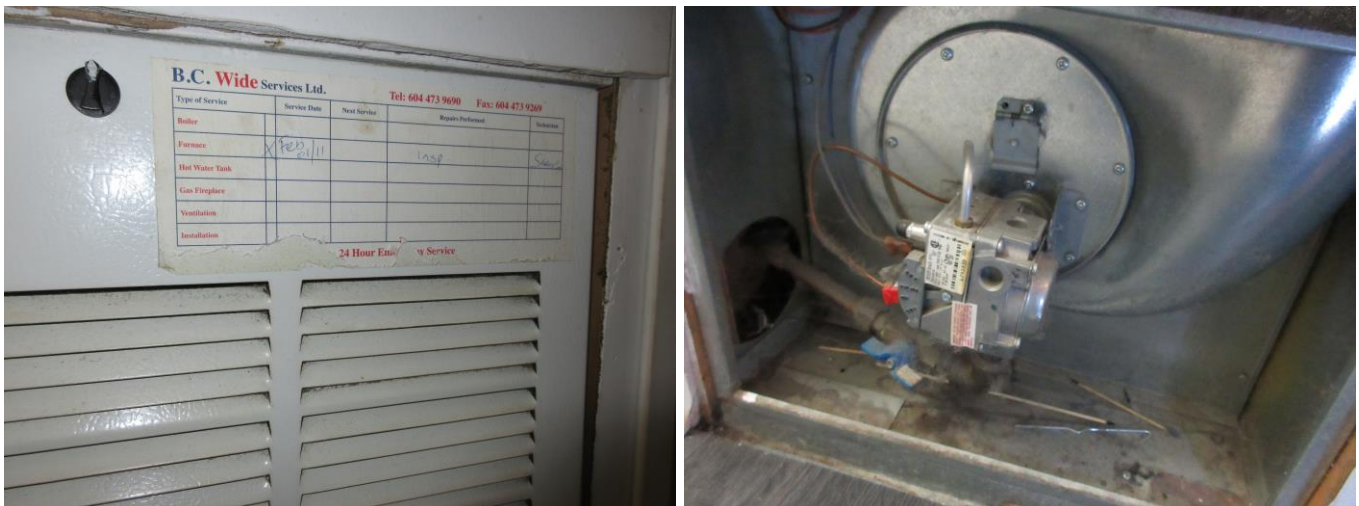
5.1 Furnace

The heating system consists of a mid-efficiency furnace with a 40,000 BTU input, manufactured in 2003. While the unit was found to be functional and in serviceable condition at the time of inspection, it is 23 years old and has exceeded its typical design life (15–20 years). Due to its age, the unit is nearing the end of its reliable service. I recommend the client budget for replacement in the near future and have a qualified HVAC technician perform an annual safety certification.

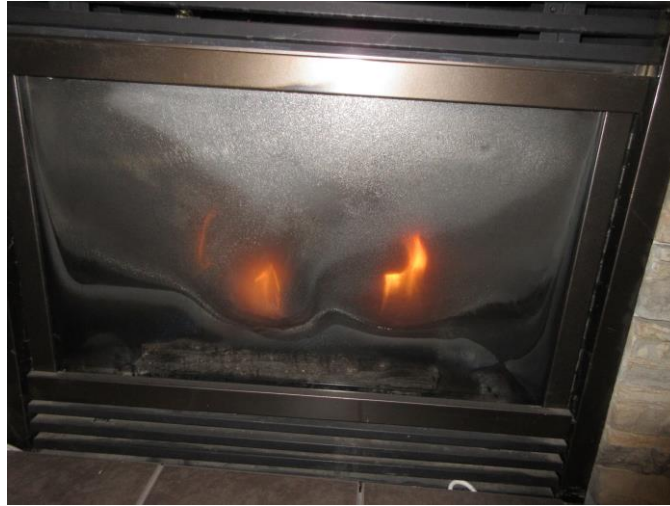
5.2 Fireplace

The home is equipped with a gas-fired fireplace. Visible clouding/film buildup was noted on the glass door (commonly referred to as 'smoke glass'). This is a typical maintenance item caused by mineral deposits during combustion. I recommend a professional cleaning and service by a qualified fireplace technician to prevent permanent etching of the glass and to ensure the burners are operating efficiently.

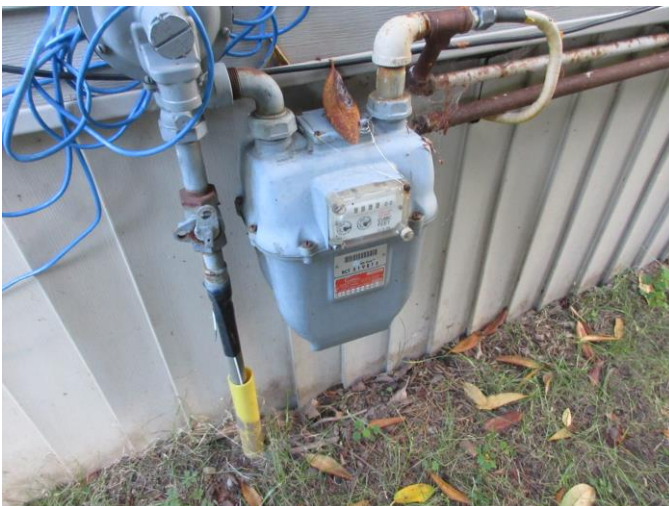
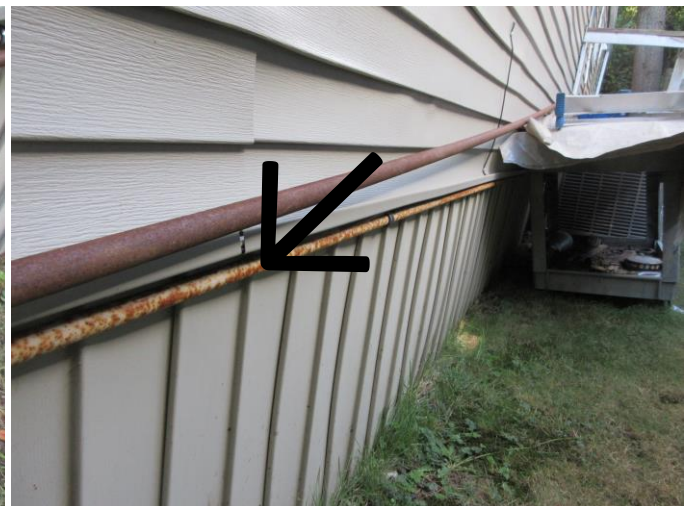
5.3 Natural Gas

The natural gas meter is located on the west side of the house. Surface corrosion (rust) was observed on the gas service piping. While the rust appears superficial at this time, it should be addressed to prevent deep pitting or pipe degradation. I recommend that the piping be cleaned and repainted with a rust-inhibiting exterior paint to ensure long-term integrity.

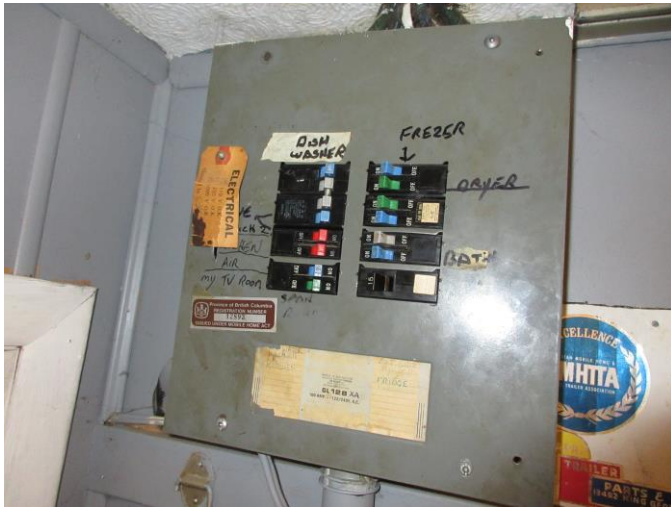
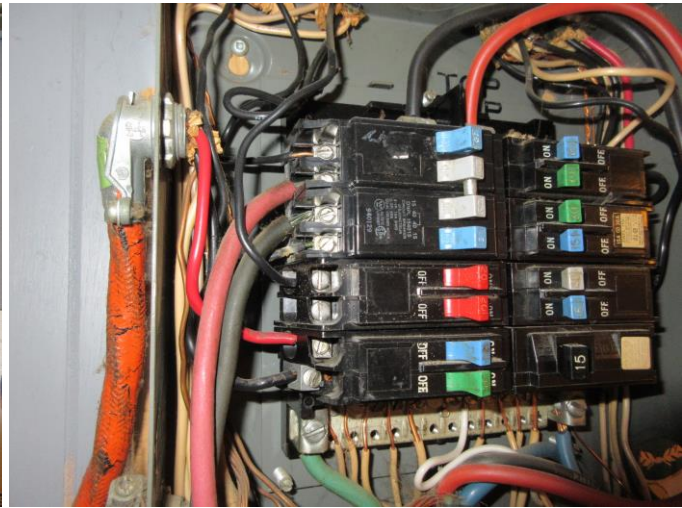
6.1 Main Electrical Panel

The home is equipped with a 100-amp electrical service; the distribution panel is located in the laundry room and appears to have been professionally installed. Branch circuit wiring is copper, and no signs of overheating, damage, or corrosion were observed within the panel. Circuit breakers appear to be correctly sized for their respective loads (e.g., 40-amp for the range, 30-amp for the dryer). The circuit directory is incomplete. I recommend accurately labeling all breakers to ensure safe and efficient operation of the electrical system.

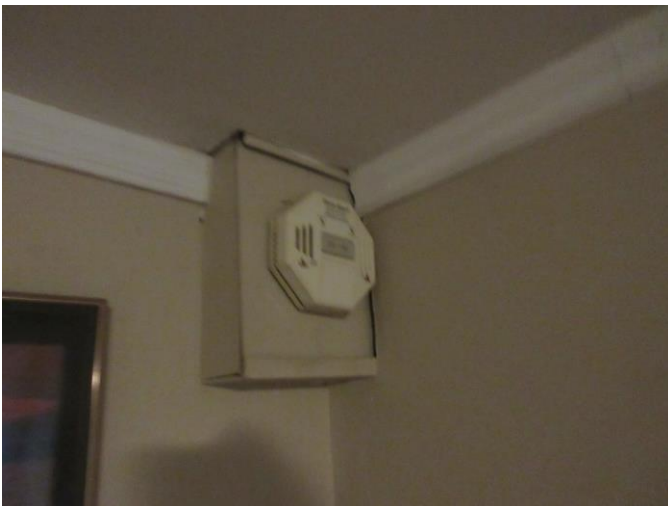
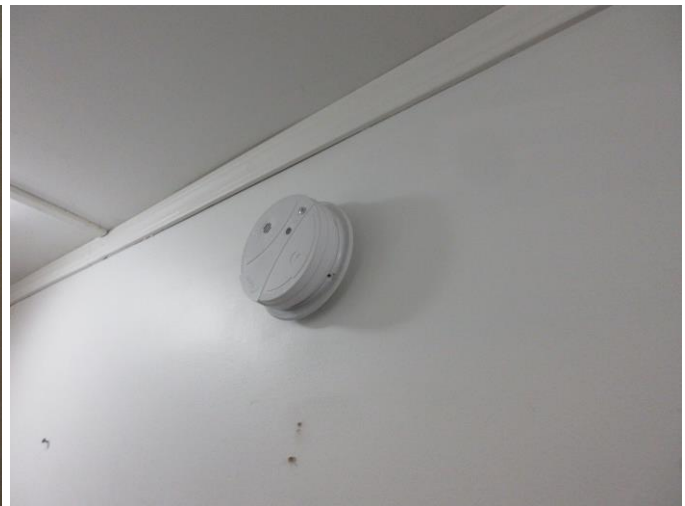
6.2 Smoke Detector & Carbon monoxide

Smoke and Carbon Monoxide (CO) detectors were identified throughout the home. For safety, smoke alarms should be replaced every 10 years, while CO detectors typically require replacement every 5 to 7 years. I recommend testing all units monthly and replacing batteries semi-annually. As a best practice, the client should replace all life-safety devices upon taking possession of the residence to ensure they are current and reliable.

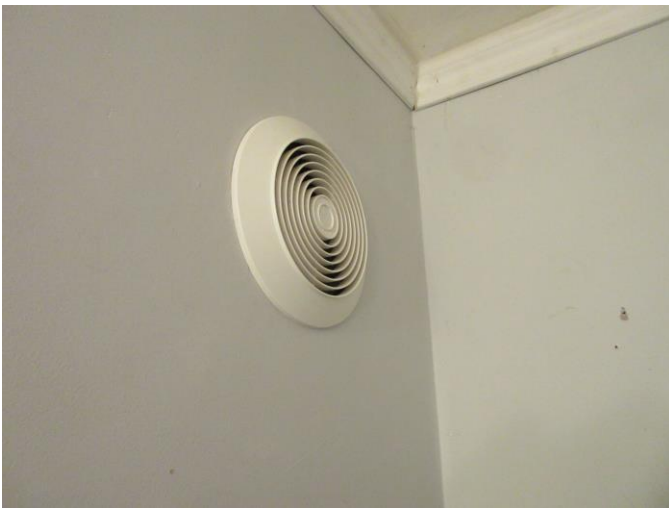
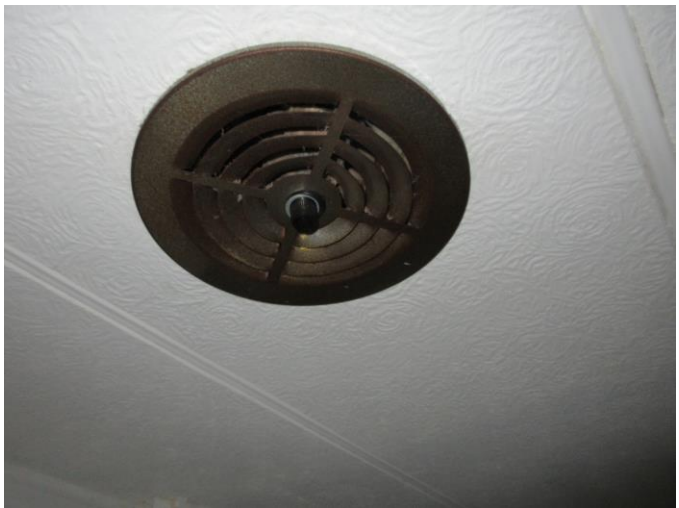
7.1 Bathroom & Washroom

The home is equipped with mechanical exhaust fans in the primary ensuite and the main bathroom. Both units were operated and found to be functional and in serviceable condition at the time of inspection. These fans are essential for removing excess moisture and preventing mold or mildew growth in high-humidity areas.

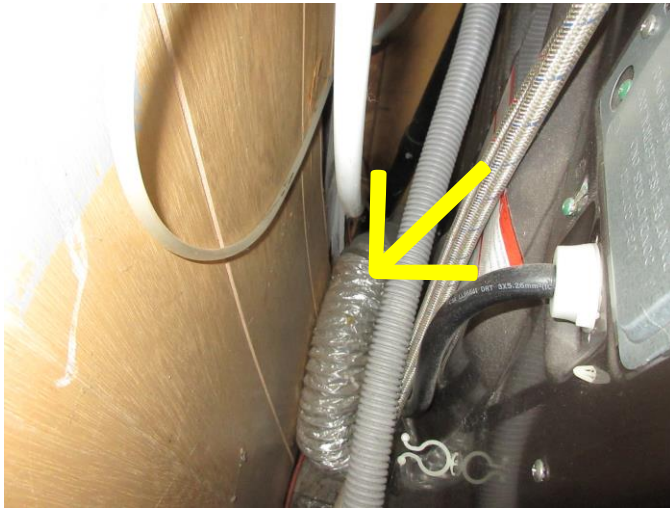
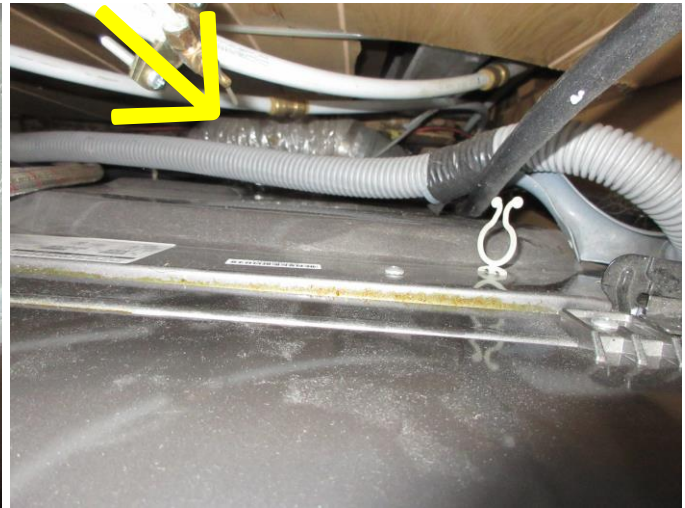
7.2 Laundry Vent

The dryer is currently equipped with a flexible foil transition duct. This type of venting is not recommended as the internal ribbing traps lint, creating a significant fire hazard. Building standards require the use of rigid or semi-rigid metal ducting (aluminum or galvanized steel) to ensure fire safety and proper airflow. I recommend the immediate replacement of the foil duct with an approved metal venting system.

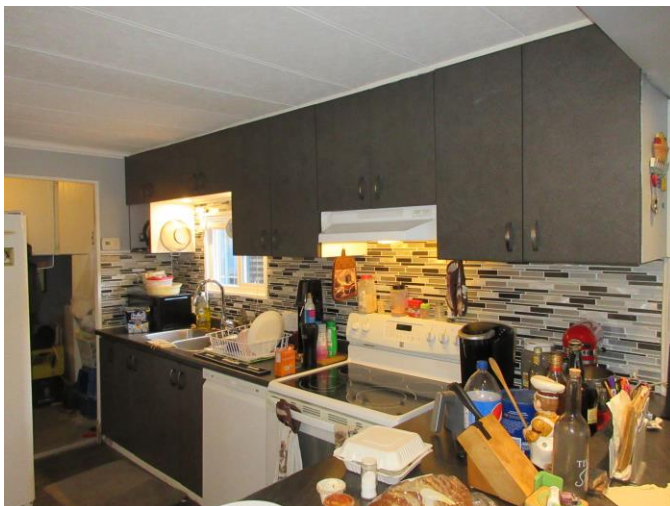
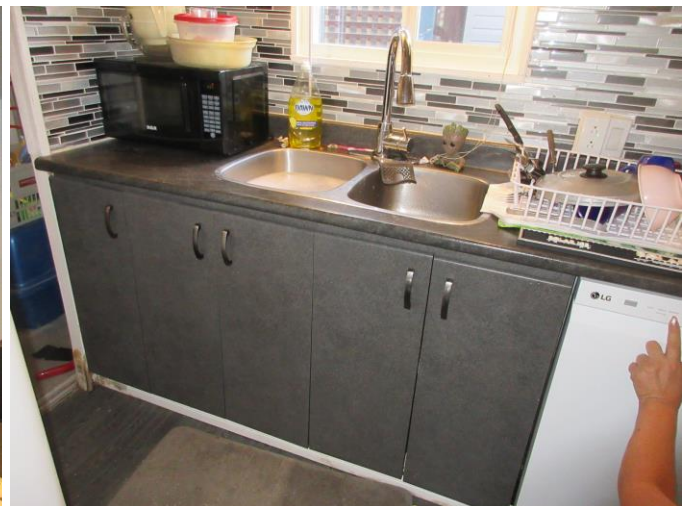
8.1 Counter and Cabinet

The kitchen features laminate-covered MDF countertops and MDF cabinetry. Both the counters and cabinet units were found to be functional and in serviceable condition at the time of inspection. While no deficiencies were observed, it is important to note that MDF is highly susceptible to moisture damage; ensure that all surface seams and areas around the sink are kept dry to prevent swelling or delamination.

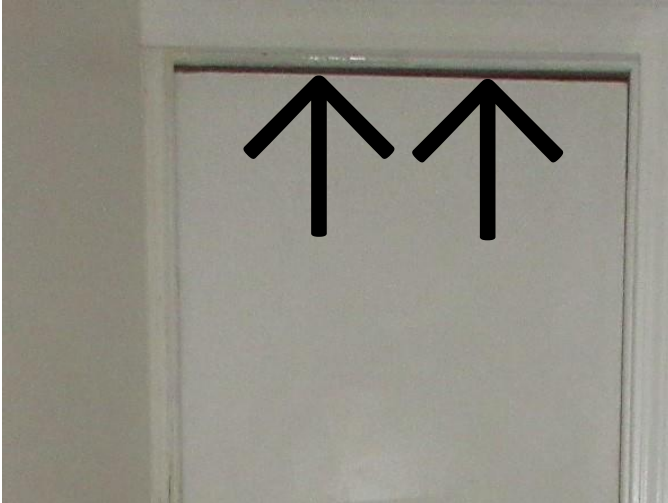
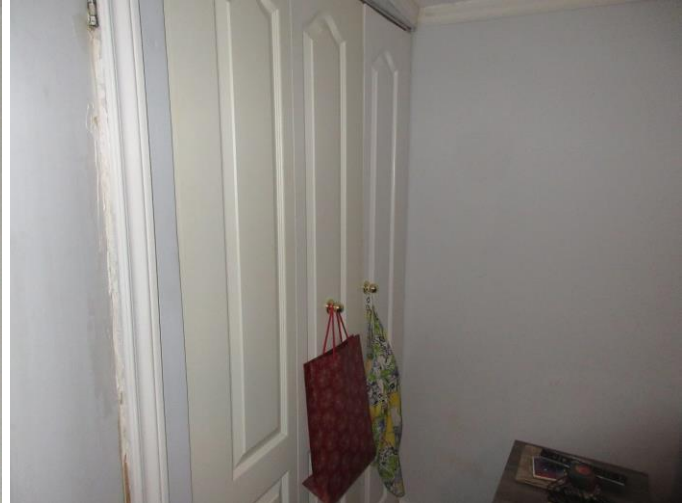
8.2 Door & Closet door

An unusual gap (cavity) was observed at the header of the master bedroom door frame. This may indicate a need for frame adjustment or trim repair to ensure proper closure and privacy. Conversely, the vinyl-wrapped closet doors and associated hardware were tested and found to be in good serviceable condition with no observed deficiencies at the time of inspection.

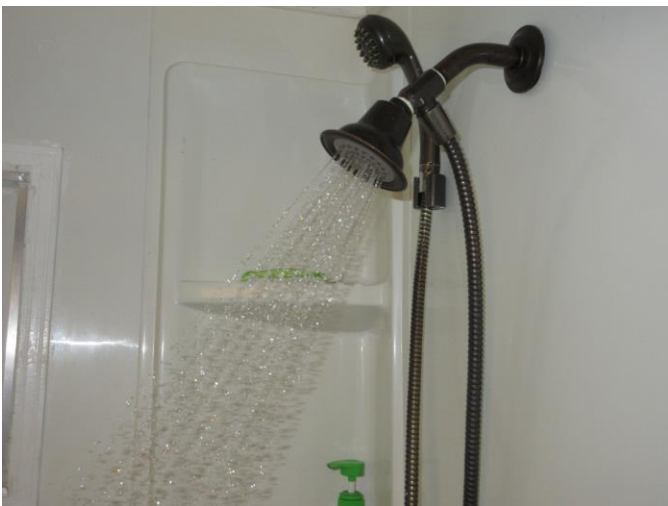
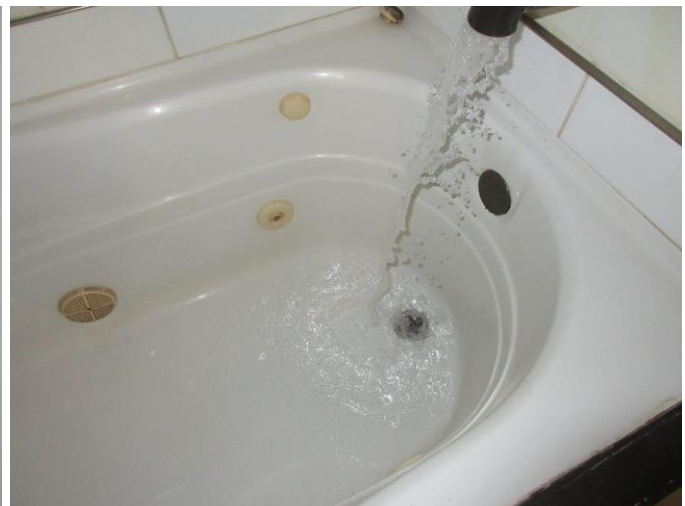
8.3 Bathtub

The bathtub and shower fixtures, including the faucets and diverter, were tested and found to be performing as intended. Both the hot and cold water supplies provided adequate pressure, and the drainage system was functional with no observed deficiencies at the time of inspection. I recommend monitoring the caulking and grout regularly to ensure a watertight seal is maintained.

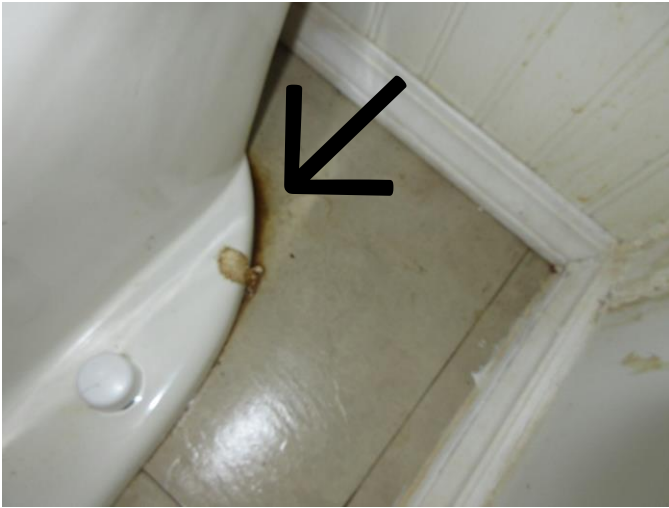
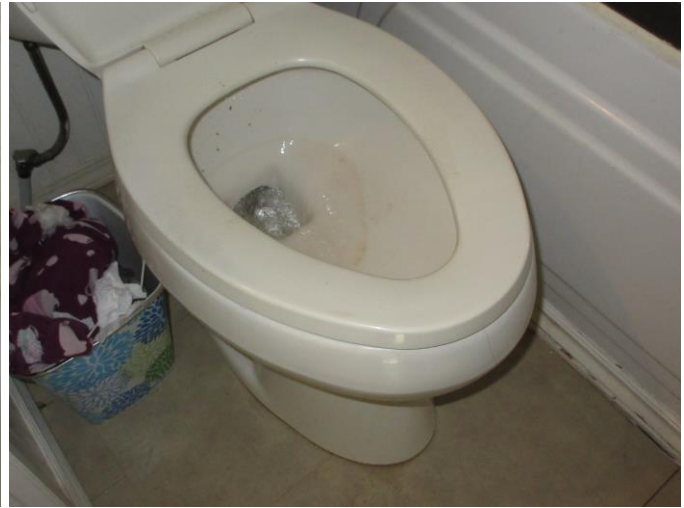
8.4 Washroom

Active moisture leakage was observed at the rear of the toilet in the main bathroom. The leak appears to be originating from the water supply connection (or the tank-to-bowl bolts). To prevent damage to the subfloor and the potential for mold growth, I recommend immediate repair by a licensed plumber. The floor area around the toilet should be monitored for signs of wood saturation or soft spots.

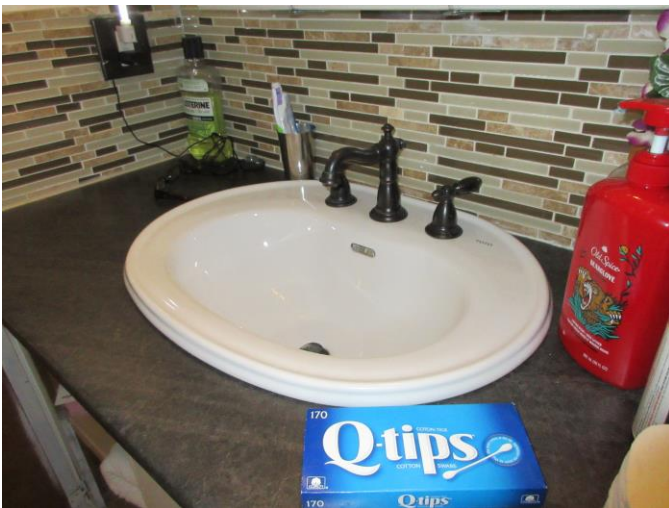
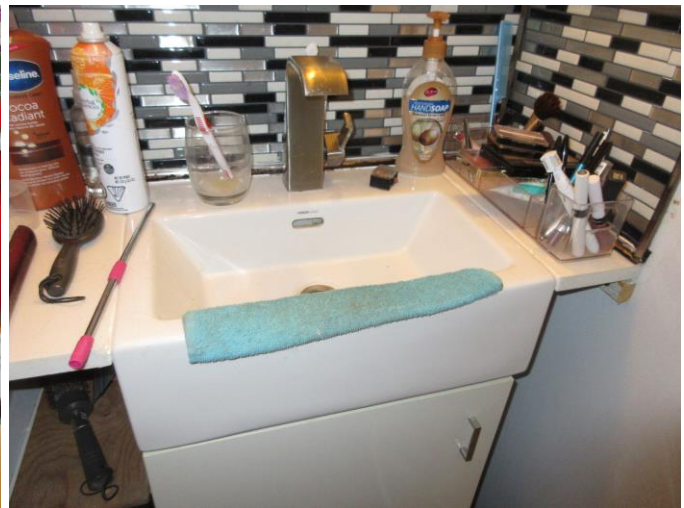
All lavatories and faucets in the primary ensuite and main bathroom were tested and found to be in satisfactory condition. The basins are securely mounted, and the faucets are performing as intended with no leaks or deficiencies observed. Water pressure and drainage were both adequate at the time of inspection.

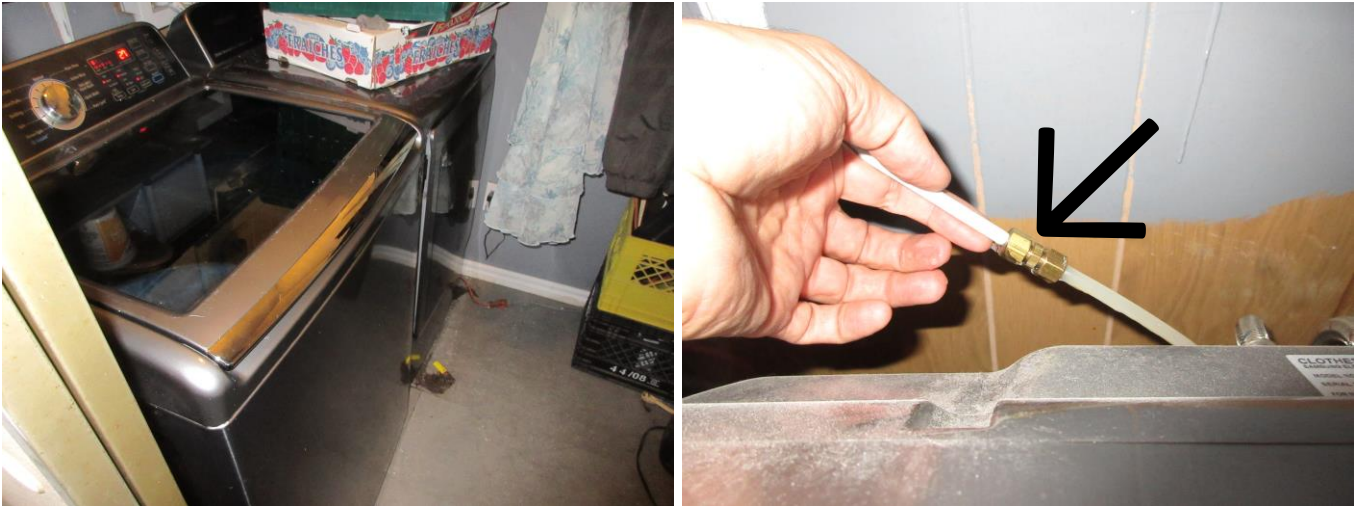
8.5 Washing machine & Dryer

The washing machine and dryer were tested and found to be performing as intended at the time of inspection. However, an active water leak was discovered at the refrigerator supply line connection located behind the washing machine. This leak appears to be constant and poses a risk of water damage to the flooring and wall assembly. I recommend immediate repair by a licensed plumber to prevent further moisture intrusion.

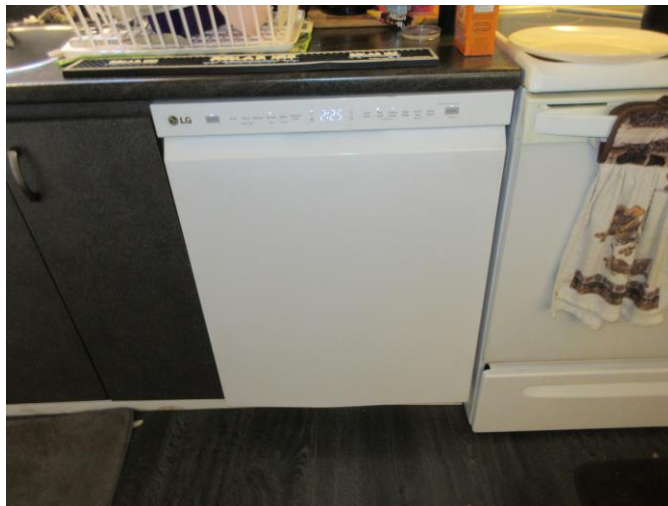
8.6 Dishwasher

The dishwasher was operated through a normal wash cycle and found to be performing as intended. No water leakage was observed at the supply or drainage connections, and the interior appeared to be in serviceable condition at the time of inspection. I recommend periodically cleaning the filter to ensure optimal drainage and performance.

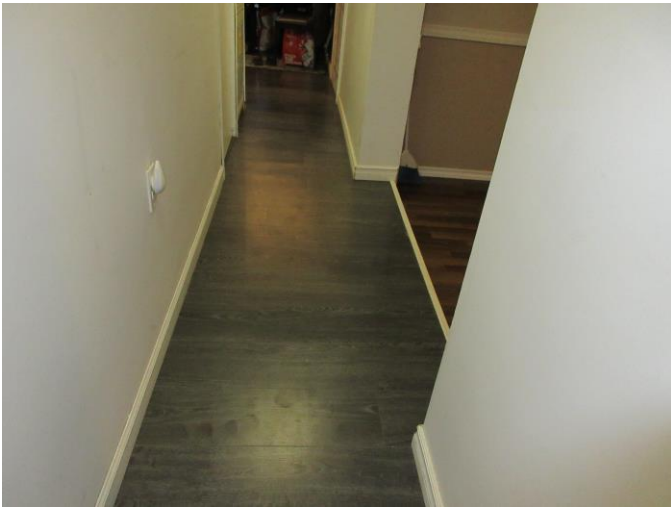
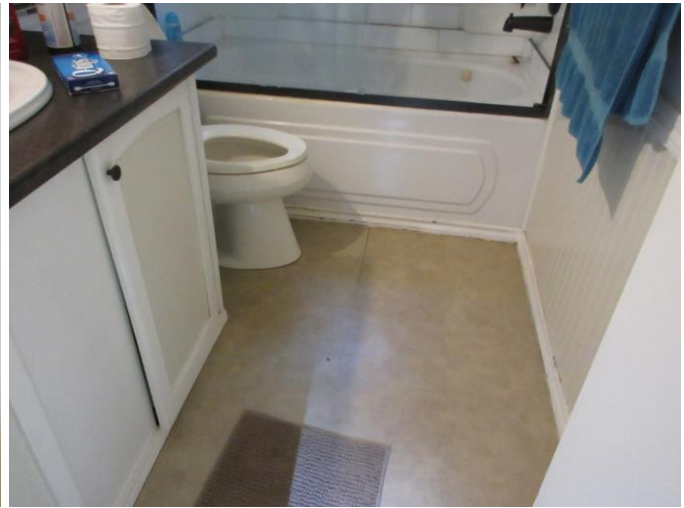
8.7 Floor cover

The home's interior flooring consists of laminate and linoleum (sheet vinyl). These surfaces were found to be in good serviceable condition with no observed deficiencies at the time of inspection. The transitions between different flooring types are secure, and no significant wear or damage was noted. Given the moisture-sensitive nature of laminate, I recommend maintaining the seals around wet areas to prevent future swelling.

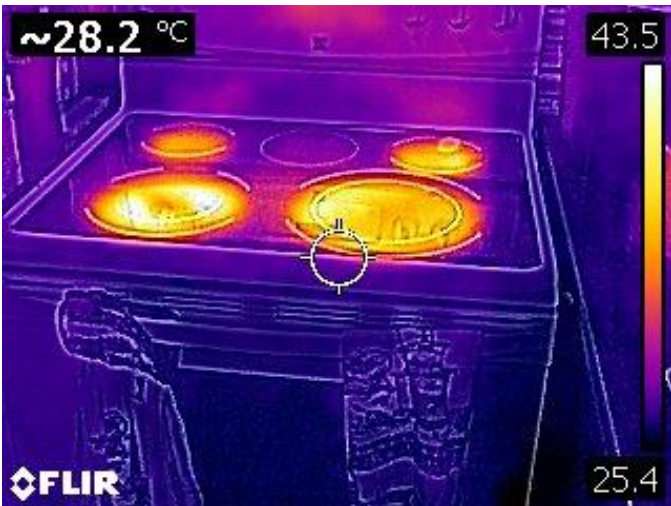
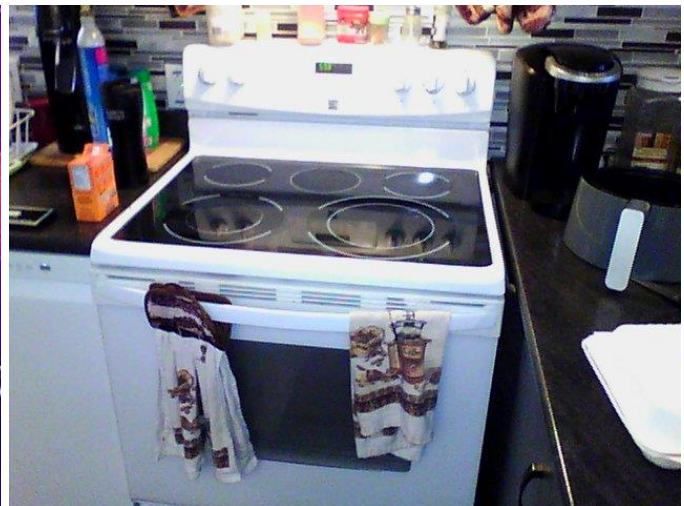
8.8 Stove & Oven

The home is equipped with an electric range. The cooktop elements and the oven's bake and broil functions were tested and found to be performing as intended at the time of inspection. No deficiencies were observed regarding the appliance's operation or physical condition.
