# Home Inspection Report

Prepared exclusively for  
North Vancouver BC

**Mahdi Sanei CHI (P)**

Property Address:  
 Date of home inspection: September 28, 2020  
 Inspection start time: 12:00 PM  
 Inspection end time: 15:00:00 PM  
 MLS# not available  
 Year Built: 1968  
 Construction: Concrete / Wood  
 Furnished: Yes  
 Occupied: Yes  
 Floor Area Total: 2263 sq. Ft.

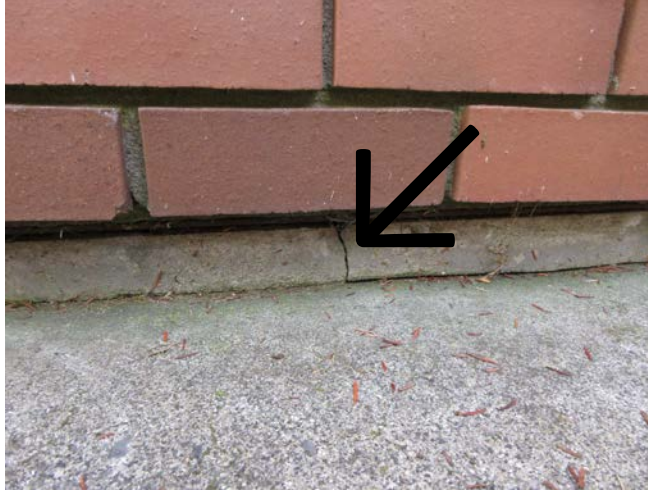
A 3 mm vertical crack was observed in the foundation wall on the north side of the house. Any separation of this width in a foundation is a potential conduit for moisture intrusion and soil gases. I recommend that this crack be sealed by a qualified foundation specialist to prevent water damage. Furthermore, the area should be monitored; if the crack widens or shifts, a structural engineering evaluation may be necessary.

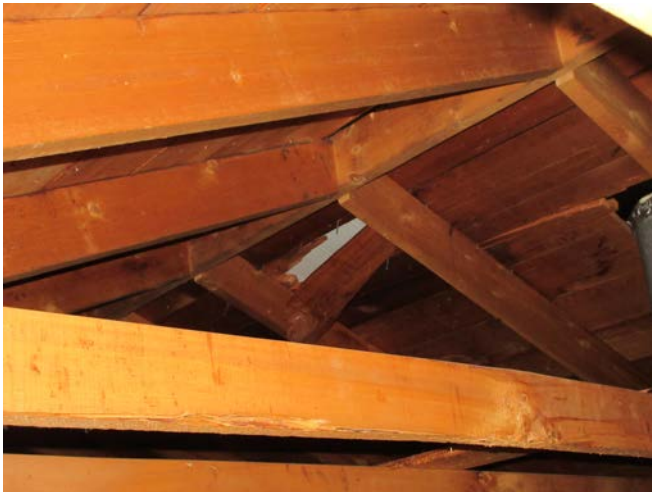
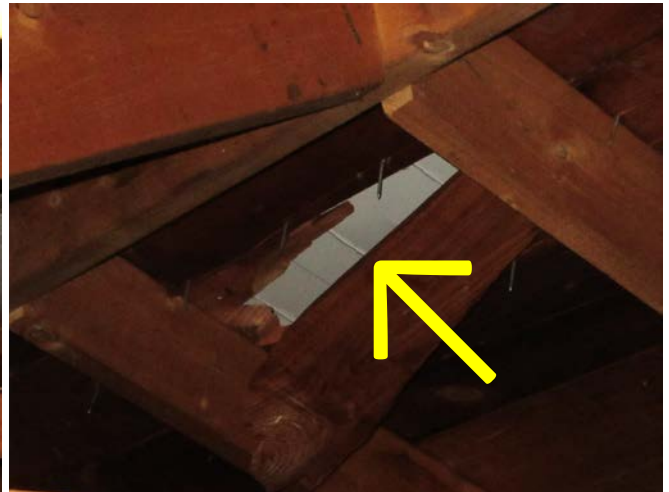
The attic structure is composed of wood trusses. During the inspection, a section of the roof sheathing (wood board panel) was found to be broken/fractured. This compromises the structural integrity of the roof deck and may lead to premature failure of the exterior roofing materials. I recommend that a qualified roofing contractor replace the damaged sheathing and inspect the surrounding area for any associated moisture damage or truss stress.

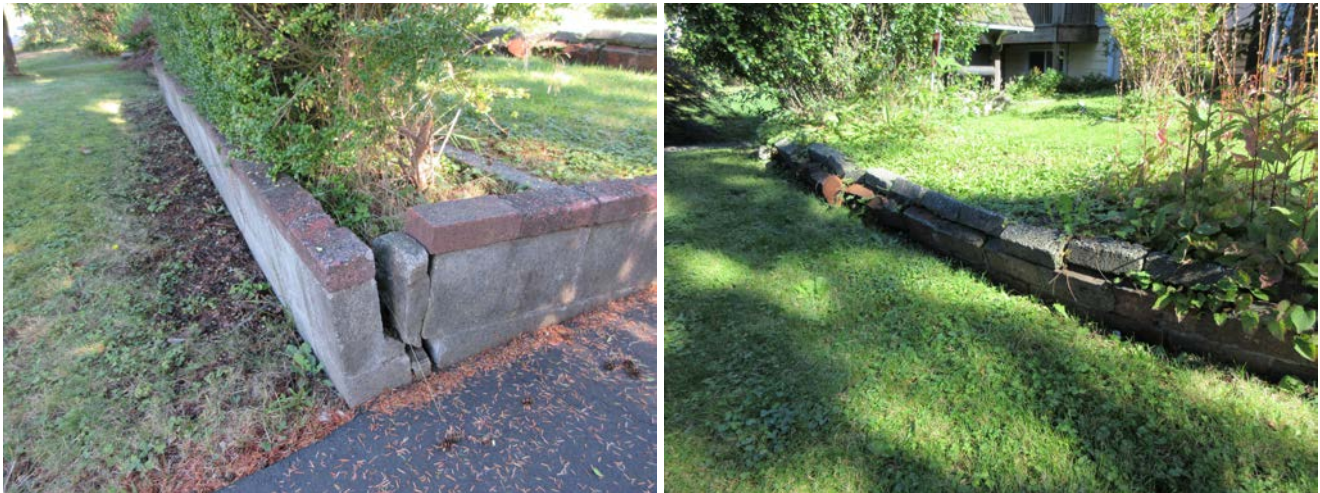
Significant lateral bowing and uneven surfaces were observed on the brick retaining wall. These conditions indicate that the wall is under excessive hydrostatic pressure or lacks sufficient structural reinforcement. Because a failure of this wall could lead to significant soil erosion, I recommend fixing the wall.

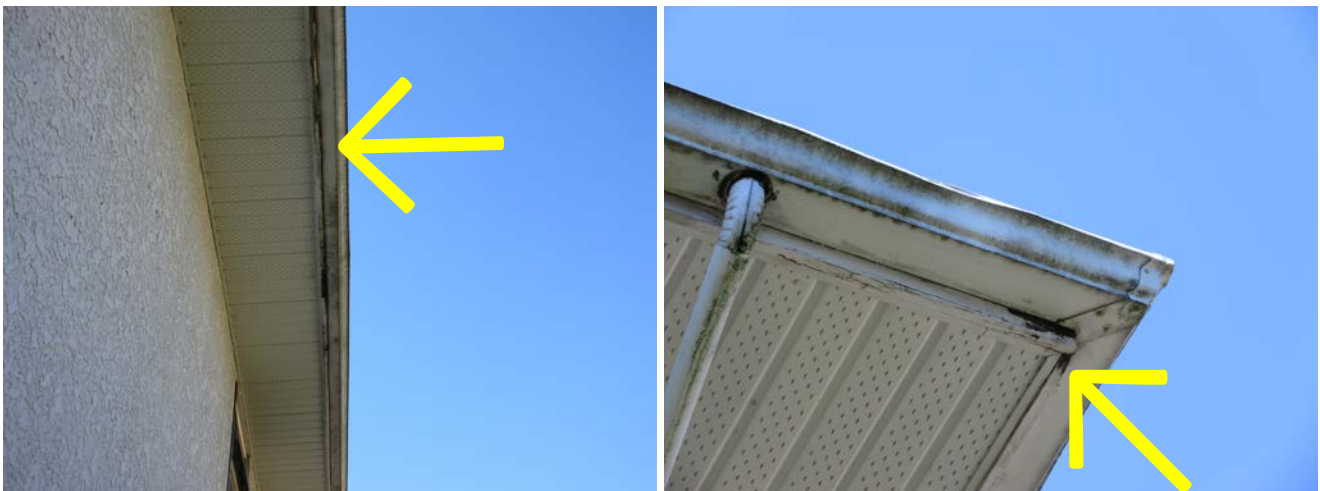
Wood fascia boards around the perimeter of the house exhibit signs of rot and significant paint peeling. While the visible surfaces are compromised, the full extent of the structural damage to the fascia and underlying rafter tails is unknown. To prevent further decay, I recommend replacing all rotted sections and implementing a periodic painting and maintenance schedule to protect the wood from moisture.

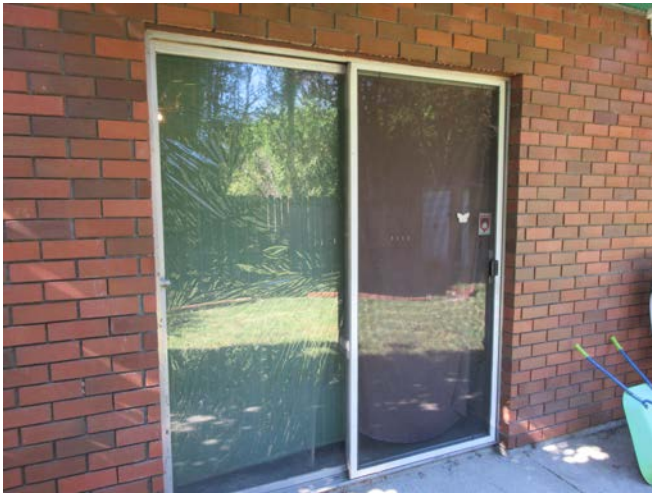
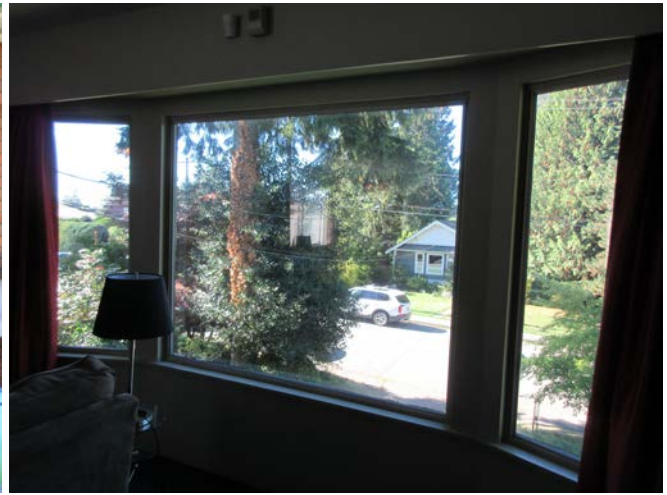
The house is equipped with single-pane windows. These units provide minimal thermal resistance, resulting in significant heat loss and higher energy costs. I recommend upgrading to double-glazed (thermal pane) windows to improve the home's energy efficiency, reduce noise transmission, and minimize interior condensation during winter months.

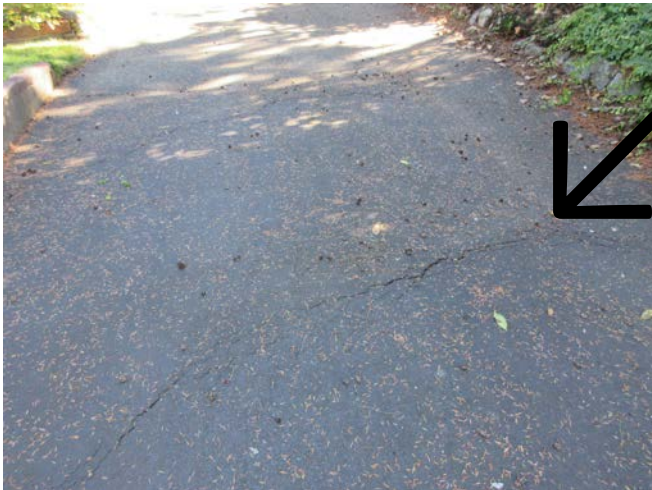
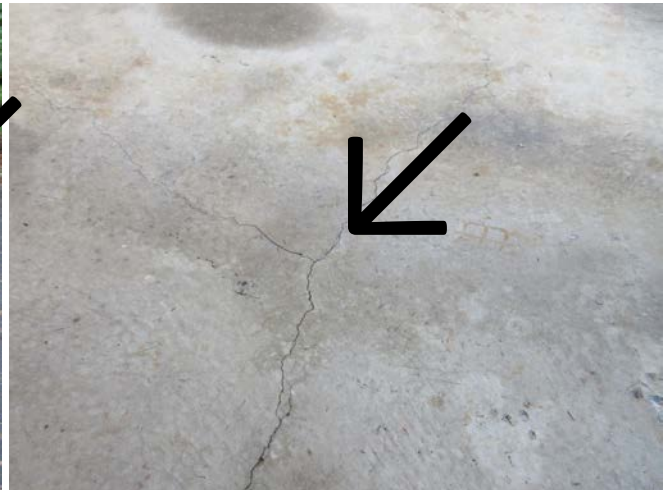
The property features an asphalt driveway and a concrete parking pad. Several minor settlement cracks were observed on the concrete surface of the parking area. While these appear to be typical for a structure of this age, I recommend sealing the cracks with a concrete filler to prevent water intrusion, which can lead to further cracking during freeze-thaw cycles.

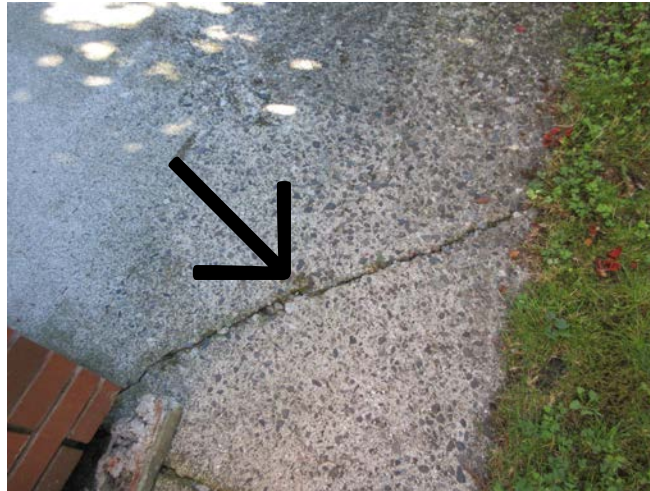
The property features a poured concrete walkway along the east side of the house. Several significant structural cracks were observed in this area. Some sections exhibit vertical displacement (uneven heights), which constitutes a trip hazard. I recommend that these cracks be repaired by a qualified masonry contractor to restore a level walking surface and prevent further deterioration from water infiltration.

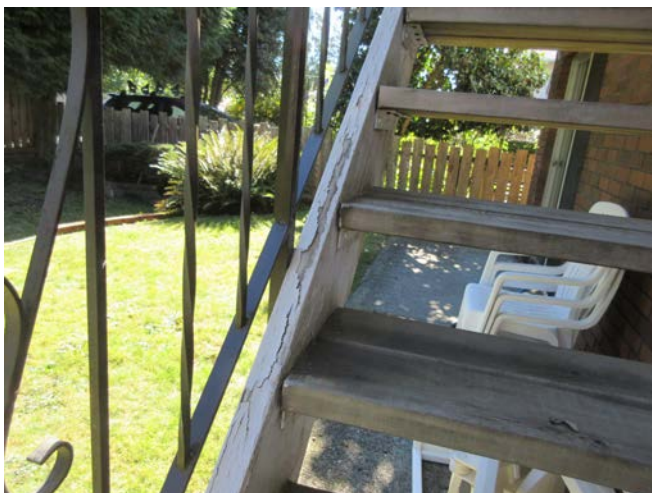
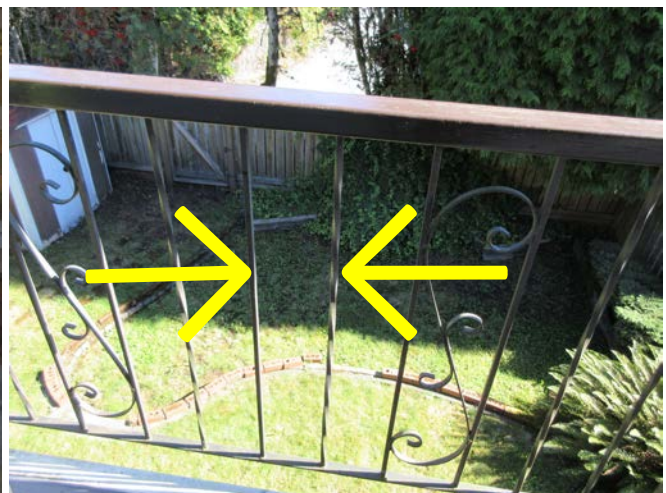
The guardrail assembly features unsafe conditions that require immediate attention. The baluster spacing exceeds the 4-inch (100 mm) maximum allowed by safety standards, creating a risk of injury for small children. I recommend that a contractor reinforce the guardrail posts and install additional balusters to ensure the assembly is secure and compliant with current safety codes.

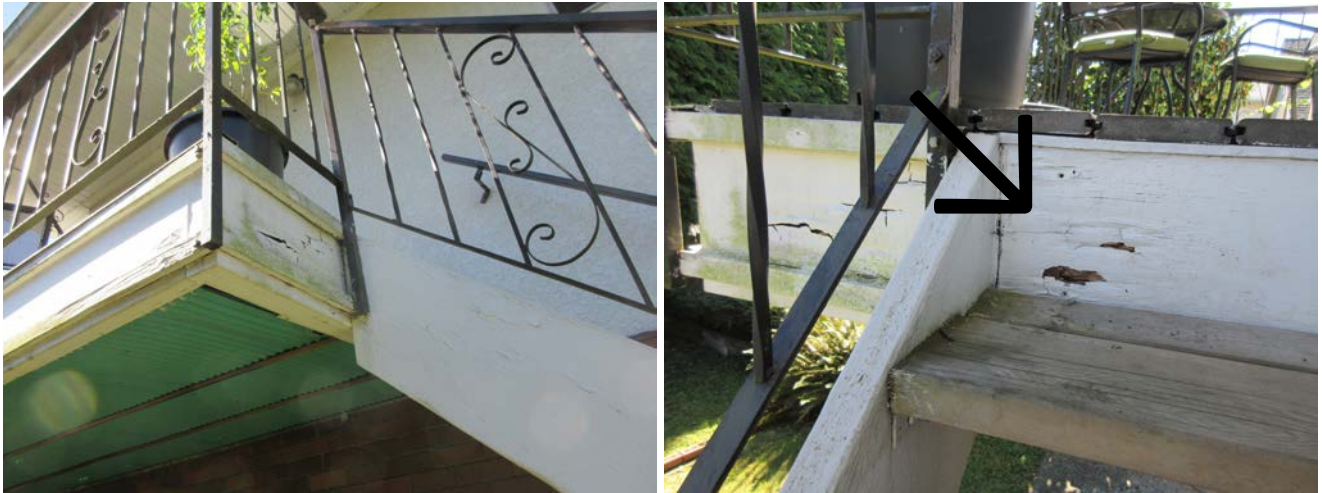
The wood fascia and stair trim on the backyard balcony exhibit advanced stages of rot and moisture decay. This deterioration appears to be caused by inadequate water shedding from the balcony surface. I recommend that a qualified contractor remove and replace all rotted wood and inspect the underlying structural joists for further damage. Ensuring proper flashing is installed during repair will prevent future recurrence.

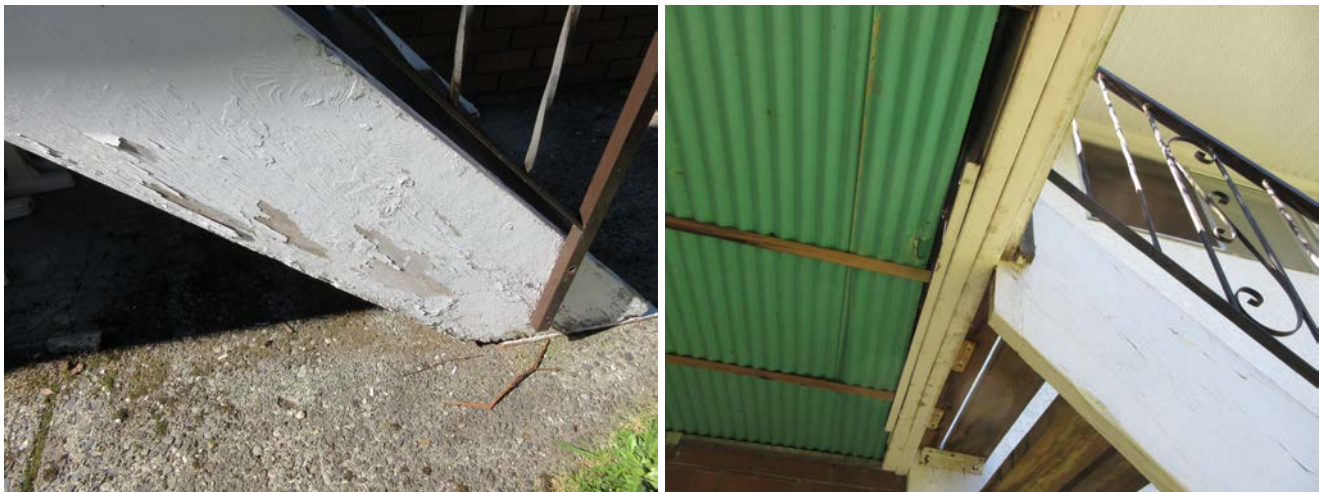
The exterior wood stairs at the rear of the house exhibit failing finishes and peeling paint. Significant surface checking (cracking) was noted in the treads and the outer stringer. I recommend that the stair assembly be thoroughly cleaned, sanded, and refinished to prevent further wood decay. Neglecting this maintenance may lead to structural rot in the stringers and treads.

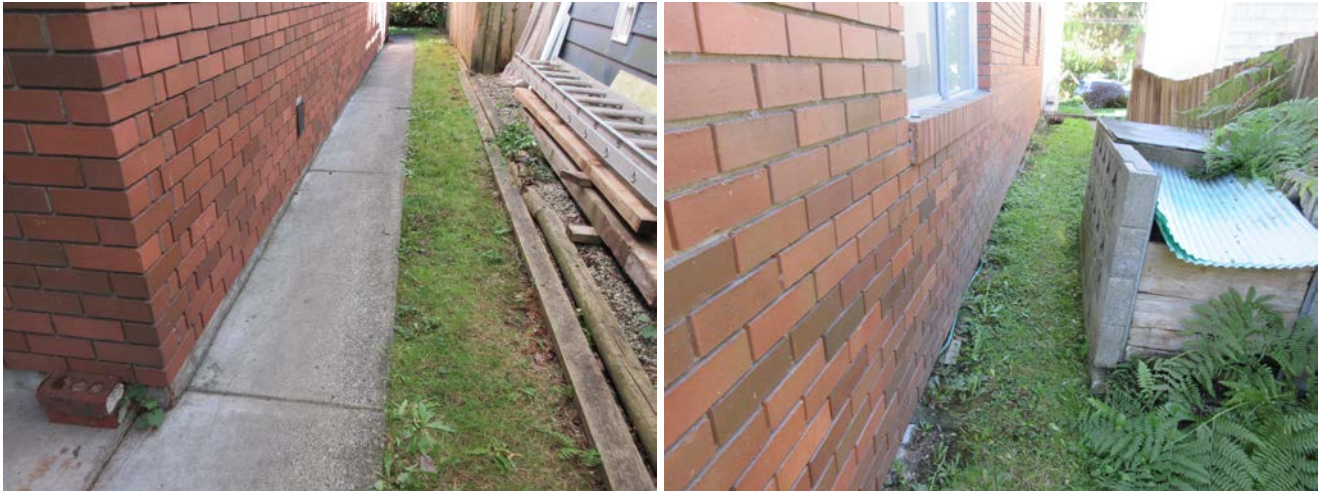
The exterior grading and concrete slabs on the property currently slope toward the foundation. This 'negative drainage' condition can direct surface runoff from rain and snowmelt against the foundation walls, increasing the risk of moisture intrusion. The ground should maintain a positive slope away from the building at a minimum gradient of 1 inch per foot for the first 6 feet. I recommend re-grading these areas to protect the structural integrity of the foundation.

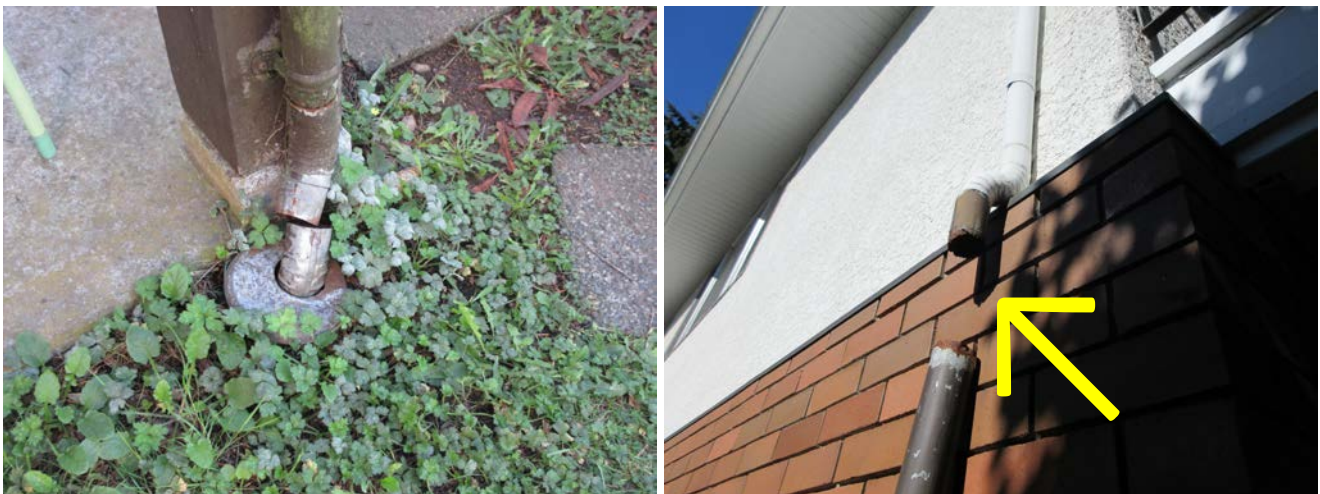
The downspouts currently discharge roof runoff in close proximity to the structural columns and the foundation wall. This concentrated water flow can lead to soil erosion and hydrostatic pressure, potentially compromising the stability of the foundation. I recommend installing downspout extensions to divert water at least 6 feet (1.8 meters) away from the building perimeter to ensure proper site drainage.

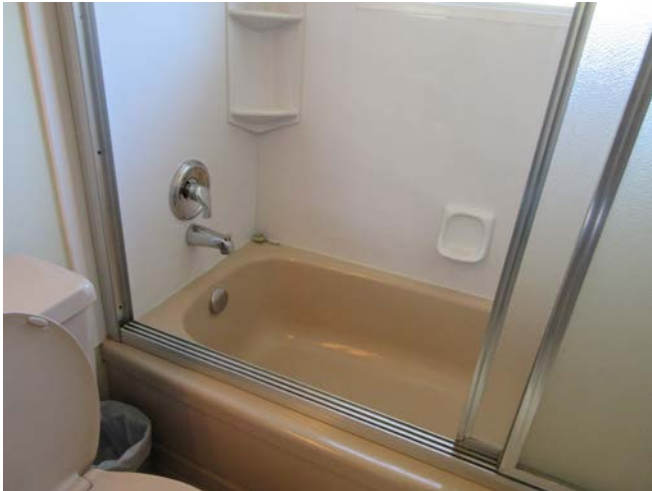
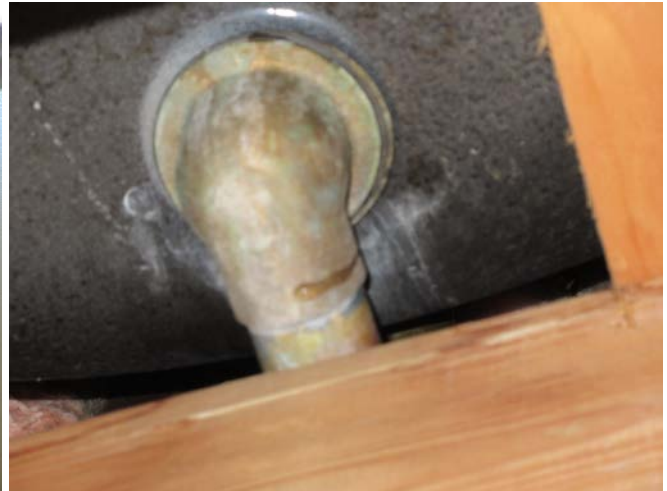
Active water leakage was observed at the bathtub waste and overflow piping within the second-floor bathroom. This leak is discharging moisture into the floor cavity, which can lead to significant structural decay and mold growth in the ceiling below. I recommend immediate repair by a licensed plumber to replace the leaking seals or pipe sections and a subsequent assessment of the subfloor for moisture damage.

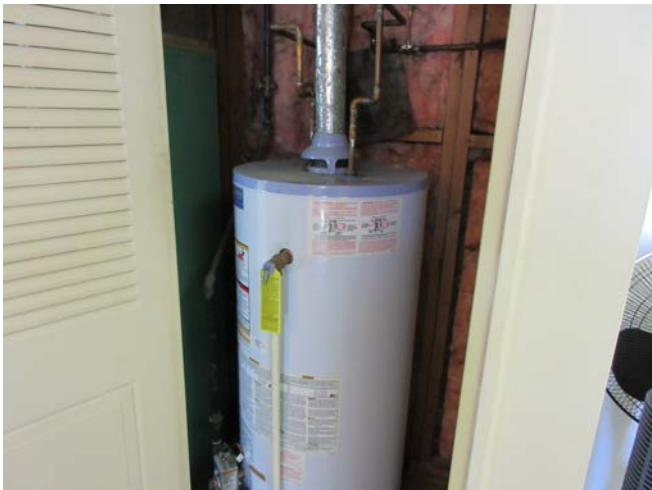
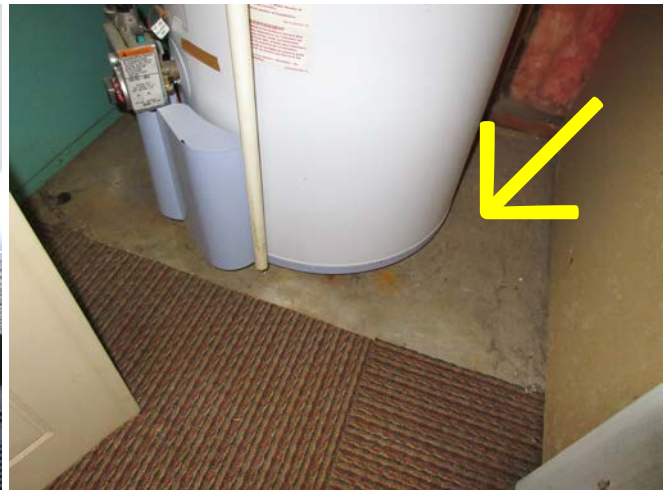
The hot water tank was manufactured in January 2011. While the unit was found to be operational and leak-free at the time of inspection, it has exceeded its typical life expectancy of 8 to 12 years. Appliances of this age are at an increased risk of sudden failure or tank leakage. I recommend that the client budget for a proactive replacement in the near future to avoid potential water damage.

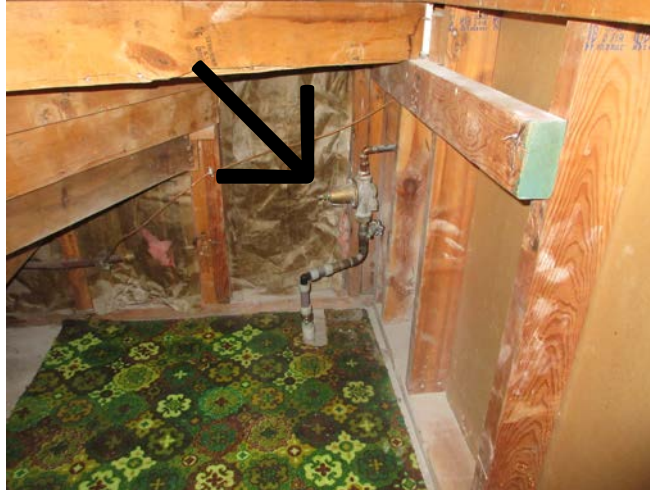
The home's potable water supply system utilizes copper piping. The main water shut-off valve is located within the bedroom closet of the basement suite. The visible sections of the piping appeared to be in good condition with no active leaks or significant corrosion noted at the time of inspection. I recommend ensuring that the area around the shut-off valve remains obstructed and clearly labeled for emergency access

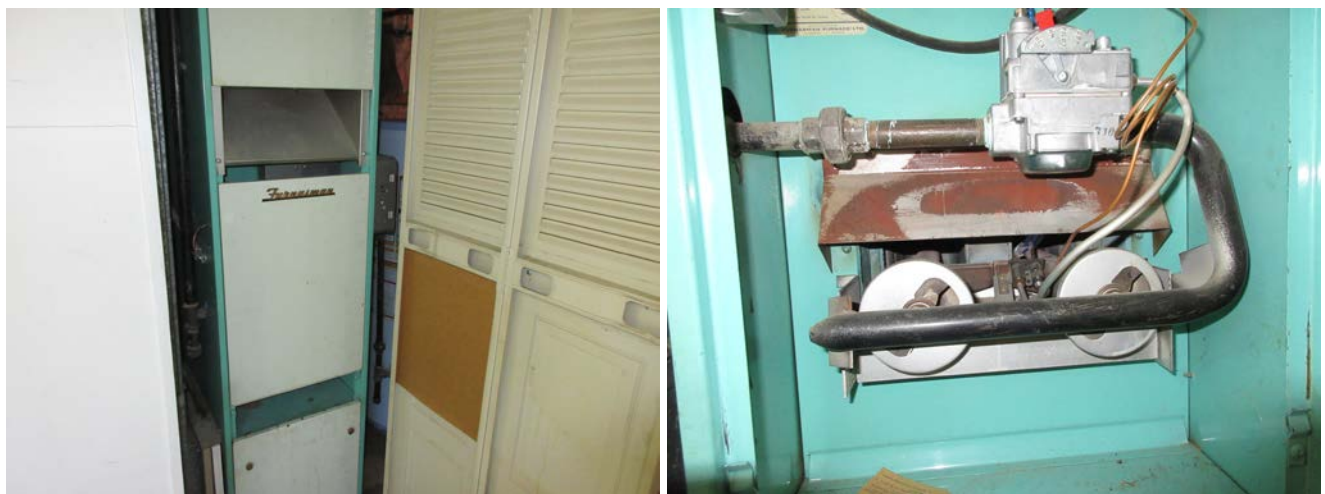
The heating system features an original, natural-draft furnace manufactured in 1968 with a 90,000 BTU input. This unit is approximately 52 years old and has far exceeded its typical design life of 20–25 years. While the furnace was operational at the time of inspection, it is significantly less efficient than modern units and poses a higher risk of heat exchanger failure. I recommend immediate budgeting for replacement with a high-efficiency model to improve safety and reduce energy costs.

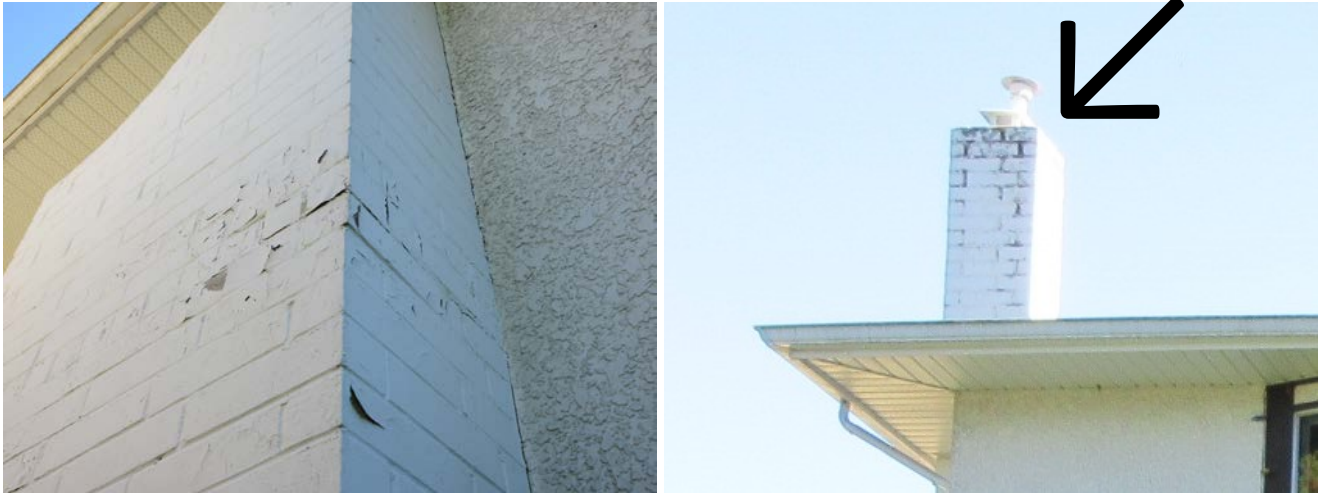
The chimney features a missing rain cap, leaving the interior flue open to the elements. This is a primary source for moisture intrusion, which can damage the fireplace firebox and dampers. Additionally, the chimney's exterior paint is peeling, and moss growth was noted on the masonry. I recommend installing a stainless steel rain cap and having a qualified masonry contractor clean and refinish the exterior to prevent further moisture-related deterioration.

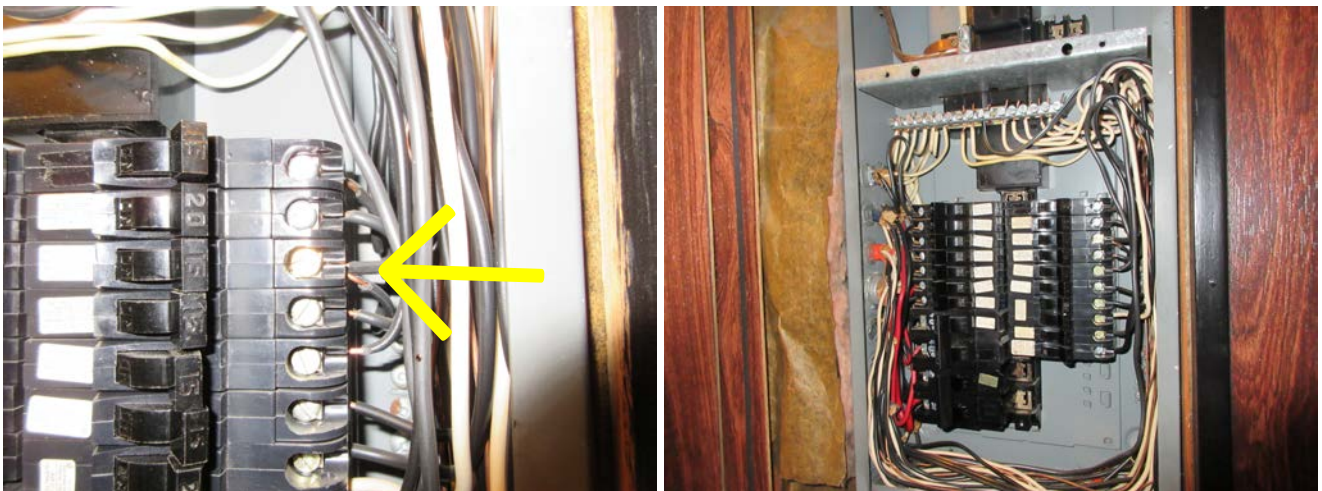
The 100-Amp electrical panel features double-tapped circuit breakers, where two conductors are connected to a single-pole breaker. This configuration is a safety concern as it can lead to poor electrical contact and overheating. The home's wiring consists of copper. I recommend a qualified electrician evaluate the panel and install additional breakers or 'tandem' breakers where appropriate to ensure all circuits are properly terminated according to code.

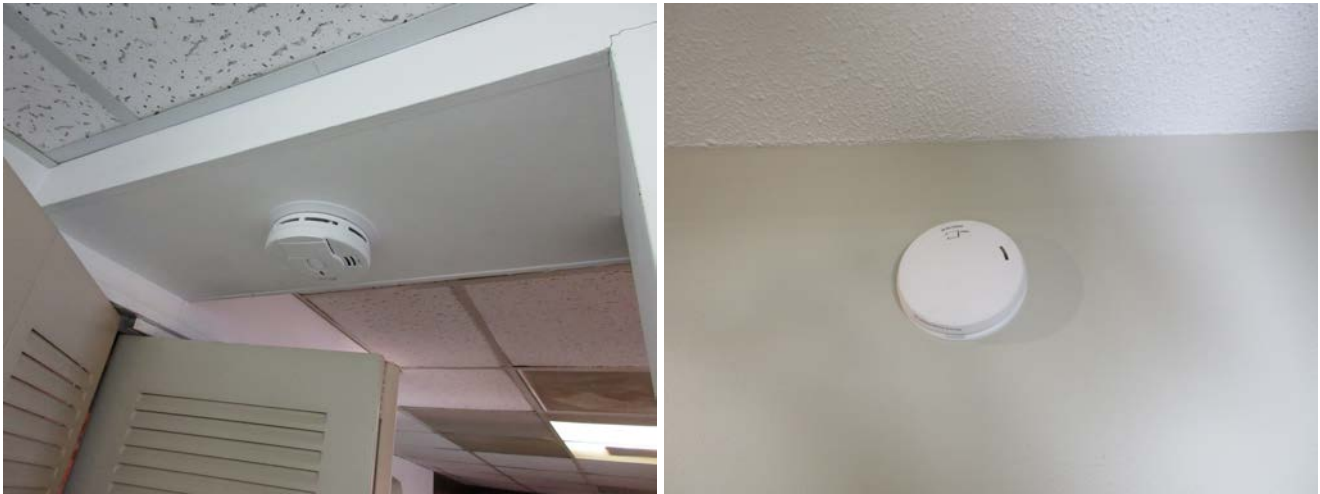
Smoke detectors have a maximum service life of 10 years, after which the internal sensors become unreliable. I recommend that the client replace all smoke detectors upon taking possession of the home to ensure the devices are current and functional. Additionally, batteries should be replaced annually, and the units should be tested monthly to ensure continued protection for all occupants.

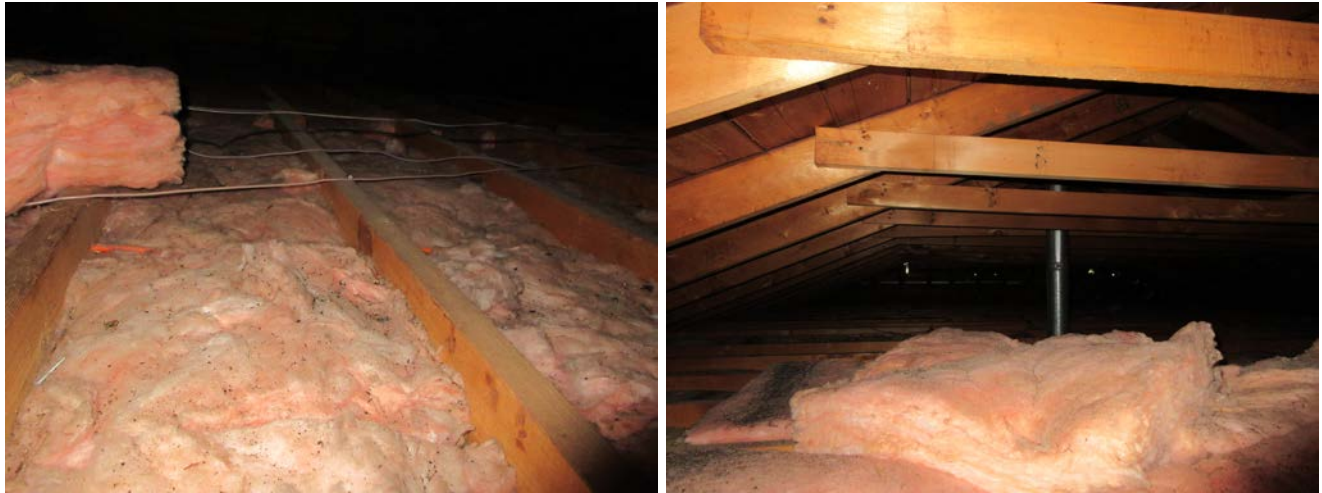
The attic is insulated with fiberglass insulation at a depth of approximately 8–10 inches, providing an estimated thermal resistance of R-25 to R-32. A polyethylene vapour barrier was observed on the attic floor. It is recommended to monitor the attic temperature during the winter to determine if additional insulation is needed.

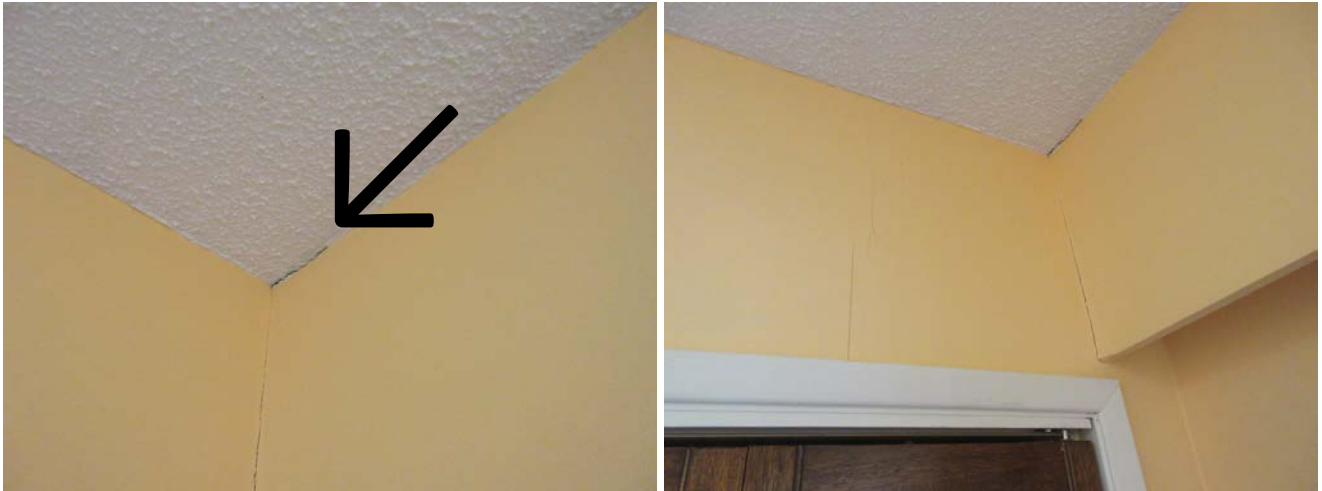
Hairline cracking was observed at the wall-to-ceiling transition in the second-floor bedroom. These cracks appear to be cosmetic in nature, likely caused by seasonal temperature changes or minor settling of the wood frame. I recommend that the client monitor these areas for any widening or lengthening. If the cracks expand significantly or if the ceiling begins to drop, a qualified contractor should be consulted to evaluate the structural connections.

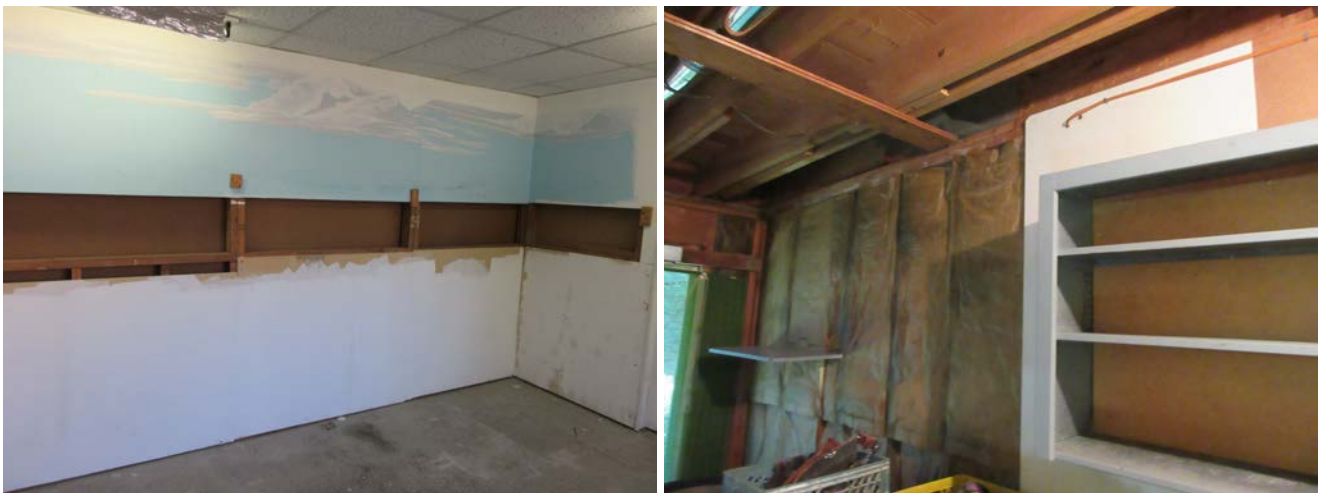
The walls in the workshop and the ground-floor room are currently unfinished, with the structural framing exposed. The interior wall cladding (drywall or sheathing) has not been installed. I recommend the installation of appropriate wall finishes to protect the structural members and, in the case of the workshop, to provide a proper fire-resistant barrier between utility spaces and the rest of the home.
