ABC Home Inspections  
**Home Inspection Report**  
**Confidential**

Prepared exclusively for  
Coquitlam, BC

Property Address: Coquitlam, BC  
 Date of home inspection: Saturday, June 22, 2024  
 Inspection start time: 10:00 AM  
 Inspection end time: 12:15 AM  
 MLS#: not available  
 Year Built: 1994  
 Construction: Concrete / Wood  
 Furnished: Yes  
 Occupied: Yes  
 Floor Area Total: 1201 sq. Ft.

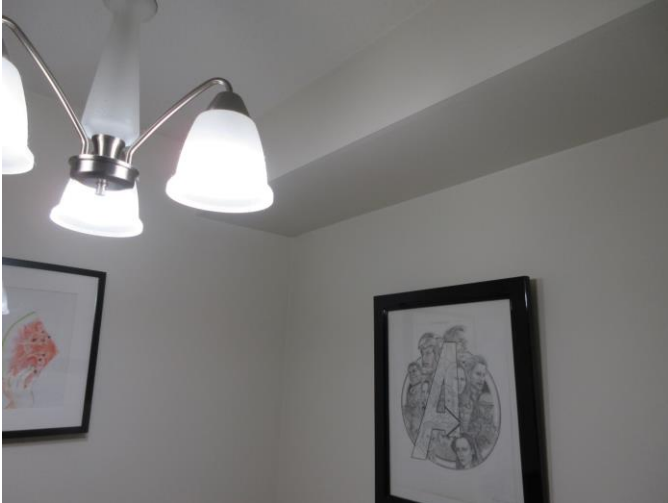
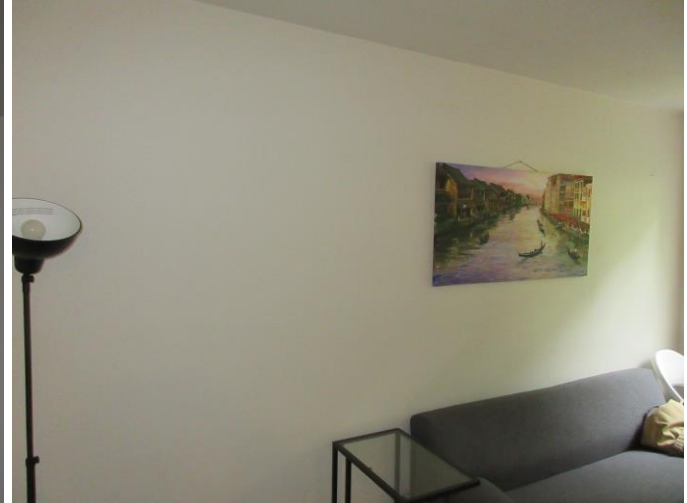
## 1.1 Main

The house features concrete floors, gypsum board (drywall) ceilings, and drywall walls. The interior walls, ceilings, and floors showed no defects or structural deficiencies at the time of this home inspection.

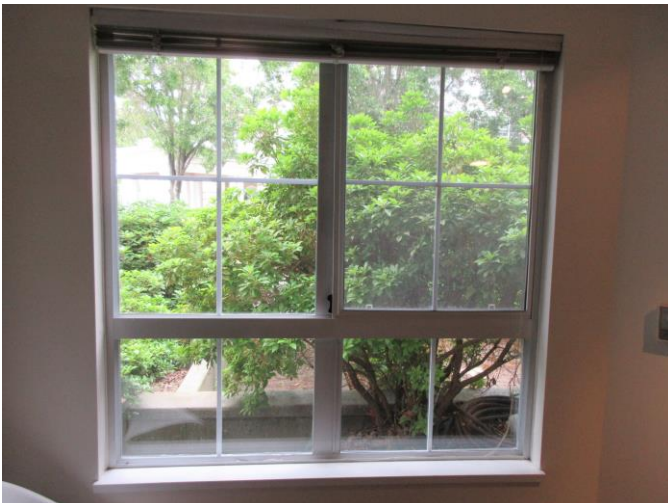
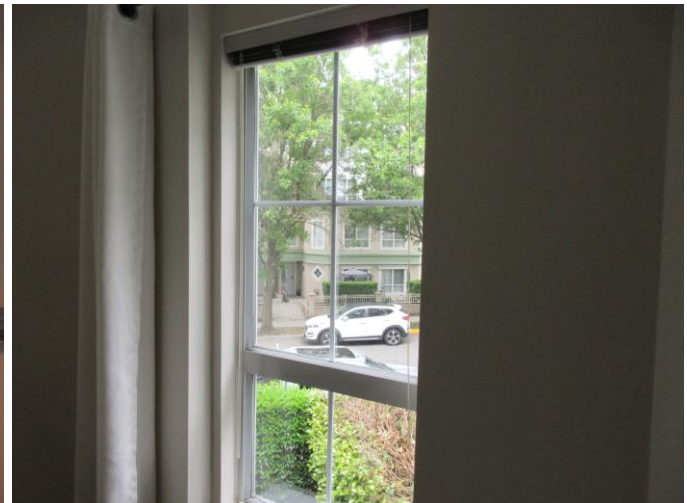
## 2.1 Window

The windows featured aluminum frames with double-pane glass. They were functional, with no deficiencies noted at the time of this home inspection.

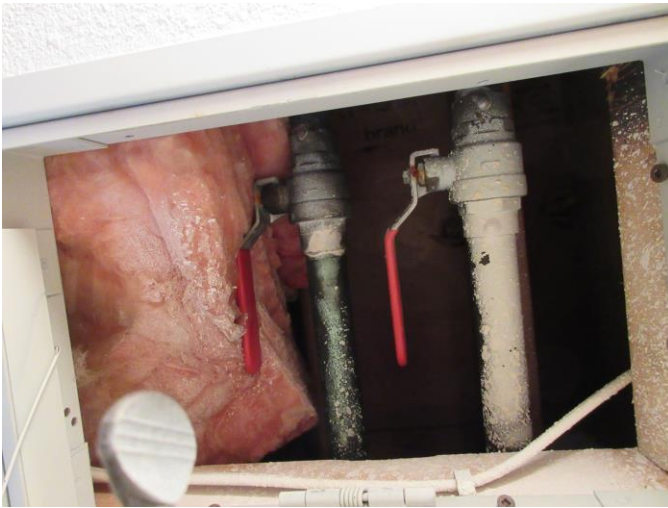
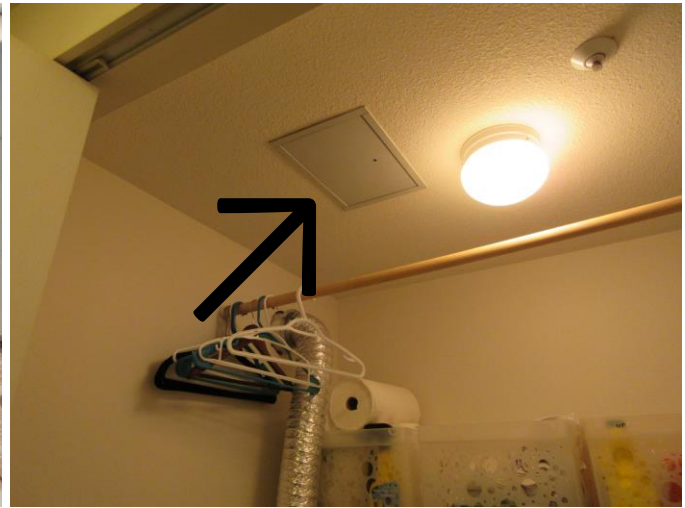
### 3.1 Water Supply System

The house original supply pipes was copper. It was functional with no deficiency at the time of this home inspection. The copper life expectancy is 20-50 years and dependent on water condition, it may fail within 20 years. The main water shut off valve was located in the ceiling of the laundry room. There was no corrosion or rusted pipe or condensation at the time of this home inspection.

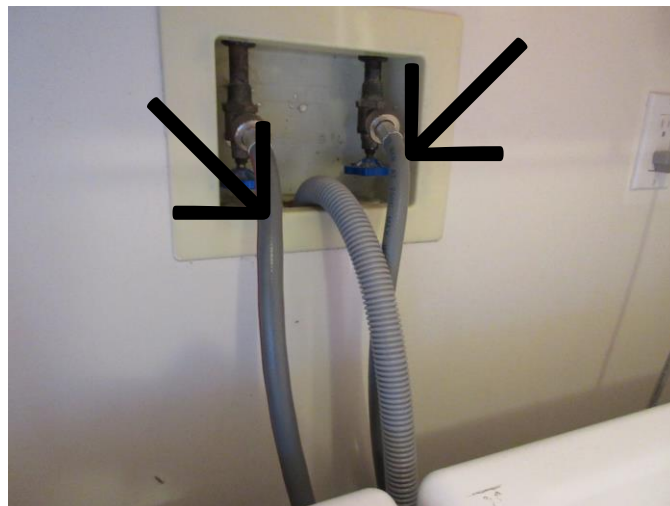
### 3.2 Washing Machine & Dryer

The washing machine utilized rubber hoses for the water supply. Over time, constant water pressure can cause rubber hoses to expand, which may lead to leaks or a sudden burst. I recommend replacing the rubber hoses with braided stainless steel flexible connectors.

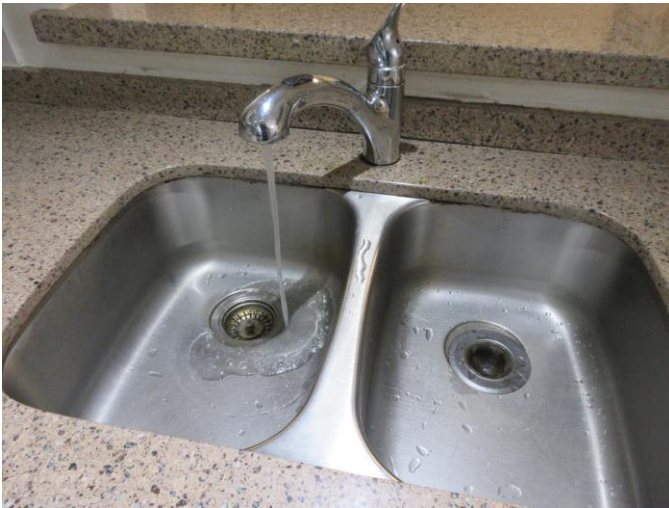
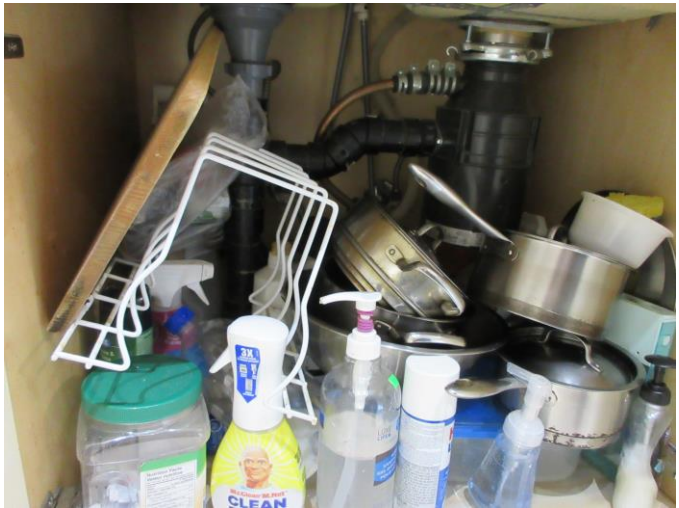
### 3.3 Kitchen sink & Faucet

The kitchen featured a stainless steel sink. The faucets and sink were functional, with no leaks observed at the time of this home inspection.

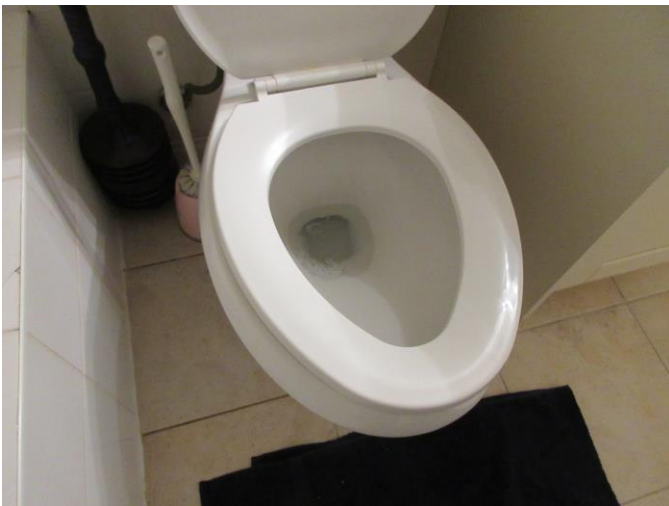
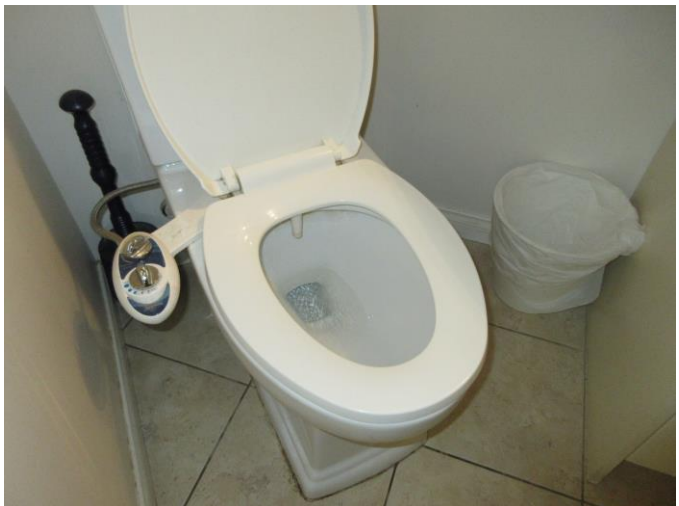
### 3.4 Toilet and Basin Sewage

All toilets in the home were tested. The toilets and their flushing mechanisms were functional at the time of this home inspection.

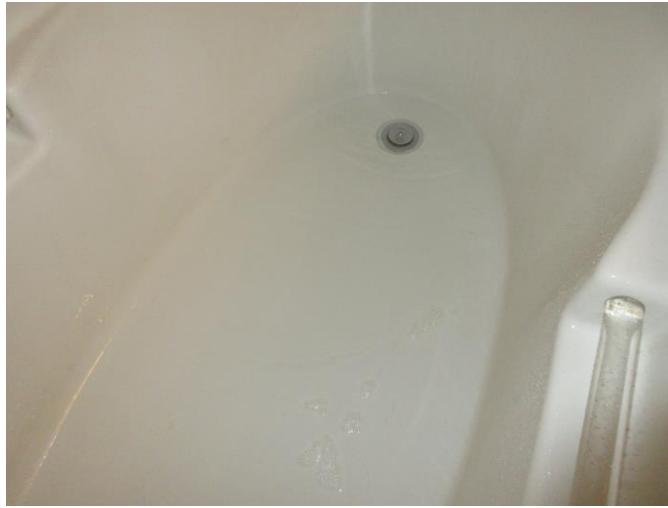
### 3.5 Bathtub

A minor water clog was noted in the bathtub. Water was discharging slowly from the bathtub in the master bathroom. Clearing the clog is recommended to restore proper drainage.

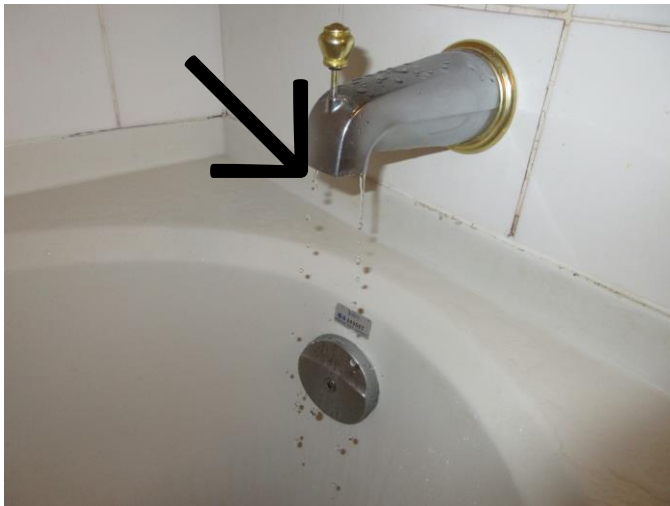
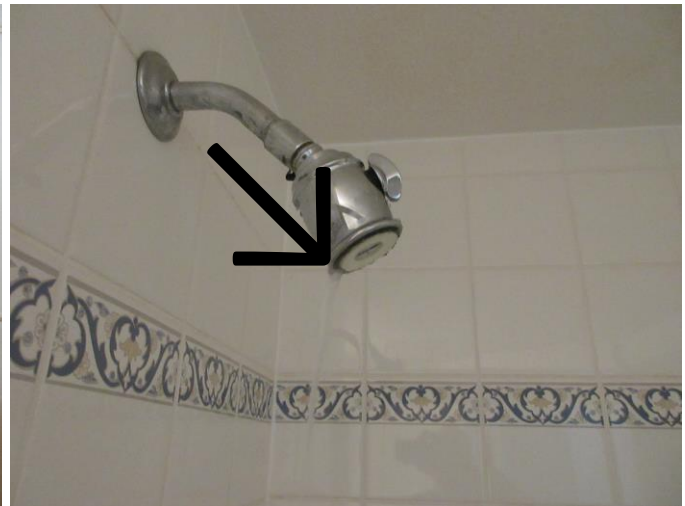
Low water pressure was noted at the shower. Water leakage was observed at both the faucet spout and the shower head in the master bathroom. Repairing these leaks is recommended to prevent water waste and potential moisture damage.

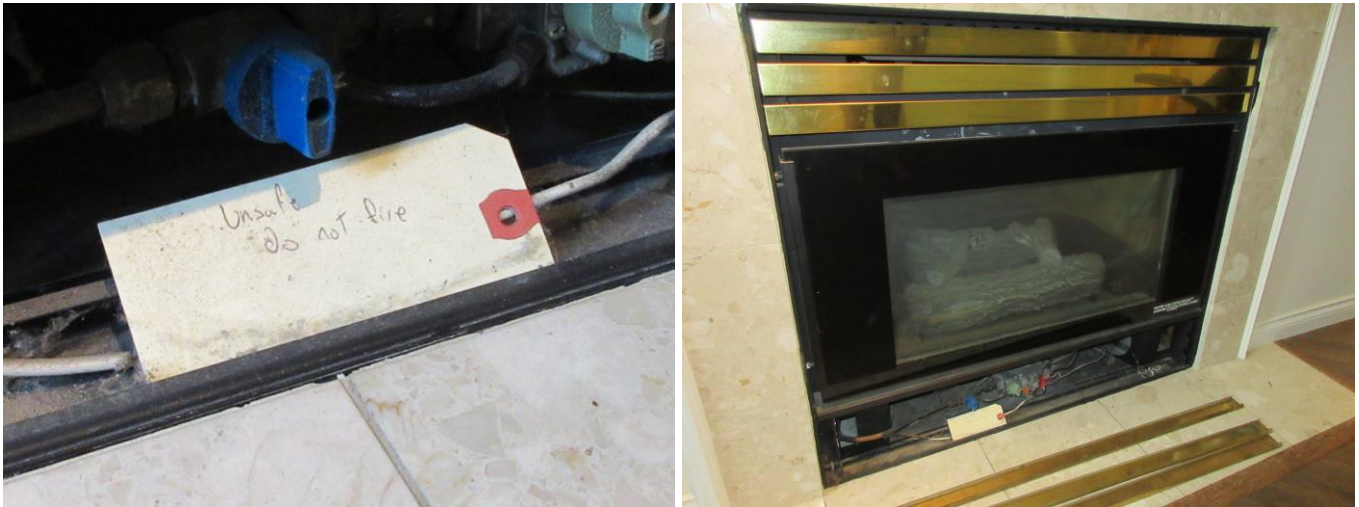
### 4.1 Fireplace

The house features a gas fireplace. A safety notice was observed on the unit; consequently, I was unable to ignite the fireplace and could not perform a functional inspection. The glass door exhibited significant soot buildup (smoke staining). I recommend professional cleaning of the fireplace glass and a full safety certification by a qualified technician.

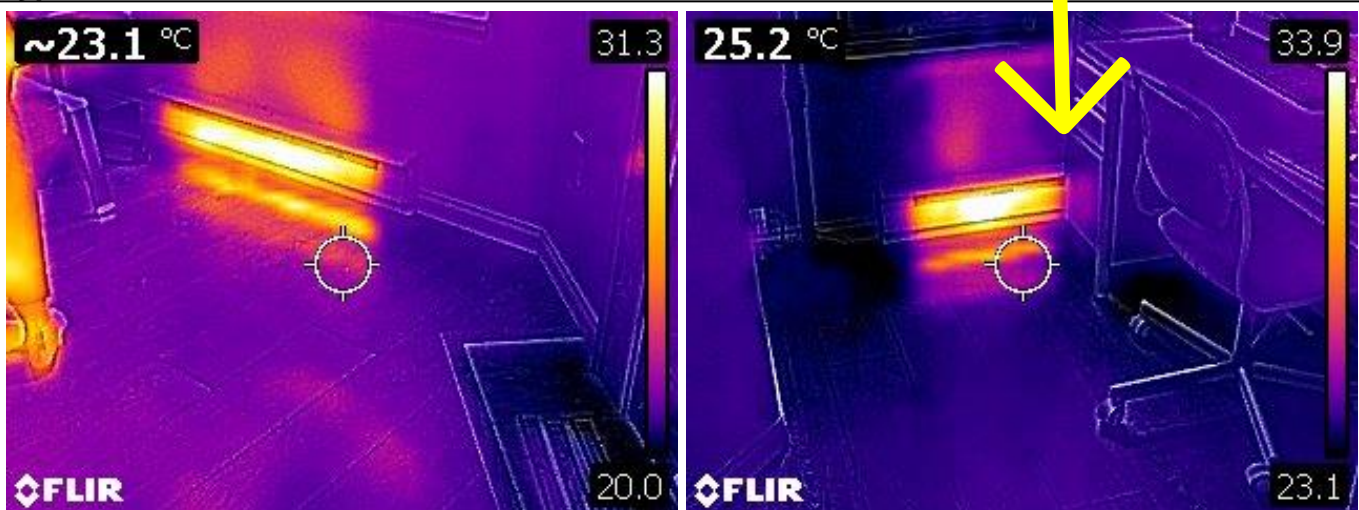
### 4.2 Electrical baseboard heater

All electrical baseboard heaters were tested and were functioning properly at the time of this home inspection. I recommend keeping furniture and textiles, such as drapes and sofas, away from the units to avoid fire hazards and ensure the system operates efficiently.

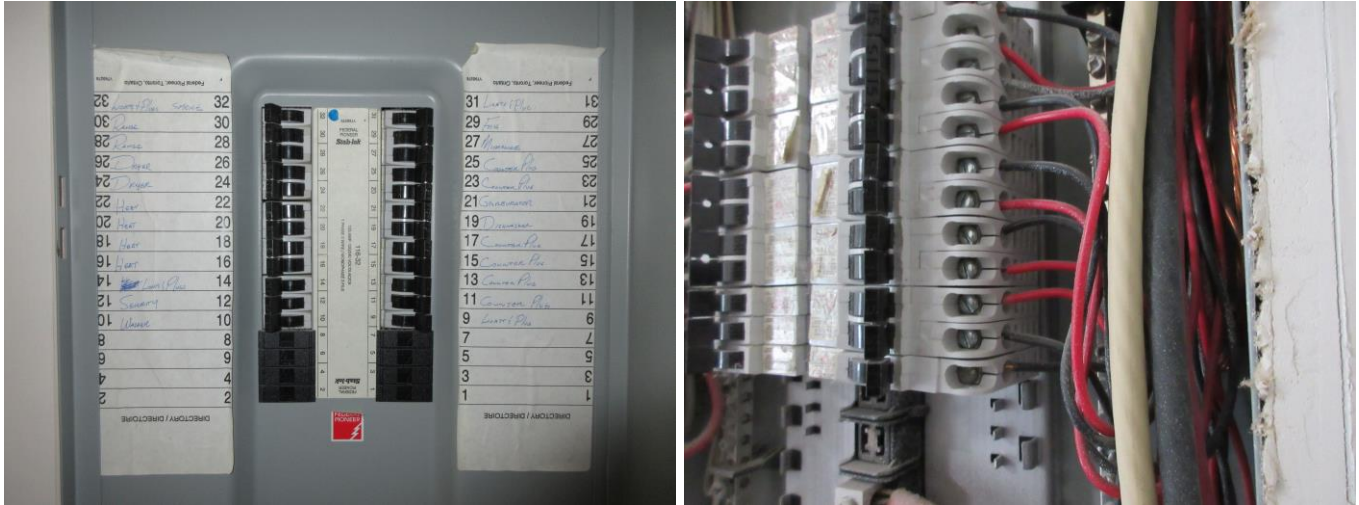
### 5.1 Main Electrical Panel

The main electrical panel was located in the northeast corner bedroom and appeared to be professionally installed. The wiring throughout the house is copper, with no signs of burnt, damaged, or corroded conductors. All breakers were labeled, and appropriate circuit breakers and wire gauges were used for specific circuits (e.g., 40-amp for the range, 30-amp for the dryer, and 15-amp for general circuitry).

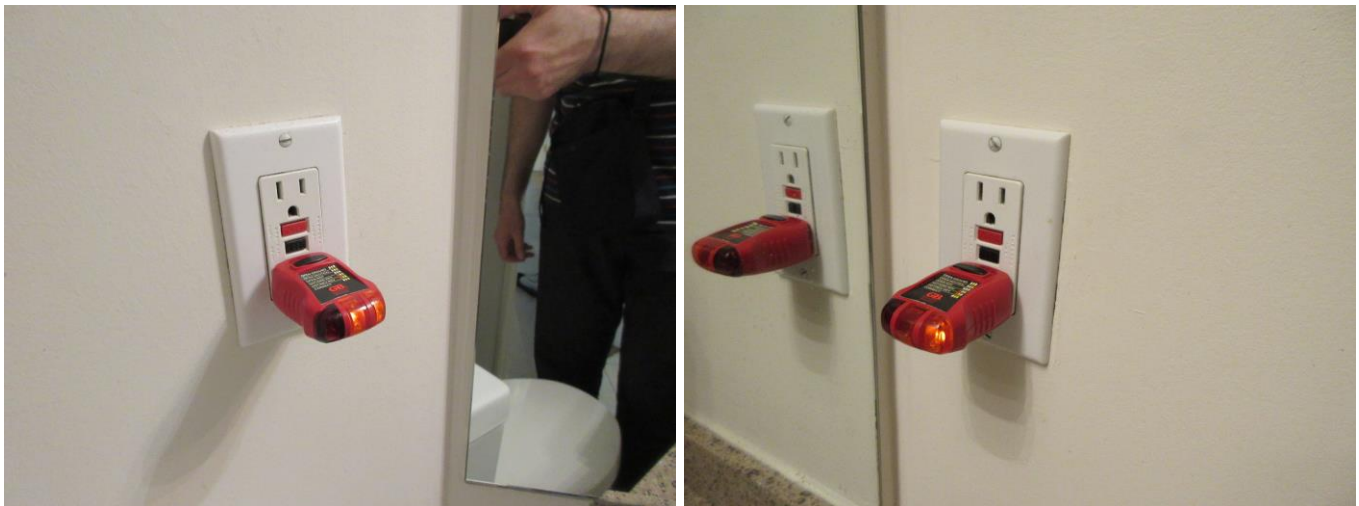
### 5.2 Outlet and Switch

GFCI-type outlets were located in the bathrooms and the washroom of the house. The GFCI outlets were tested and appeared to be in serviceable condition on the day of this home inspection.

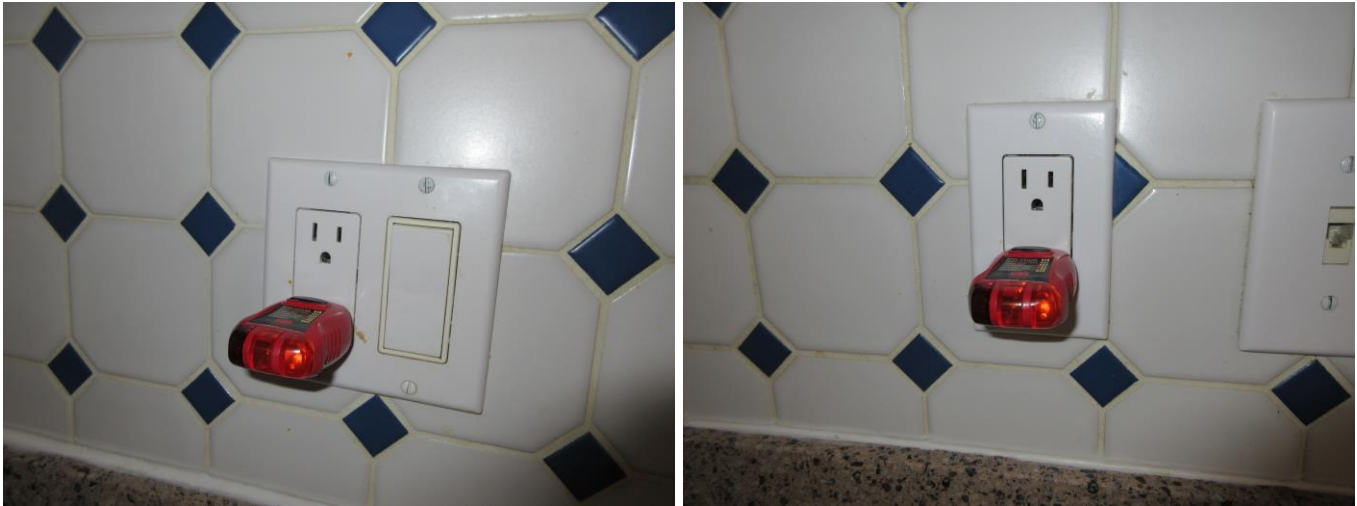
There were no GFCI-type outlets in the kitchen. Standard outlets were installed instead, which presents a safety concern. To protect users from electrical shock and hazardous conditions, outlets within the kitchen (especially those near water sources) should be GFCI-protected. I recommend the installation of Ground Fault Circuit Interrupter (GFCI) outlets for all kitchen countertop locations.

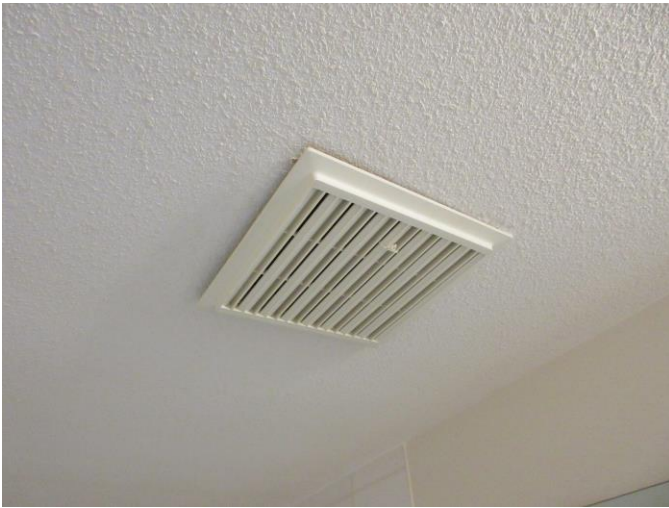
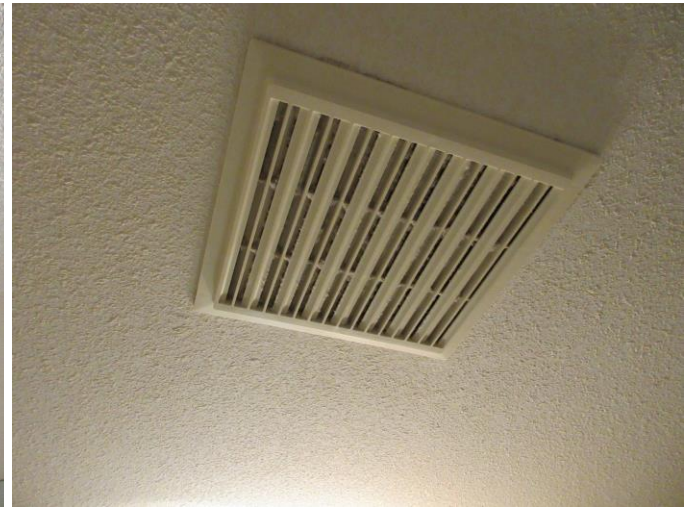
### 6.1 Bathroom & Washroom

Electrical exhaust fans were located in the bathrooms and the washroom. The fans in the master bathroom and main bathroom were functional at the time of this home inspection. However, the exhaust fan grilles were dirty and clogged with dust throughout the house; cleaning them is recommended to improve airflow and functionality. Additionally, the grille in the master bathroom was loose and should be properly secured.

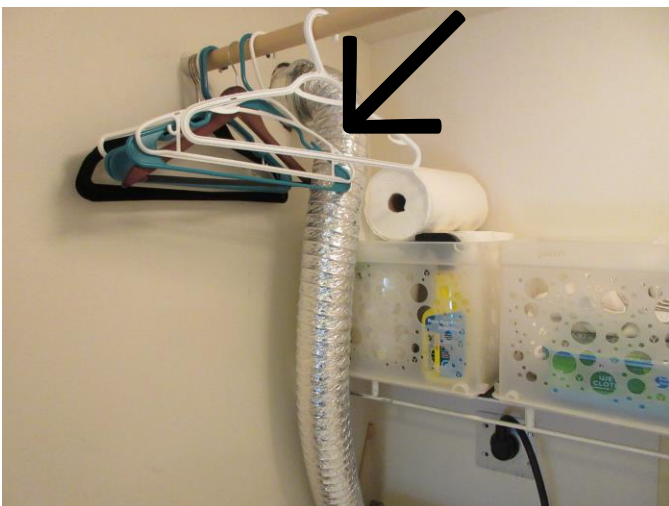
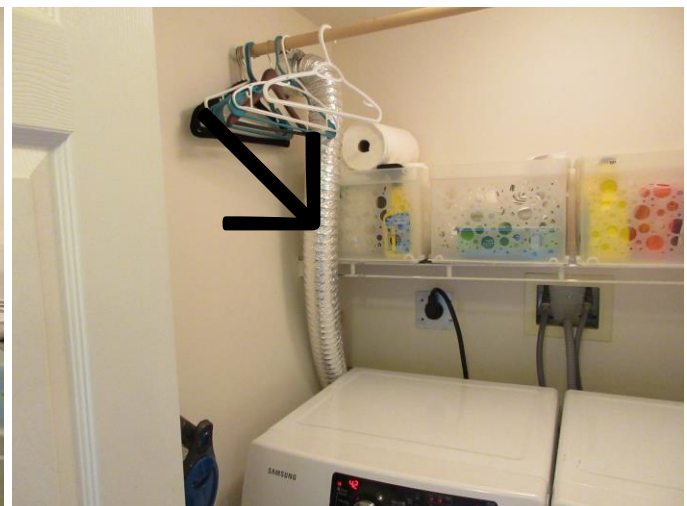
### 6.2 Laundry duct

The dryer was equipped with a foil duct, which is not recommended for this application. This presents a safety concern and a potential fire hazard. Only rigid metal or semi-rigid aluminum ducting is approved and recommended for dryer transitions. I recommend replacing the foil duct with a hard metal or aluminum duct.

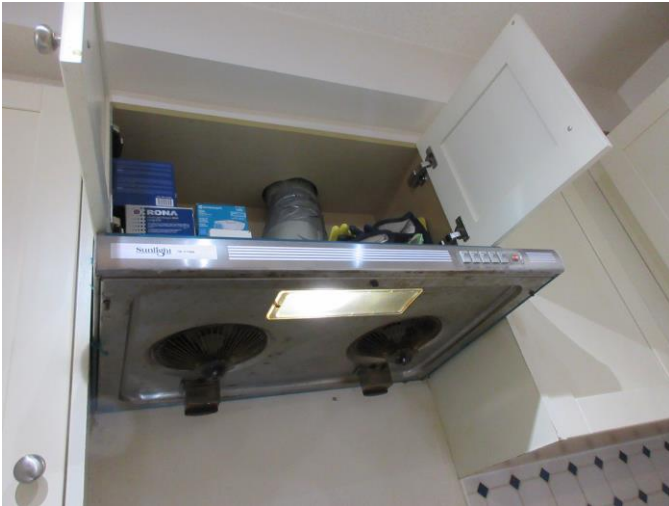
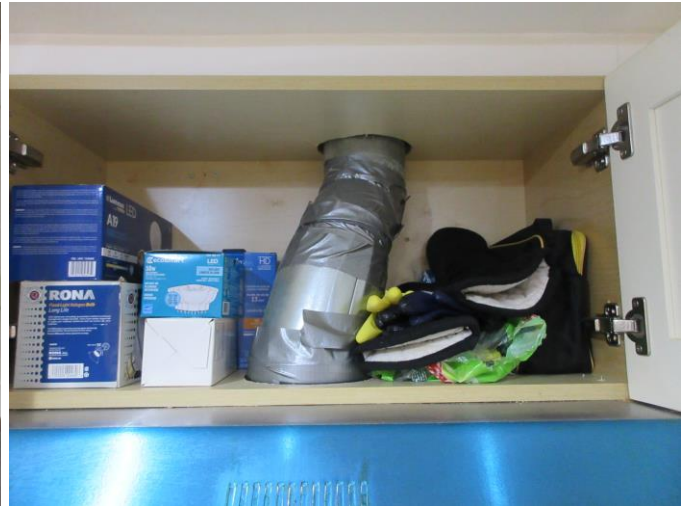
## 6.3 Rang Hood

The house was equipped with an electrical range hood. The exhaust fan was tested and found to be functional at the time of this home inspection.

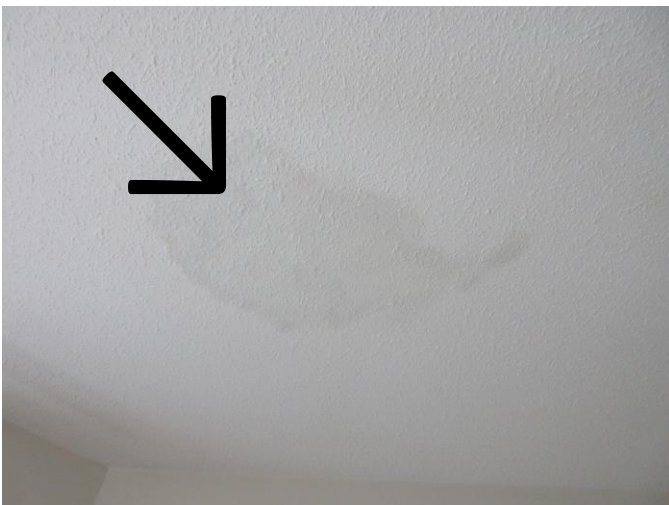
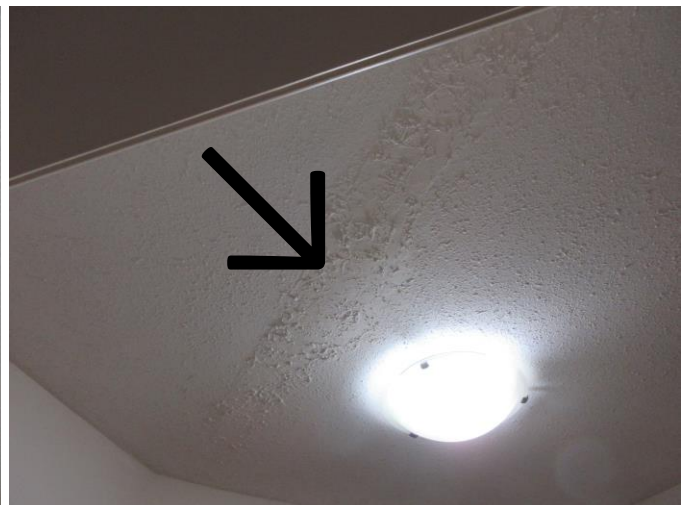
### 7.1 Ceiling

Previous water leakage stains and damaged areas were observed on the ceilings of the bedroom and corridor. These moisture stains were dry at the time of this home inspection. I recommend monitoring these areas for any changes and consulting a qualified contractor for further assessment or repair.

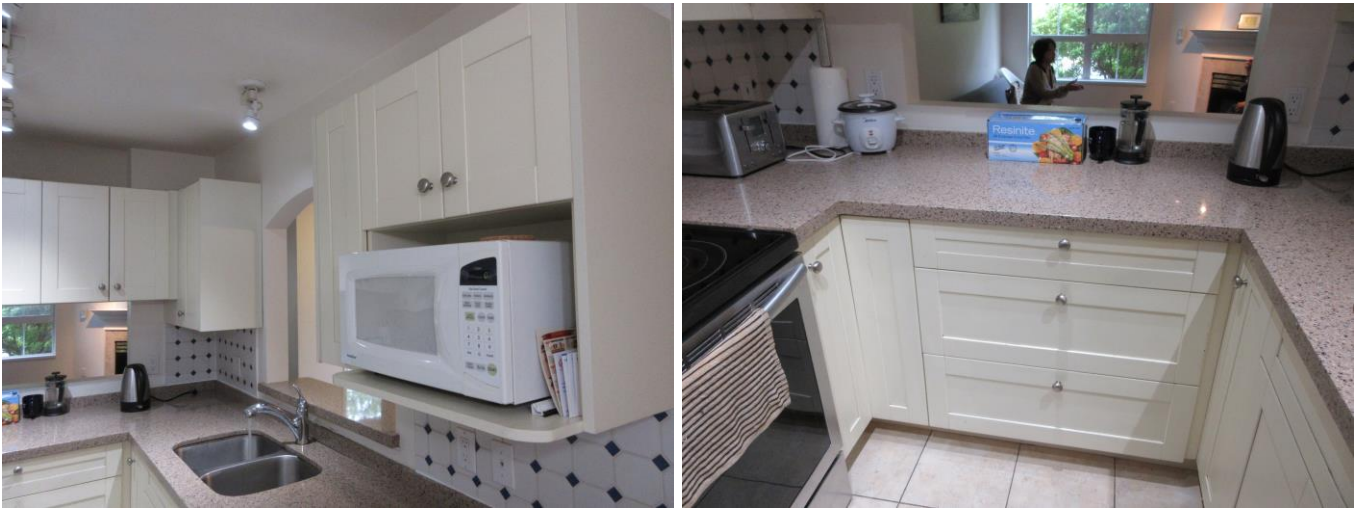
## 7.2 Counter and Cabinet

The kitchen featured quartz countertops and laminate-faced cabinet doors. Both the cabinets and countertops were functional, with no deficiencies noted at the time of this home inspection.

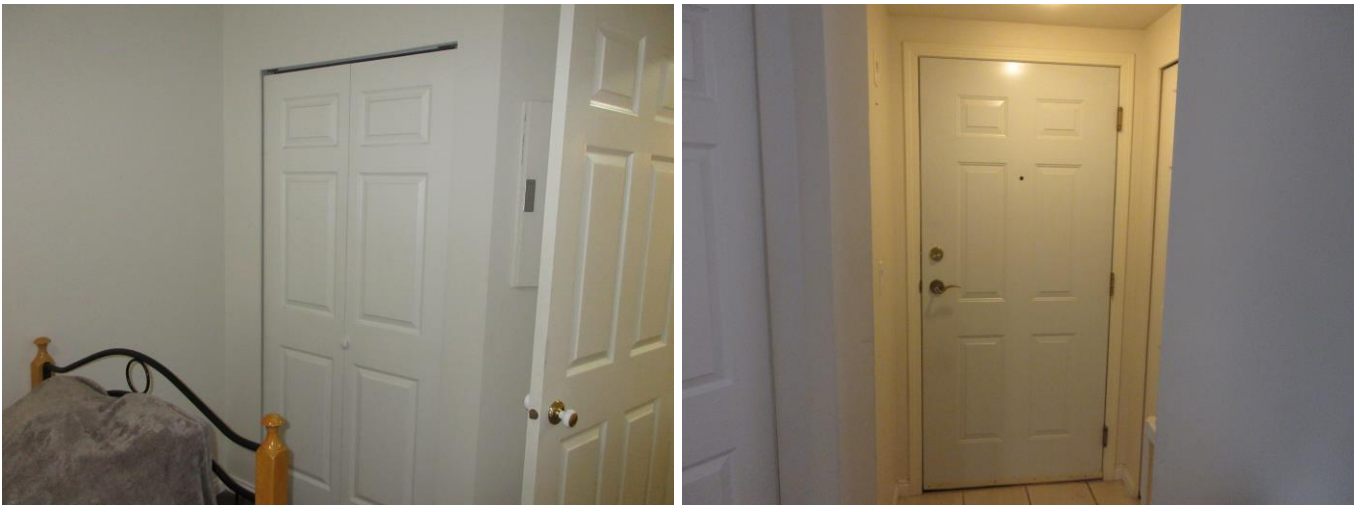
## 7.3 Door & Closet door

The house was equipped with vinyl-surfaced interior doors for the rooms and bifold doors for the closets. The interior doors, closet doors, and their associated hardware were functional and in good condition, with no deficiencies noted at the time of this home inspection.

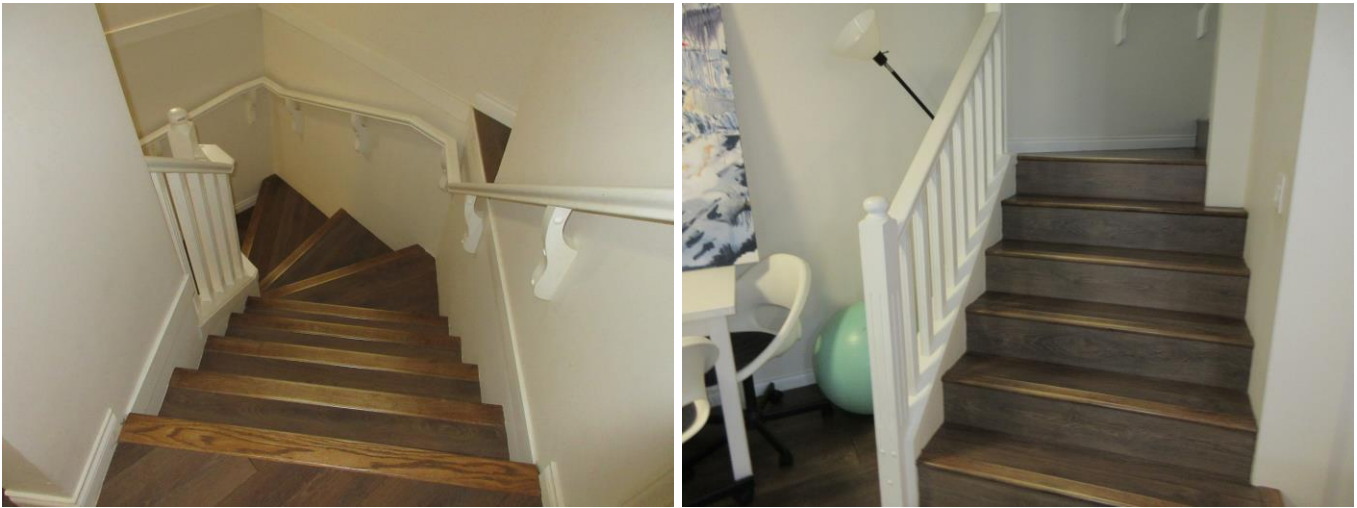
## 7.4 Stair, Railing and Guard

The interior stairs were finished with laminate flooring. The staircase was functional, and the handrail was securely installed, with no deficiencies noted at the time of this home inspection.

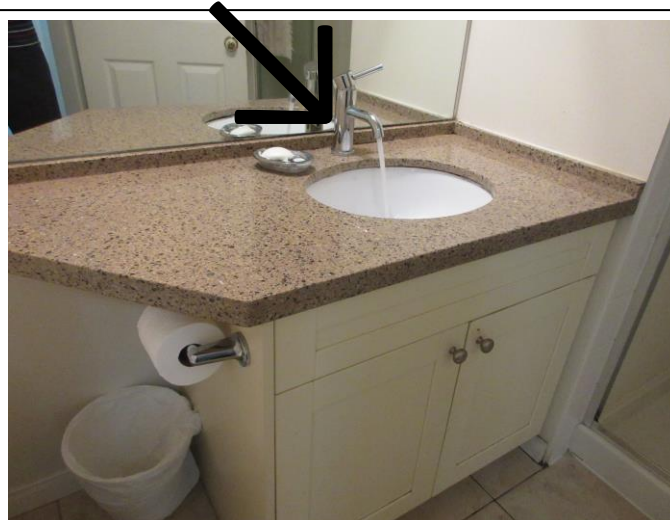
## 7.5 Bathroom

The basin stopper was not functional in the main bathroom. I recommend repairing or replacing the stopper to restore proper operation of the sink drain.

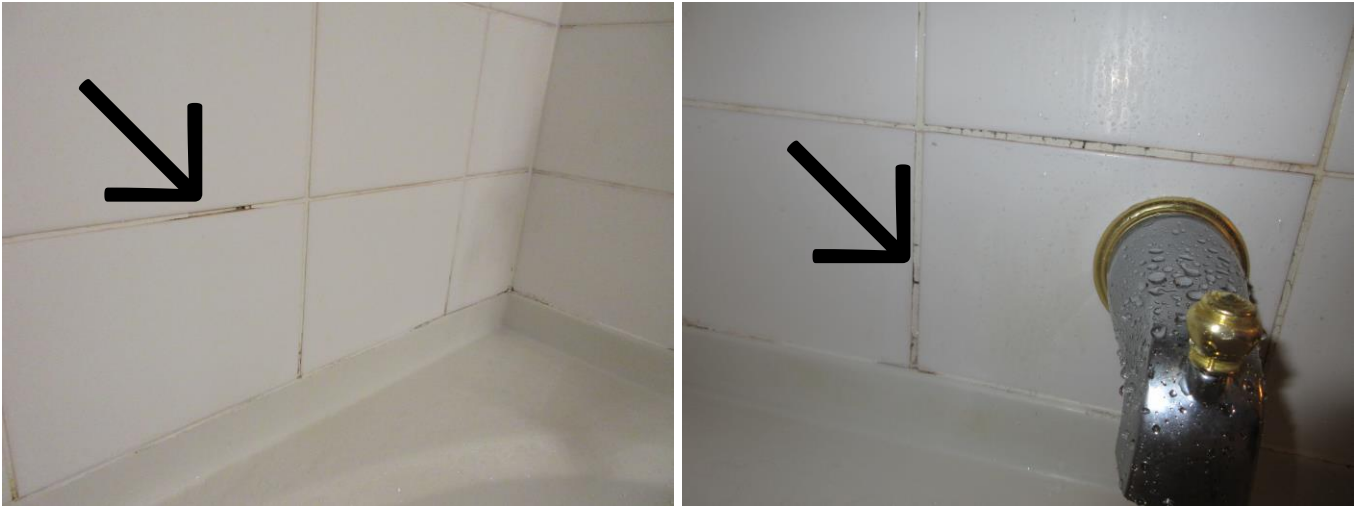
## 7.6 Shower stall

Missing grout was observed in the master bathroom wall tiles. The grout within the shower enclosure requires maintenance to prevent water from penetrating the wall cavity. I recommend replacing the missing grout and performing periodic sealing to maintain a watertight barrier.

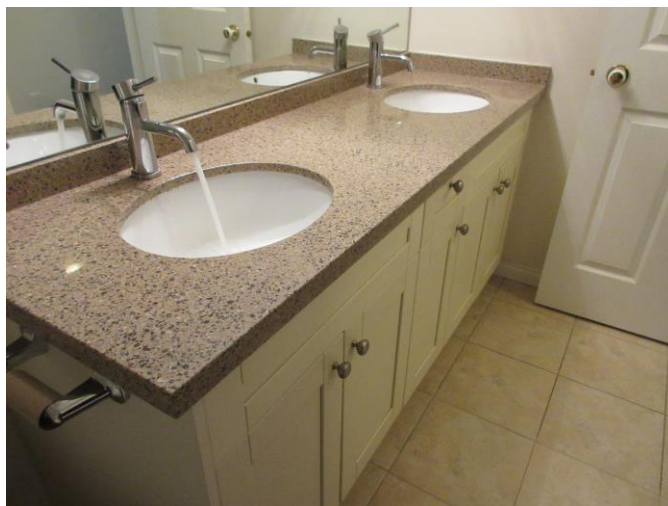
## 7.7 Washroom

All basins (sinks) were tested throughout the house. They were found to be functional and appropriately installed, with no deficiencies noted at the time of this home inspection.

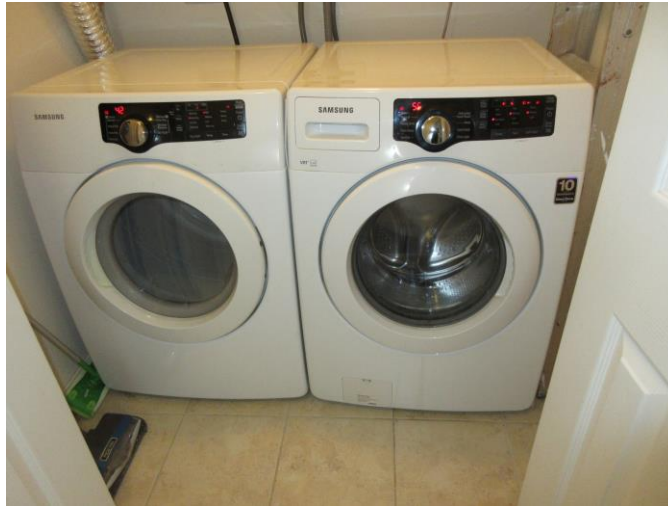
## 7.8 Washing machine & Dryer

The washing machine and dryer were tested in the laundry room. No water leakage was observed at the washing machine. Both appliances were functional at the time of this home inspection.

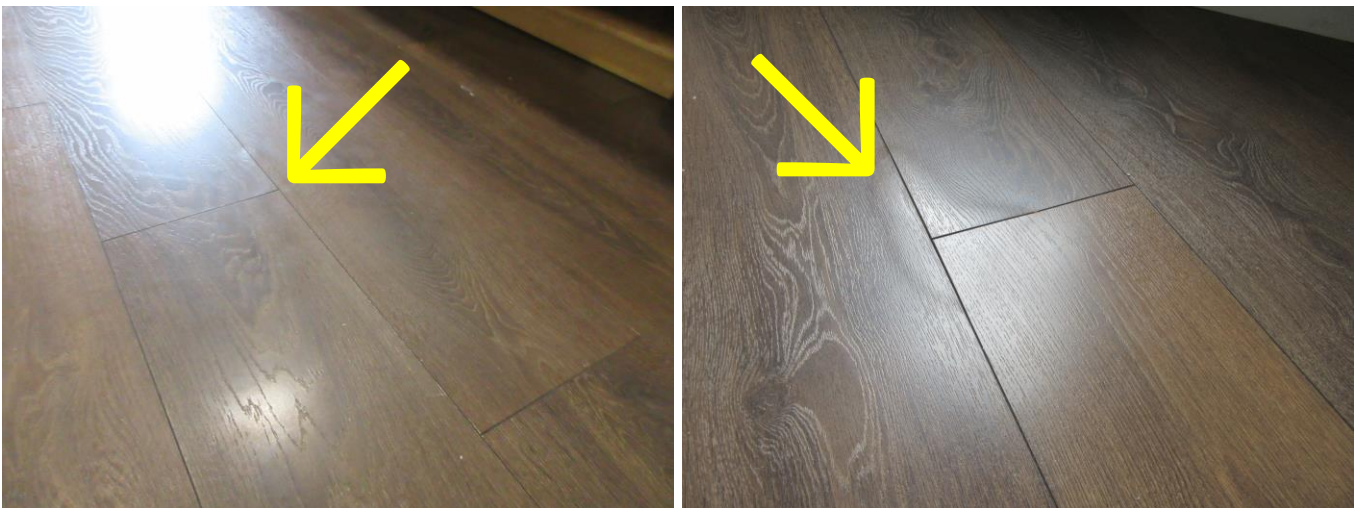
## 7.9 Floor cover

The house was primarily finished with laminate flooring. Minor buckling and lifting were observed in the laminate on the second floor. I recommend repairing or replacing the affected areas to ensure a level walking surface and prevent further damage.

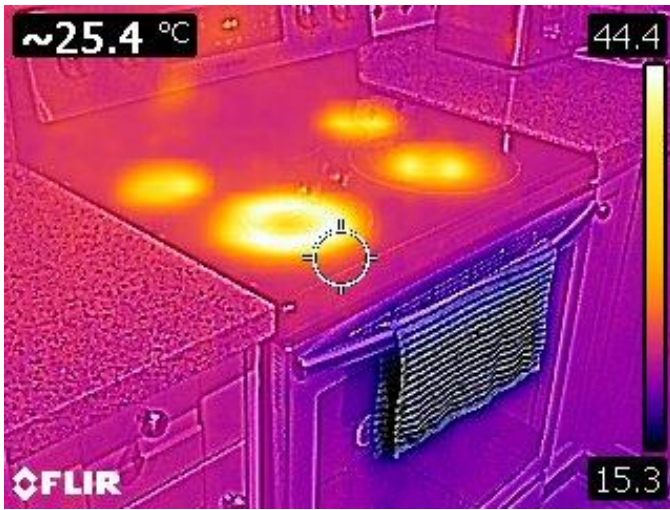
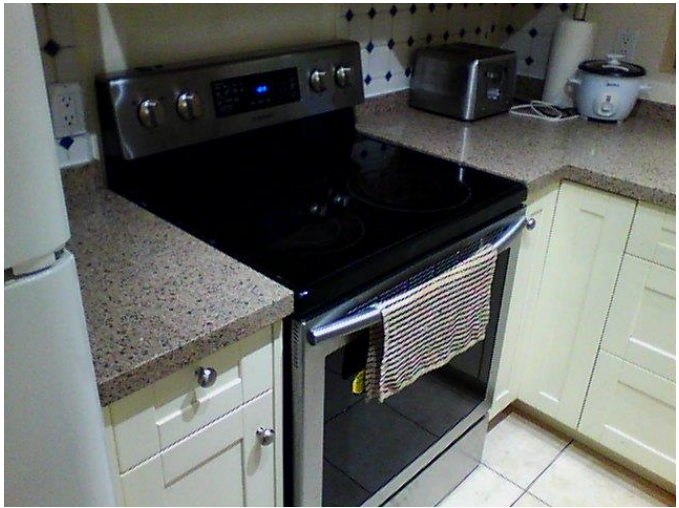
## 7.10 Stove & Oven

The house was equipped with an electric range. The unit was tested and found to be functional at the time of this home inspection.

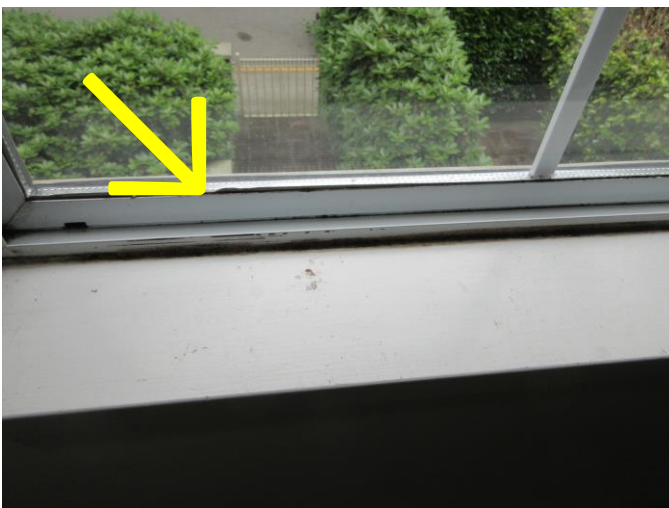
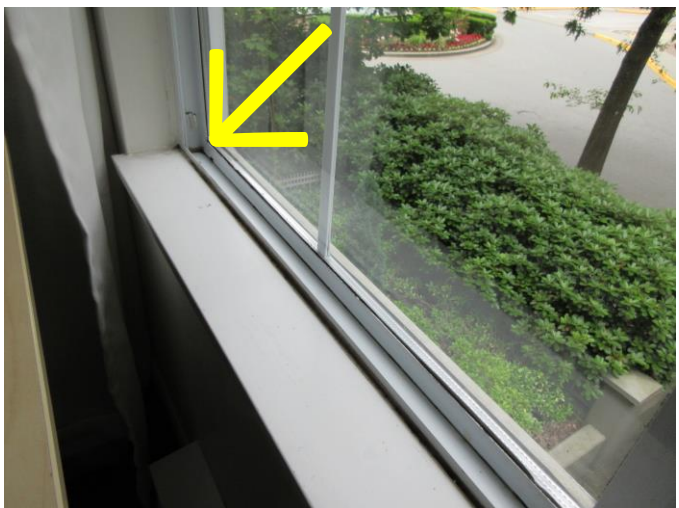
## 7.12 Dark stain & Blackspot

Dark staining and black spots were noted on the master bedroom windows on the second floor. These spots are suspicious and may indicate mold growth. While it is difficult to confirm without laboratory testing, I recommend cleaning and removing the stains to prevent further accumulation.
