# Home Inspection Report

Prepared exclusively for  
Surrey, BC

Property Address: Surrey, BC  
Date of home inspection: Tuesday, September 6, 2022  
Inspection start time: 5:00 PM  
Inspection end time: 7:30 PM  
Registration BC No: 12893  
Manufacture model No (CSA): 364  
MLS# not available  
Year Built: 1972  
Construction: -  
Furnished: Yes  
Occupied: Yes  
Floor Area Total: 960 sq. Ft.

Style: Mobile\_home  
Stories: 1  
Orientation (Front Facing): North

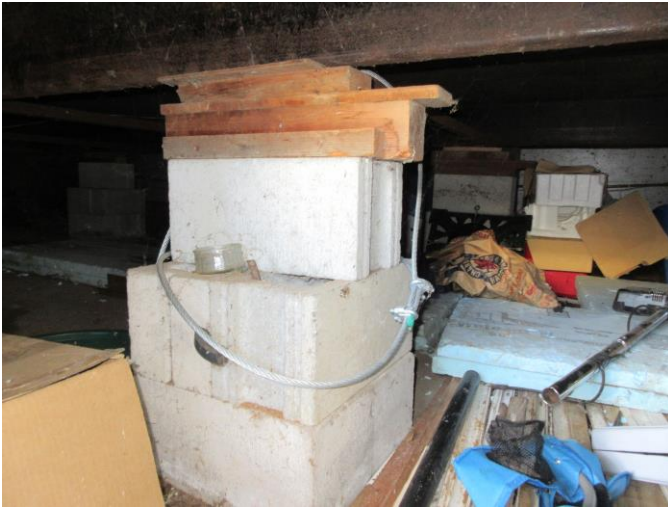
## 1.1 Foundation

The mobile home is situated on a concrete foundation; however, the unit is not fastened or anchored to the ground. This is a significant structural deficiency, as the home lacks the required stability against wind uplift or shifting. I recommend contacting a qualified contractor immediately for further evaluation and to install a proper anchoring system.

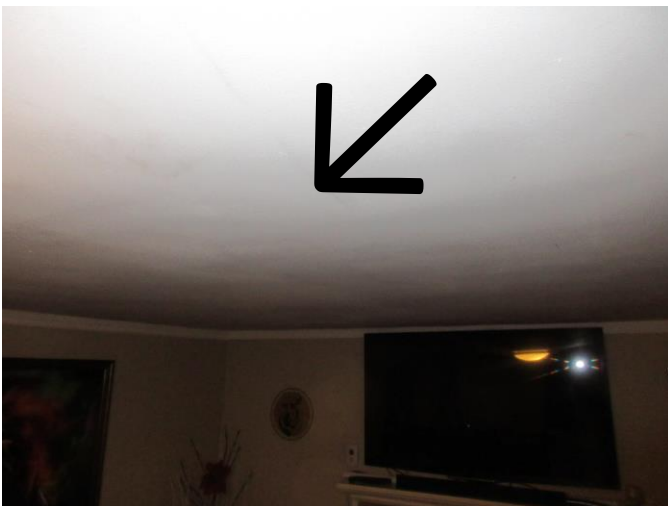
## 1.2 Ceiling

Visible sagging (deflection) was observed in the living room ceiling. This condition may indicate a structural concern, a failure of the ceiling joists, or moisture-related damage. I recommend that a qualified structural contractor or engineer be consulted to determine the cause and perform necessary repairs.

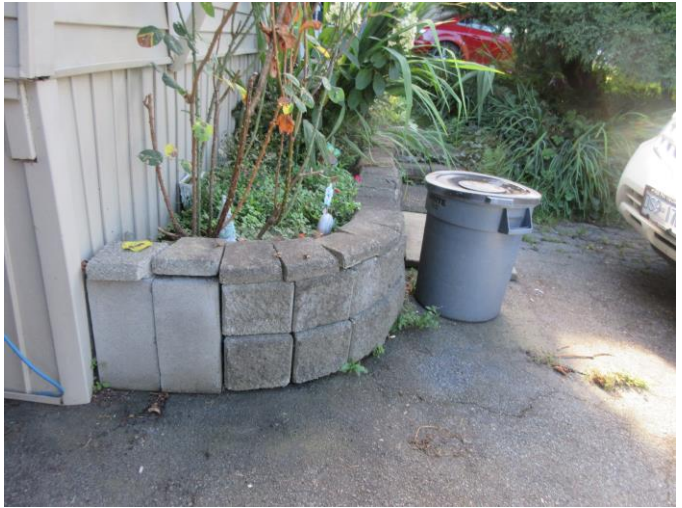
### 1.3 Retaining wall

A masonry retaining wall is located on the north side of the property. The wall shows signs of structural movement, including uneven surfaces and displaced blocks. This indicates potential soil pressure or drainage issues. I recommend a qualified hardscape or structural contractor evaluate the wall for stabilization and repair.

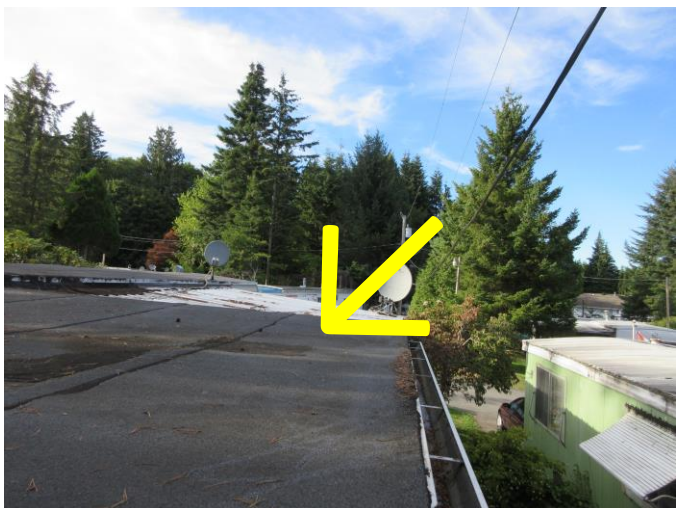
### 1.4 Roof

A significant sagging and wavy surface was noted on the roof. The sagging and wavy surface of the roof is the significant deficiency and indicate the potential of the moisture entering to the house. The sagging needs to be fixed, and maintained by the qualified contractor as recommended.

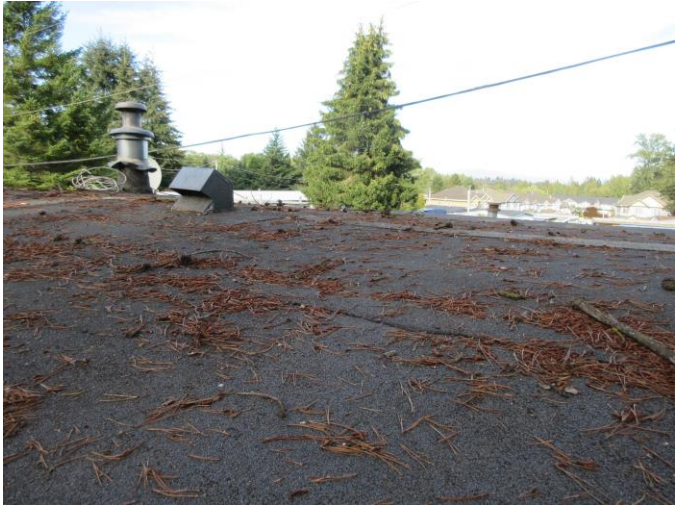
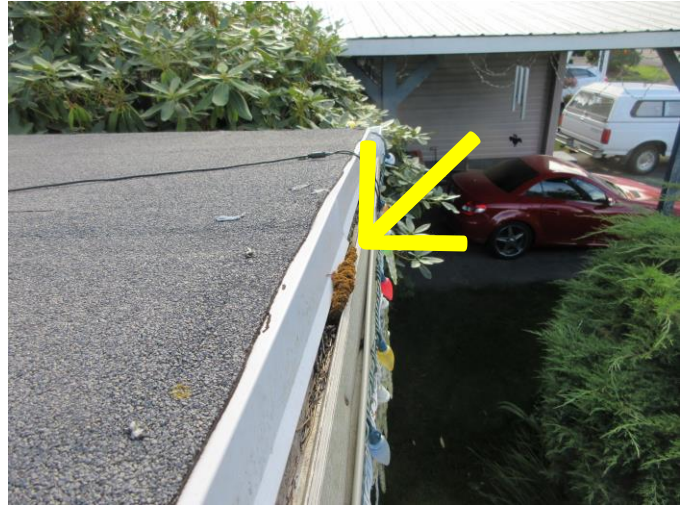
Organic debris (tree leaves) has accumulated across the roof surface. This buildup can trap moisture, promote moss growth, and lead to the premature deterioration of the roofing membrane and metal components. Regular cleaning and maintenance of the roof surface and gutters are recommended to ensure proper drainage and extend the life of the roof.

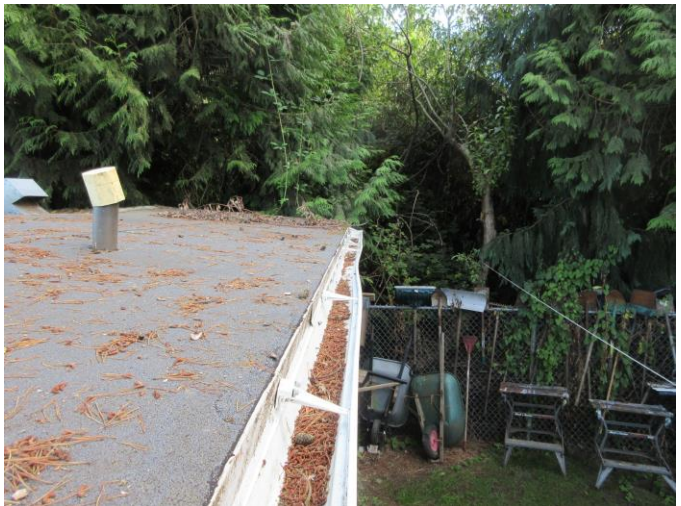
### 3.3 Gutter and Downspout

The gutter system is significantly obstructed by an accumulation of organic debris and tree leaves. Clogged gutters prevent proper drainage, which can lead to water backing up under the roof edge, damaging the fascia boards, and causing the gutters to pull loose from the structure. I recommend cleaning and flushing the entire gutter and downspout system to prevent potential water intrusion and costly structural repairs.

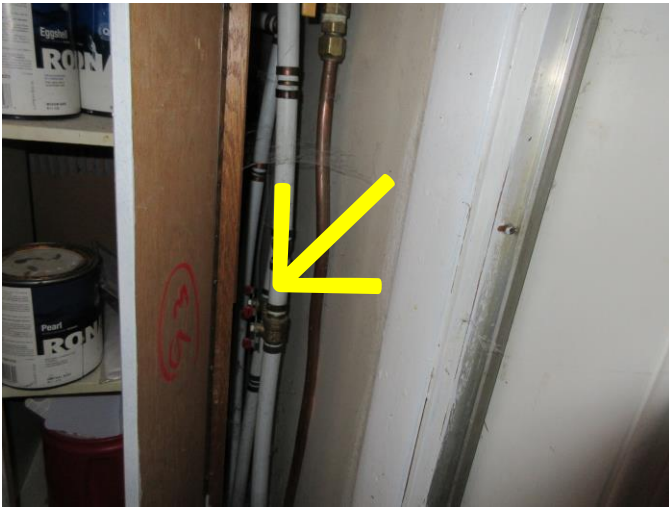
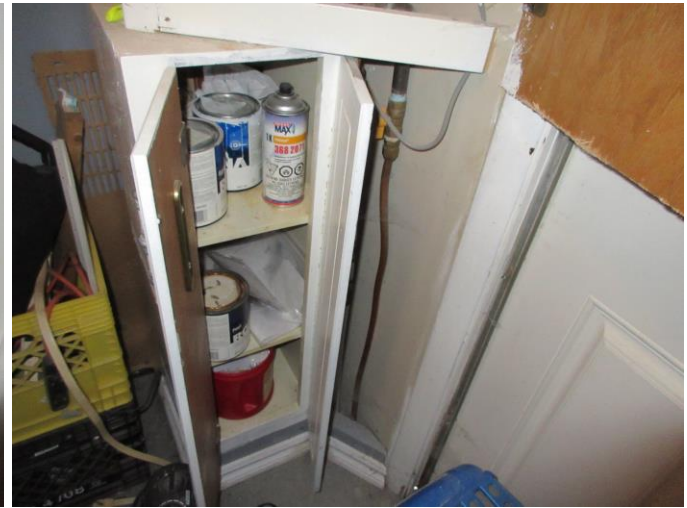
### 4.1 Water Supply System

The potable water supply piping is PEX (cross-linked polyethylene). The system was inspected and found to be functional and in serviceable condition with no observed leaks or deficiencies at the time of inspection. The main water shut-off valve is located in the laundry room. PEX piping typically has an estimated service life of 40 to 50 years.

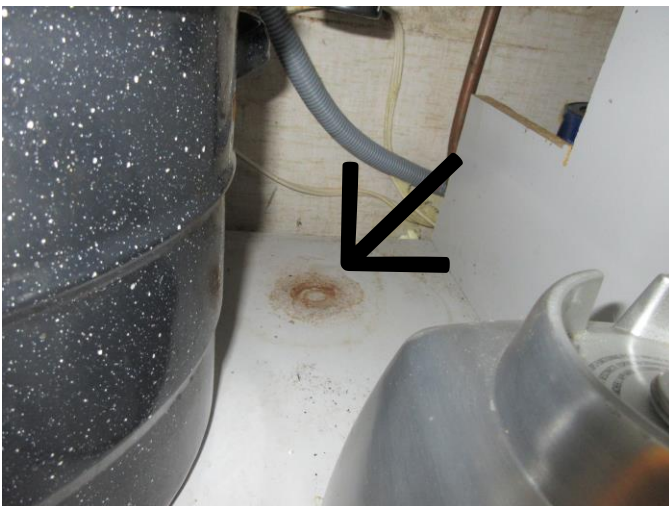
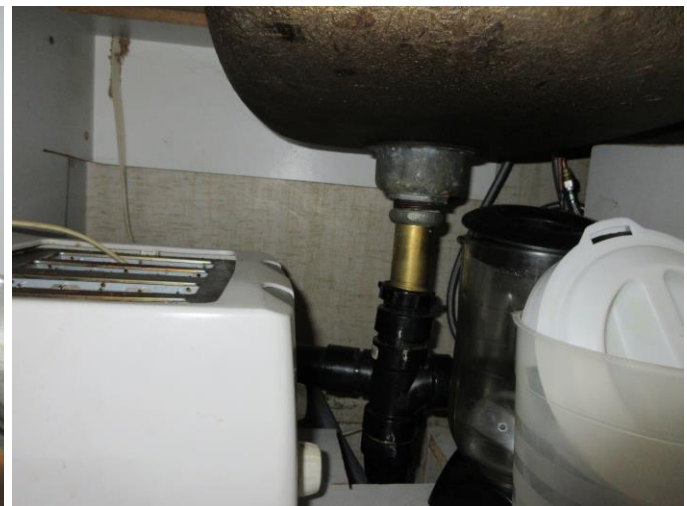
### 4.2 Kitchen and laundry sink & faucet

Active moisture leakage was observed at the kitchen sink drain assembly (P-trap). Water was noted dripping from the slip-joint connections, which has caused minor staining to the base of the cabinet. I recommend immediate repair or replacement of the drainage fittings by a licensed plumber to prevent further water damage and potential mold growth.

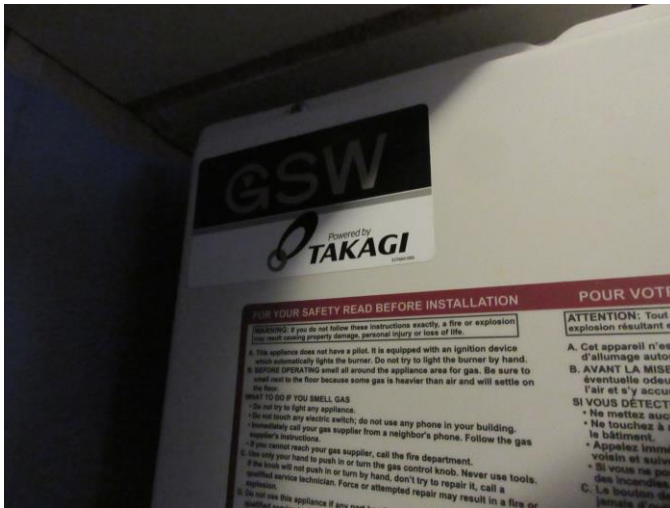
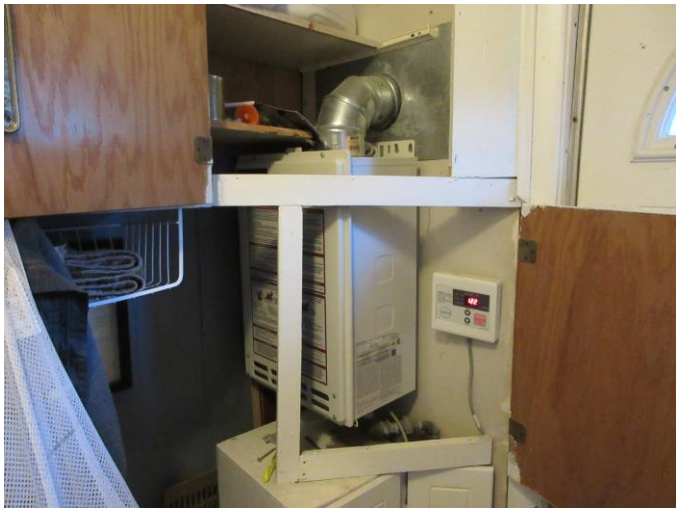
### 4.3 Hot Water Tank

The home is equipped with a tankless water heater manufactured in 2019. The unit was inspected and found to be performing as intended with no visible leaks or deficiencies at the time of inspection. Tankless units typically have a service life of 20+ years. I recommend regular professional maintenance, including descaling, to ensure the unit reaches its maximum life expectancy.

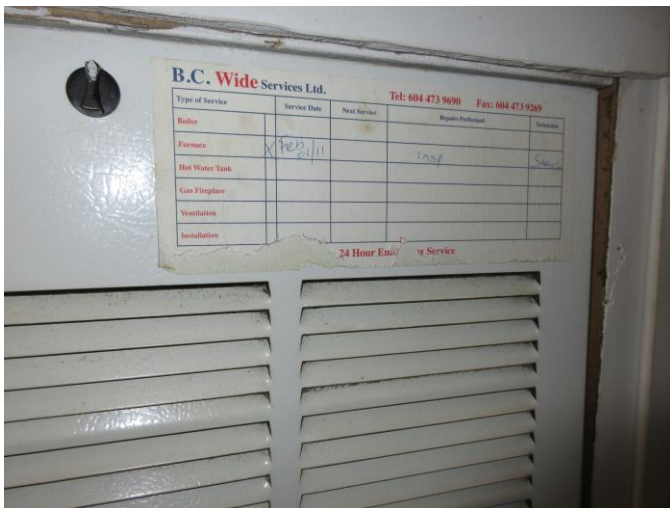
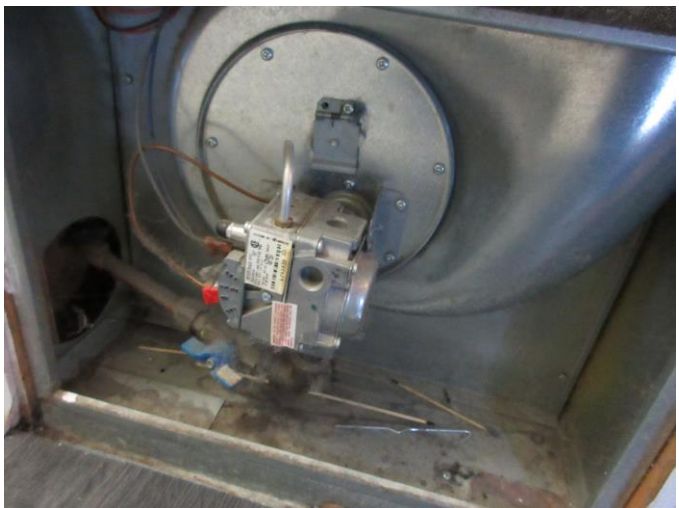
## 5.1 Furnace

The heating system consists of a mid-efficiency furnace with a 40,000 BTU input, manufactured in 2003. While the unit was found to be functional and in serviceable condition at the time of inspection, it is 23 years old and has exceeded its typical design life (15–20 years). Due to its age, the unit is nearing the end of its reliable service. I recommend the client budget for replacement in the near future and have a qualified HVAC technician perform an annual safety certification.

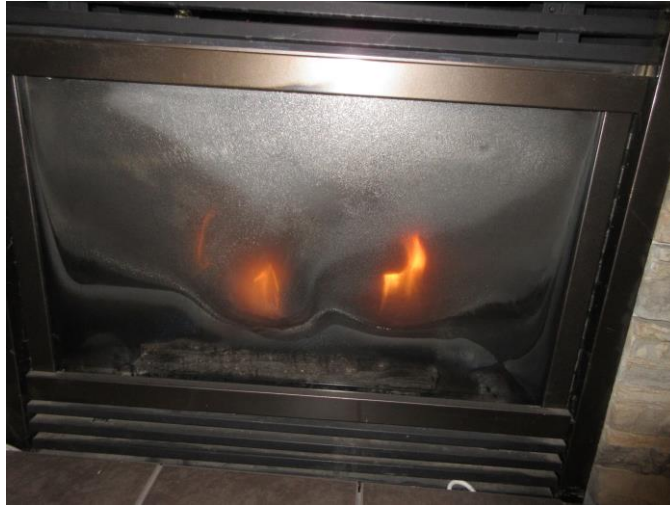
## 5.2 Fireplace

The home is equipped with a gas-fired fireplace. Visible clouding/film buildup was noted on the glass door (commonly referred to as 'smoke glass'). This is a typical maintenance item caused by mineral deposits during combustion. I recommend a professional cleaning and service by a qualified fireplace technician to prevent permanent etching of the glass and to ensure the burners are operating efficiently.

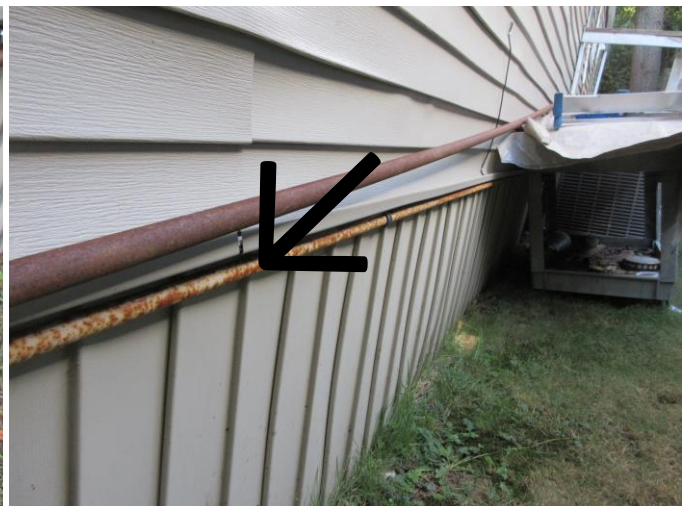
## 5.3 Natural Gas

The natural gas meter is located on the west side of the house. Surface corrosion (rust) was observed on the gas service piping. While the rust appears superficial at this time, it should be addressed to prevent deep pitting or pipe degradation. I recommend that the piping be cleaned and repainted with a rust-inhibiting exterior paint to ensure long-term integrity.

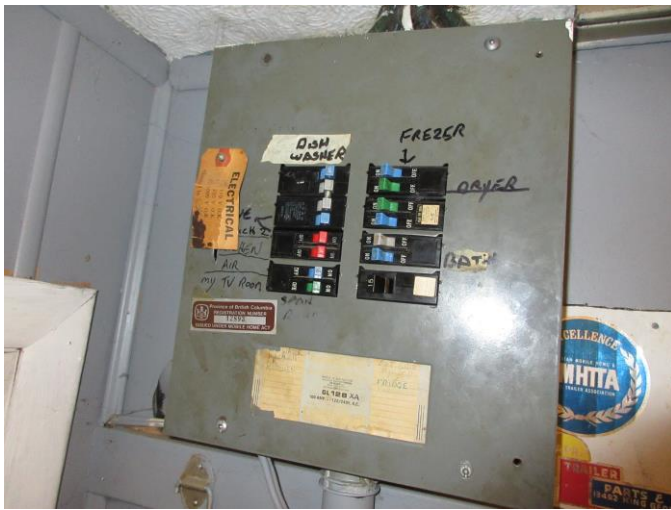
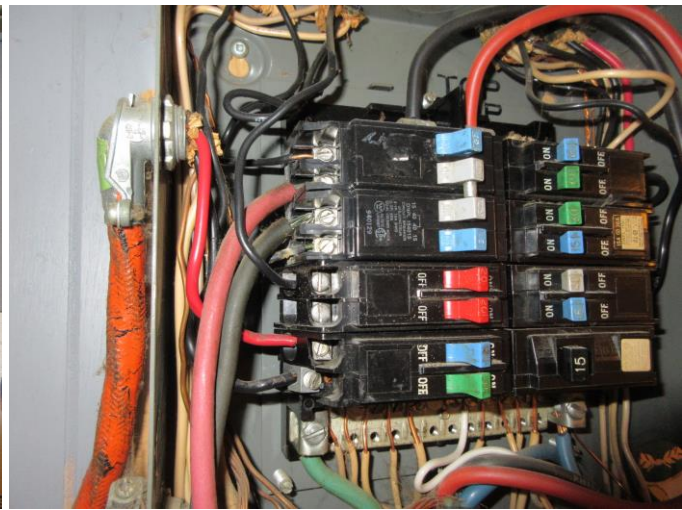
### 6.1 Main Electrical Panel

The home is equipped with a 100-amp electrical service; the distribution panel is located in the laundry room and appears to have been professionally installed. Branch circuit wiring is copper, and no signs of overheating, damage, or corrosion were observed within the panel. Circuit breakers appear to be correctly sized for their respective loads (e.g., 40-amp for the range, 30-amp for the dryer). The circuit directory is incomplete. I recommend accurately labeling all breakers to ensure safe and efficient operation of the electrical system.

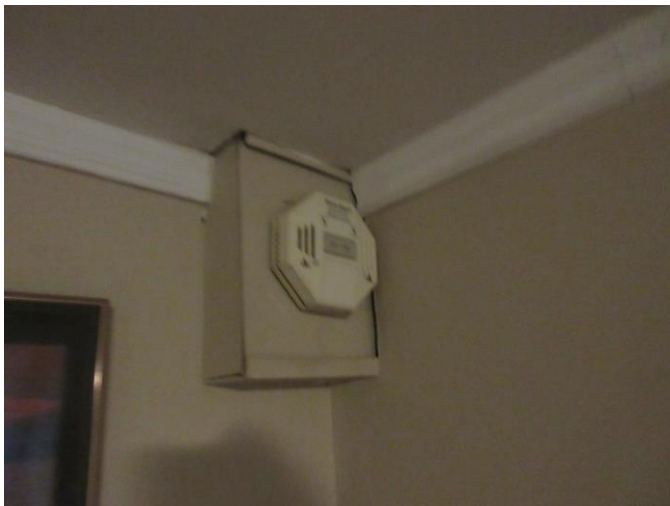
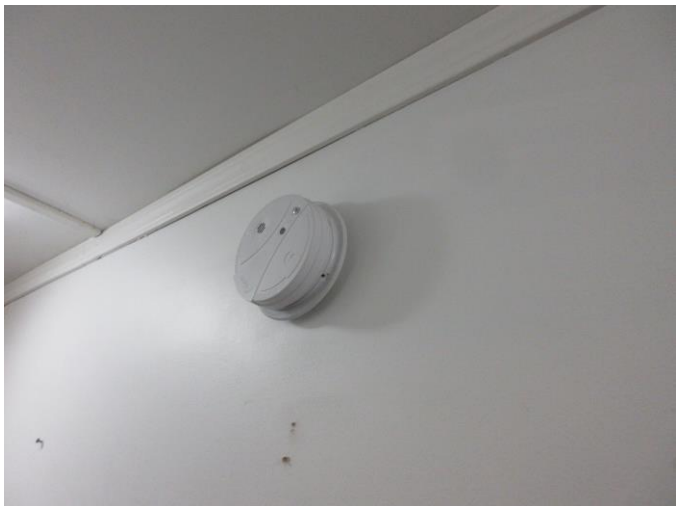
### 6.2 Smoke Detector & Carbon monoxide

Smoke and Carbon Monoxide (CO) detectors were identified throughout the home. For safety, smoke alarms should be replaced every 10 years, while CO detectors typically require replacement every 5 to 7 years. I recommend testing all units monthly and replacing batteries semi-annually. As a best practice, the client should replace all life-safety devices upon taking possession of the residence to ensure they are current and reliable.

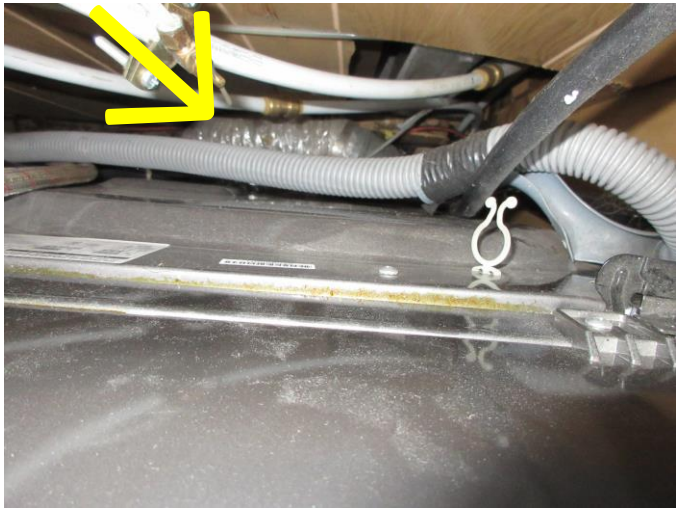
## 7.2 Laundry Vent

The dryer is currently equipped with a flexible foil transition duct. This type of venting is not recommended as the internal ribbing traps lint, creating a significant fire hazard. Building standards require the use of rigid or semi-rigid metal ducting (aluminum or galvanized steel) to ensure fire safety and proper airflow. I recommend the immediate replacement of the foil duct with an approved metal venting system.

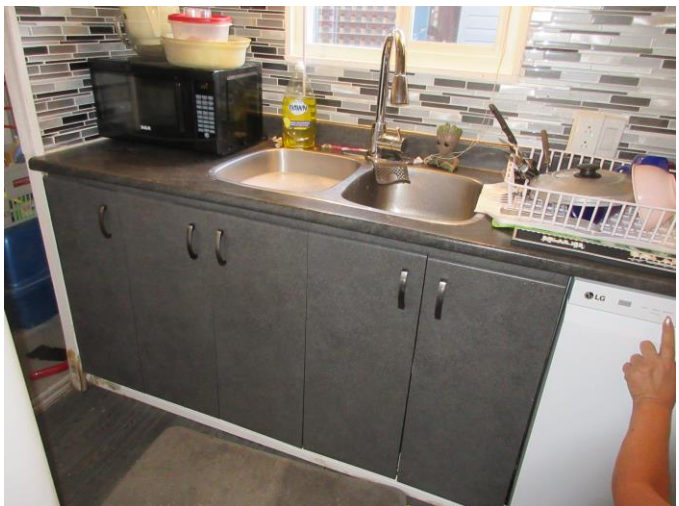
### 8.1 Counter and Cabinet

The kitchen features laminate-covered MDF countertops and MDF cabinetry. Both the counters and cabinet units were found to be functional and in serviceable condition at the time of inspection. While no deficiencies were observed, it is important to note that MDF is highly susceptible to moisture damage; ensure that all surface seams and areas around the sink are kept dry to prevent swelling or delamination.

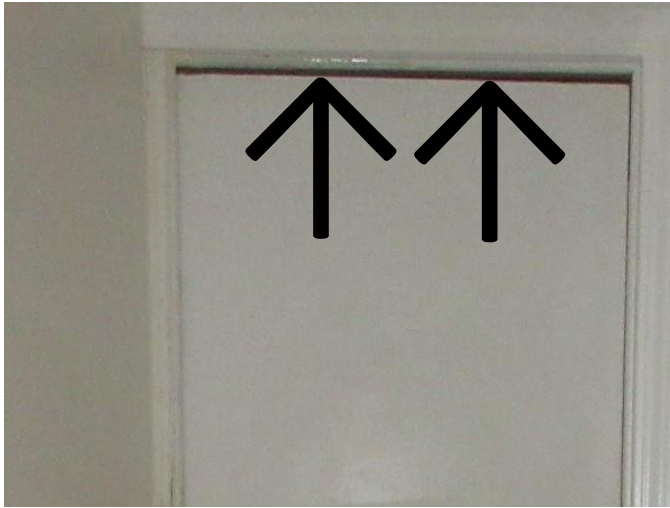
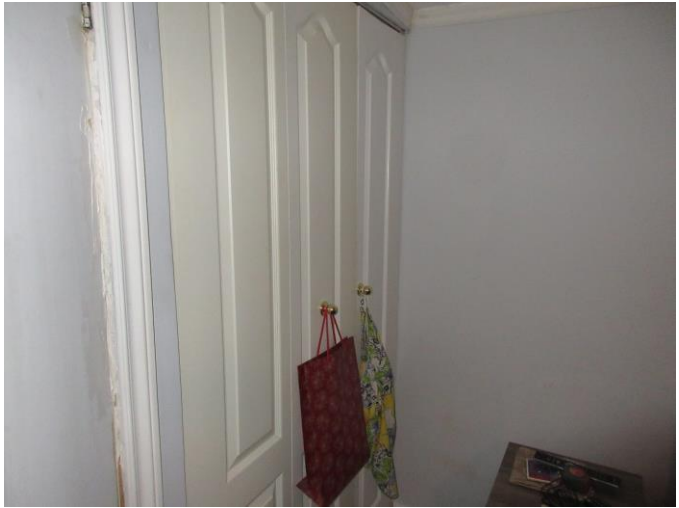
## 8.2 Door & Closet door

An unusual gap (cavity) was observed at the header of the master bedroom door frame. This may indicate a need for frame adjustment or trim repair to ensure proper closure and privacy. Conversely, the vinyl-wrapped closet doors and associated hardware were tested and found to be in good serviceable condition with no observed deficiencies at the time of inspection.

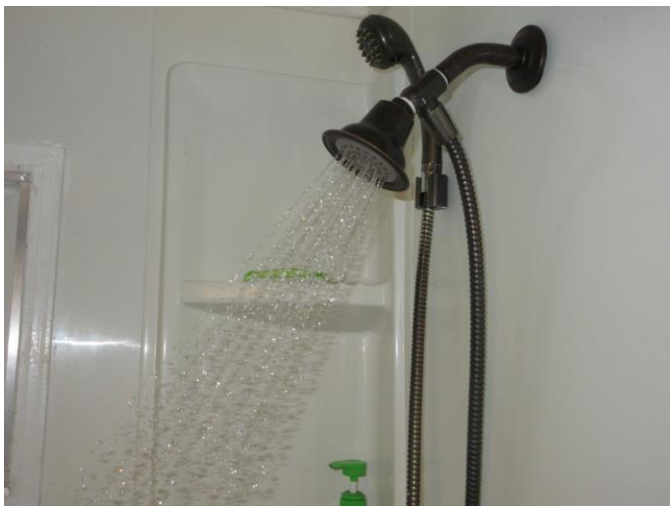
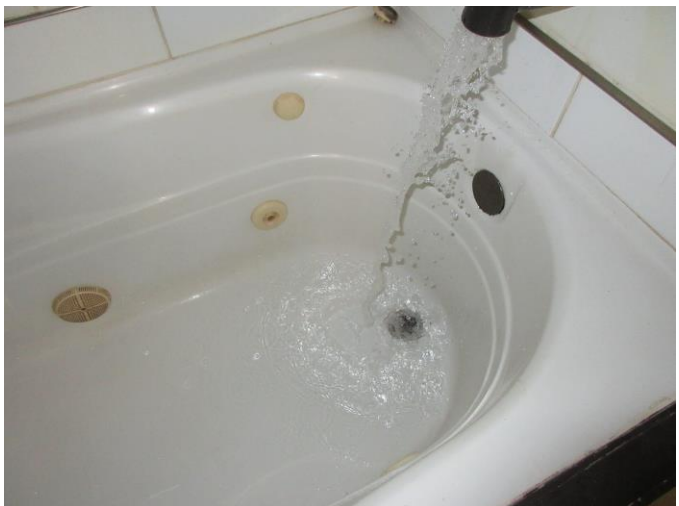
## 8.3 Bathtub

The bathtub and shower fixtures, including the faucets and diverter, were tested and found to be performing as intended. Both the hot and cold water supplies provided adequate pressure, and the drainage system was functional with no observed deficiencies at the time of inspection. I recommend monitoring the caulking and grout regularly to ensure a watertight seal is maintained.

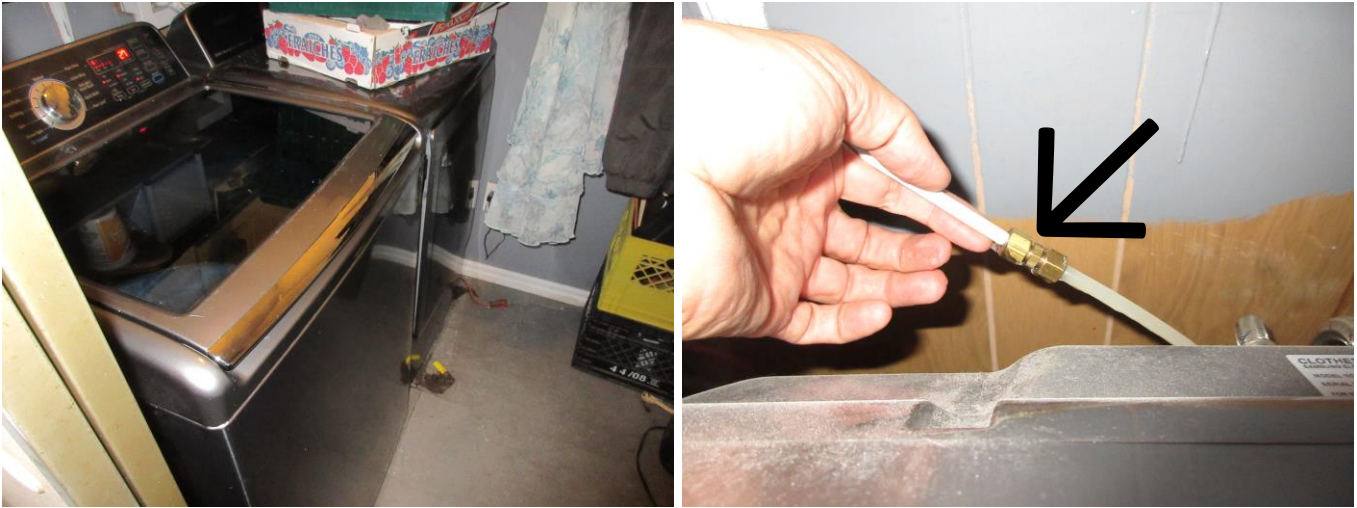
## 8.5 Washing machine & Dryer

The washing machine and dryer were tested and found to be performing as intended at the time of inspection. However, an active water leak was discovered at the refrigerator supply line connection located behind the washing machine. This leak appears to be constant and poses a risk of water damage to the flooring and wall assembly. I recommend immediate repair by a licensed plumber to prevent further moisture intrusion.

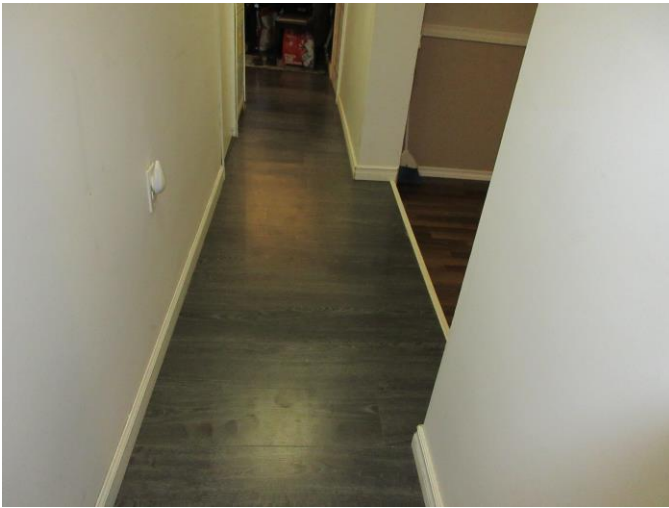
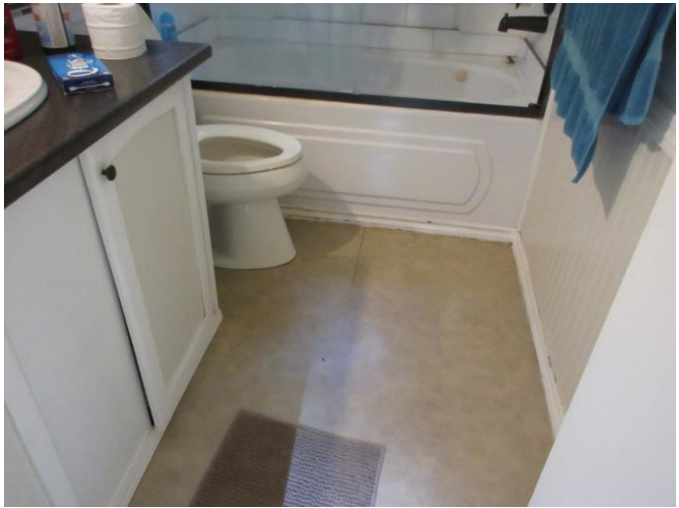
## 8.7 Floor cover

The home's interior flooring consists of laminate and linoleum (sheet vinyl). These surfaces were found to be in good serviceable condition with no observed deficiencies at the time of inspection. The transitions between different flooring types are secure, and no significant wear or damage was noted. Given the moisture-sensitive nature of laminate, I recommend maintaining the seals around wet areas to prevent future swelling.

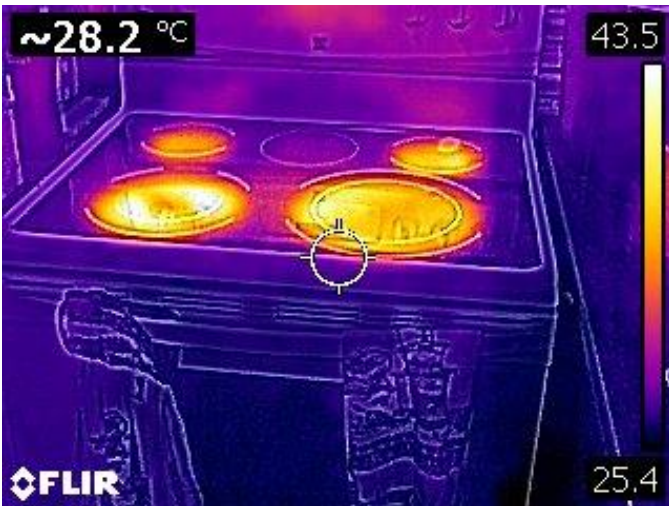
## 8.8 Stove & Oven

The home is equipped with an electric range. The cooktop elements and the oven's bake and broil functions were tested and found to be performing as intended at the time of inspection. No deficiencies were observed regarding the appliance's operation or physical condition.
