# Home Inspection Report

Prepared exclusively for  
Port Coquitlam, BC

This inspection is conducted in accordance with inspection Standards. The field work took place on Saturday, May 30, 2026.

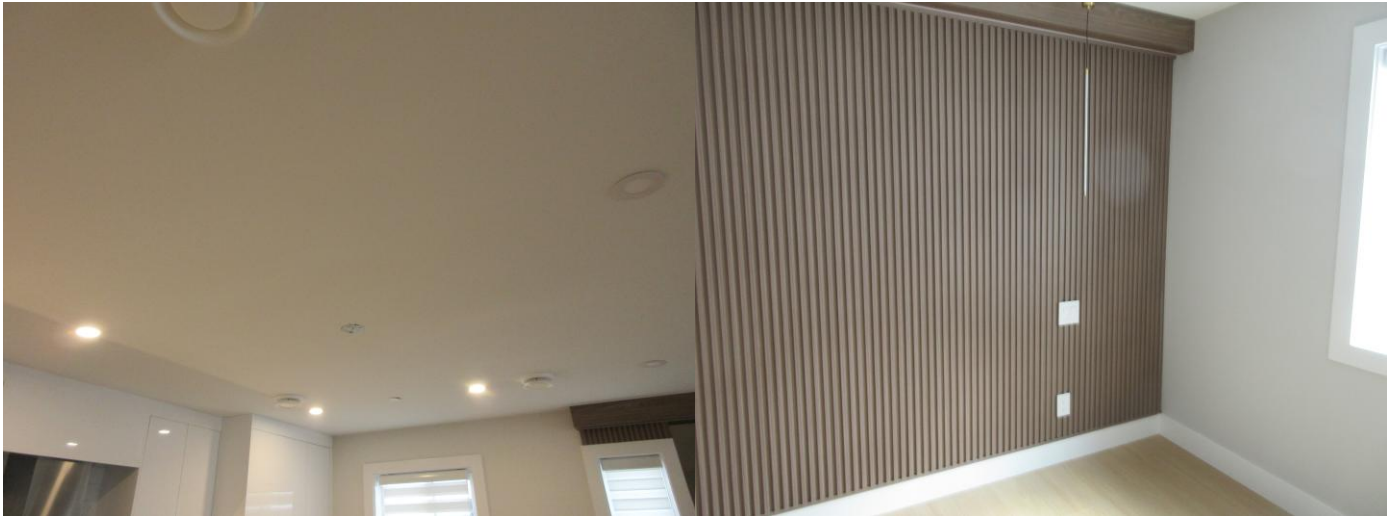
## 1.1 Main

The house has a concrete floor, dry board ceiling, and drywall. Overall, the building structure appears to be stable. At the time of this home inspection, the interior walls, ceilings, and floors showed no defects or structural deficiencies.

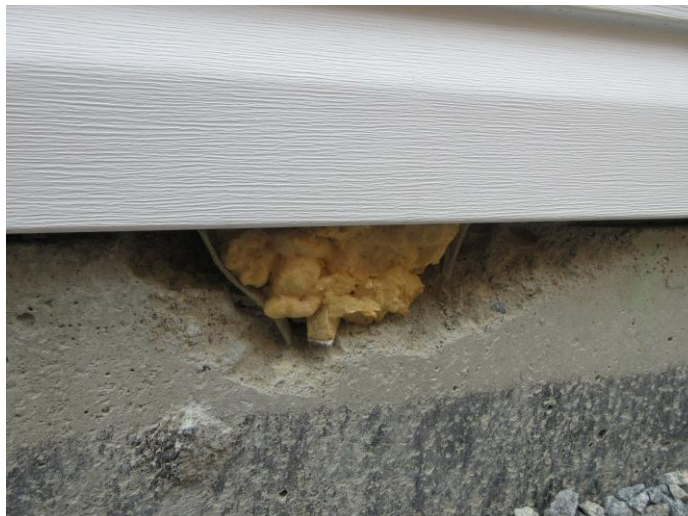
## 1.2 Foundation Wall

Concrete spalling and a void were observed at the top of the foundation wall directly beneath the siding. Expanding spray foam has been improperly used to fill the void/penetration. Spray foam is not a weather-resistant or structurally sound material for exterior foundation repairs. Monitoring the spalling any changes is recommended. If any changes are observed, contact a qualified contractor for further evaluation and necessary repairs.

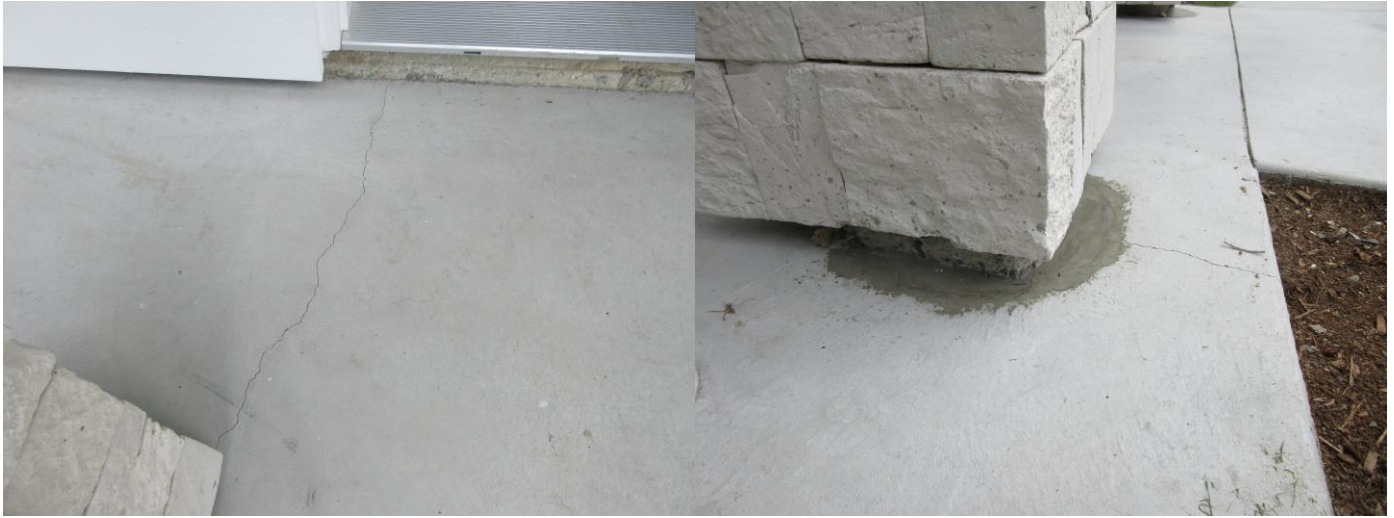
## 1.3 Floor

A distinct shrinkage crack was observed extending from the base of a stone-veneered structural column across the concrete entryway slab to the door threshold. At the base of the column a substandard, superficial application of mortar/grout has been placed over the concrete slab interface. The underlying structural footing or pier extension appears rough, exposed, and is directly concentrating point loads onto a cracked section of the slab.

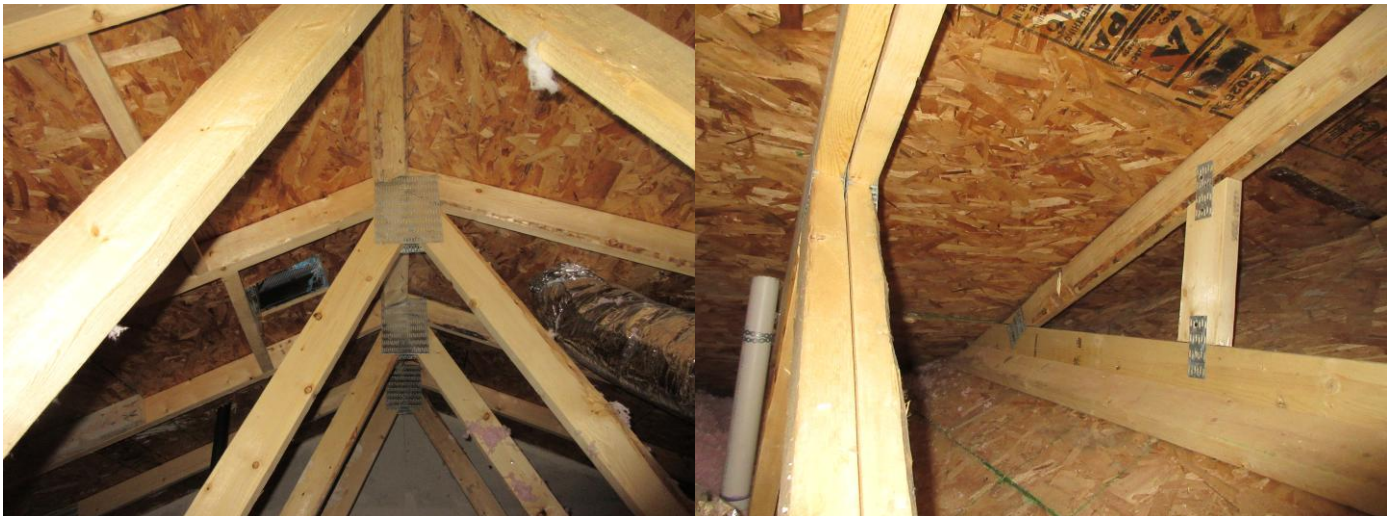
## 1.4 Roof

The roof structure consisted of wood trusses. The roof appeared to be functioning well at the time of this inspection.

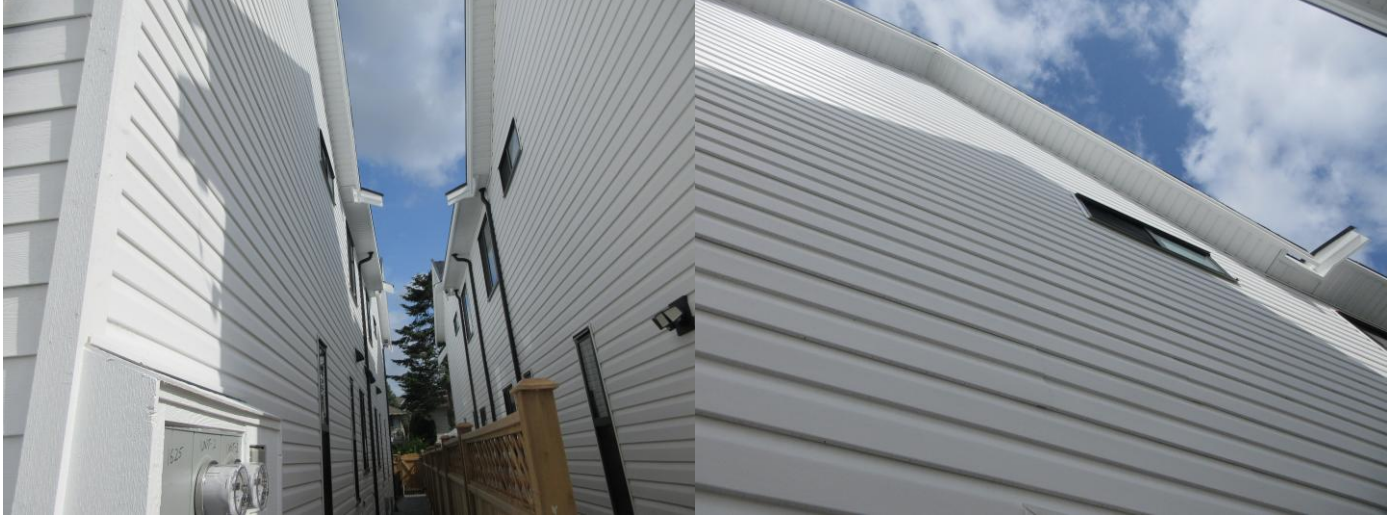
The house exterior wall had vinyl siding. The vinyl siding was functional no deficiency at the time of this home inspection.

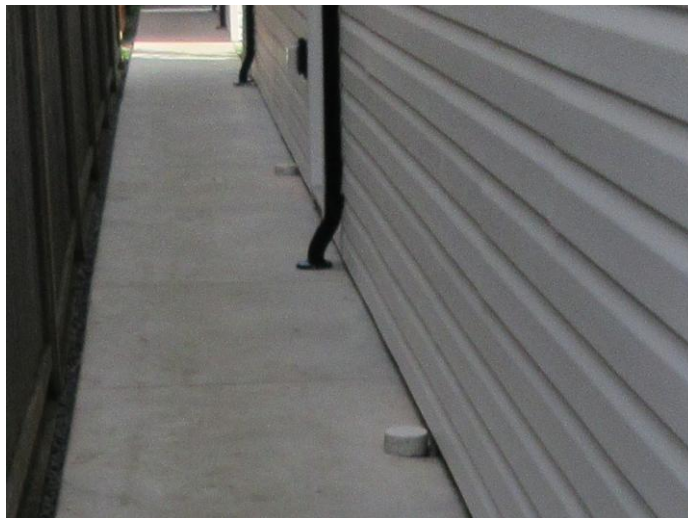
The vinyl wall cladding on the west side of the house is in contact with the ground. Rain and moisture can seep into the wall, potentially causing hidden rot. A clearance of 6-8 inches between the wall cladding and the ground is recommended.

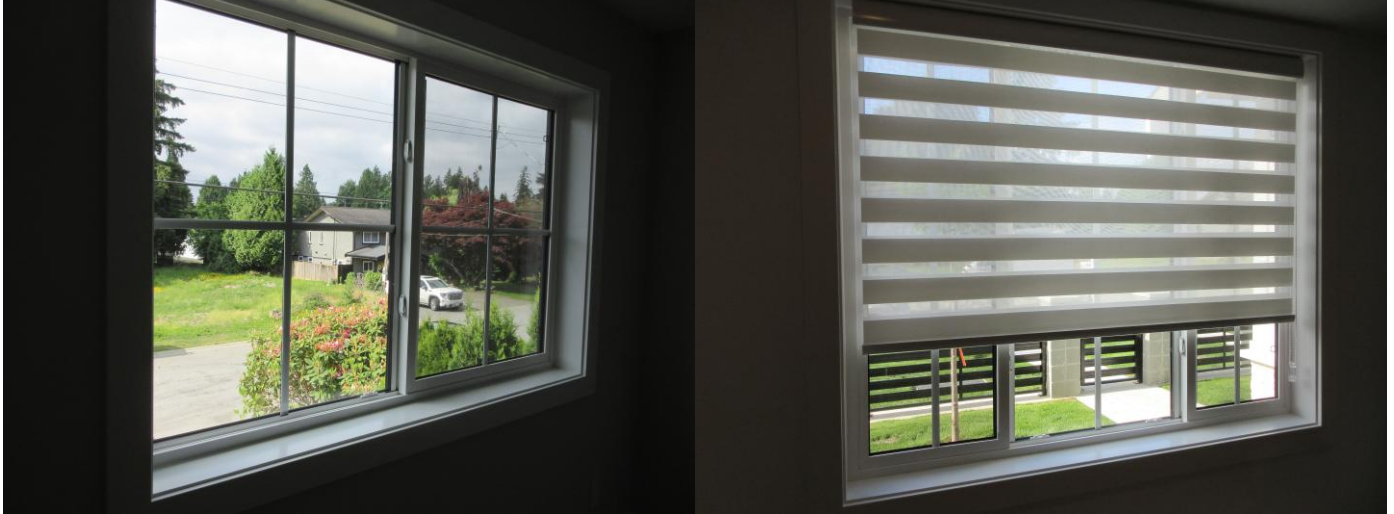
## 2.2 Window

The house featured vinyl windows, with double-pane glazing. At the time of this home inspection, all windows were found to be functional with no observed deficiencies.

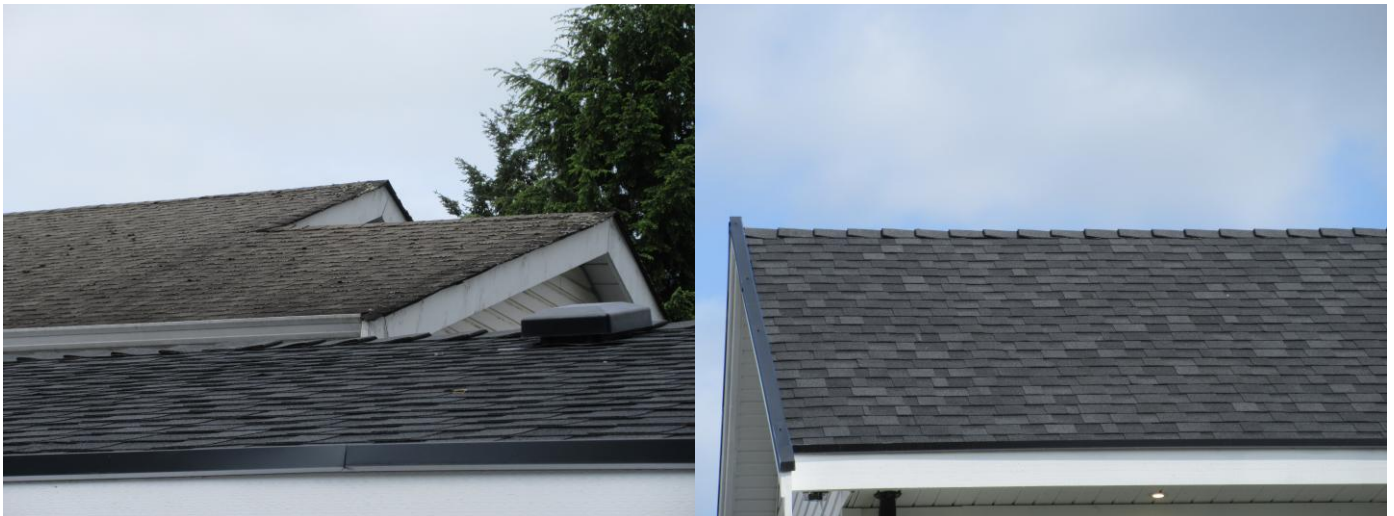
### 3.1 Roof Covering

The house had an asphalt shingle roof covering. The roof had no leaks and no damaged or missing shingles. The roof covering was functioning well at the time of this inspection. With proper care, it should serve the house for many years. Typically, the normal service life of asphalt shingles is 15–20 years. The asphalt shingles appear to be in the first or second half of their useful life.

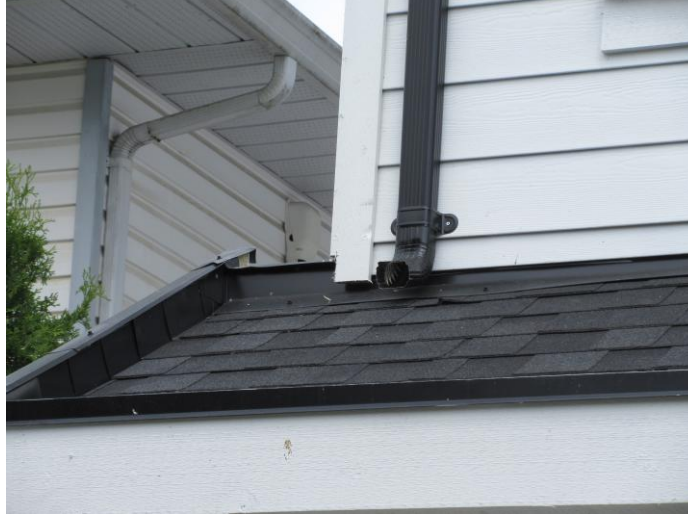
## 3.2 Gutter and Downspout

The downspout was discharging water from the upper roof and deck to the lower roof in south of the house. This improper drainage can lead to water damage to roofing components. All downspouts need to be directed to the house's drainage system. I recommend fixing the downspouts to prevent water from entering the attic and to avoid further decay of the wall components.

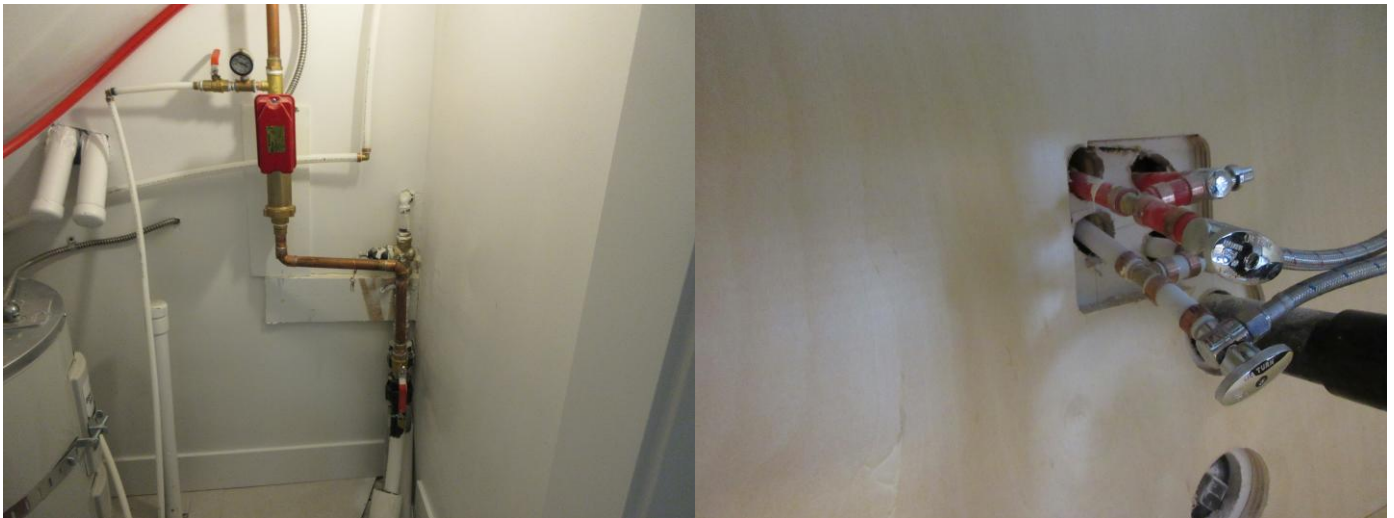
### 4.1 Water Supply System

The house's original supply pipes was PEX. It was functional with no deficiencies at the time of this home inspection. The life expectancy of PEX piping is 40-50 years. The main water shut-off valve was located in the hot water tank room of the house. There was no corrosion, rust, or condensation on the pipes at the time of this inspection. A pressure-reducing valve was also installed.

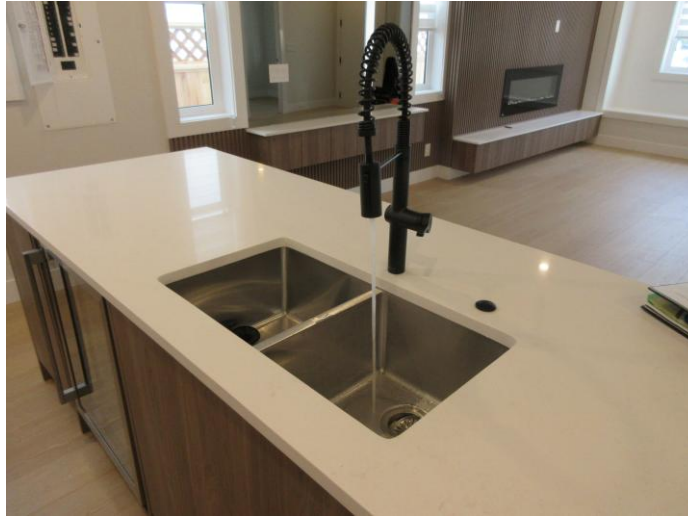
## 4.2 Kitchen sink & Faucet

The water pressure at the sink faucet was noted to be low. The water pressure should be monitored for any changes, and it is advised to contact a qualified contractor for further evaluation and action if needed.

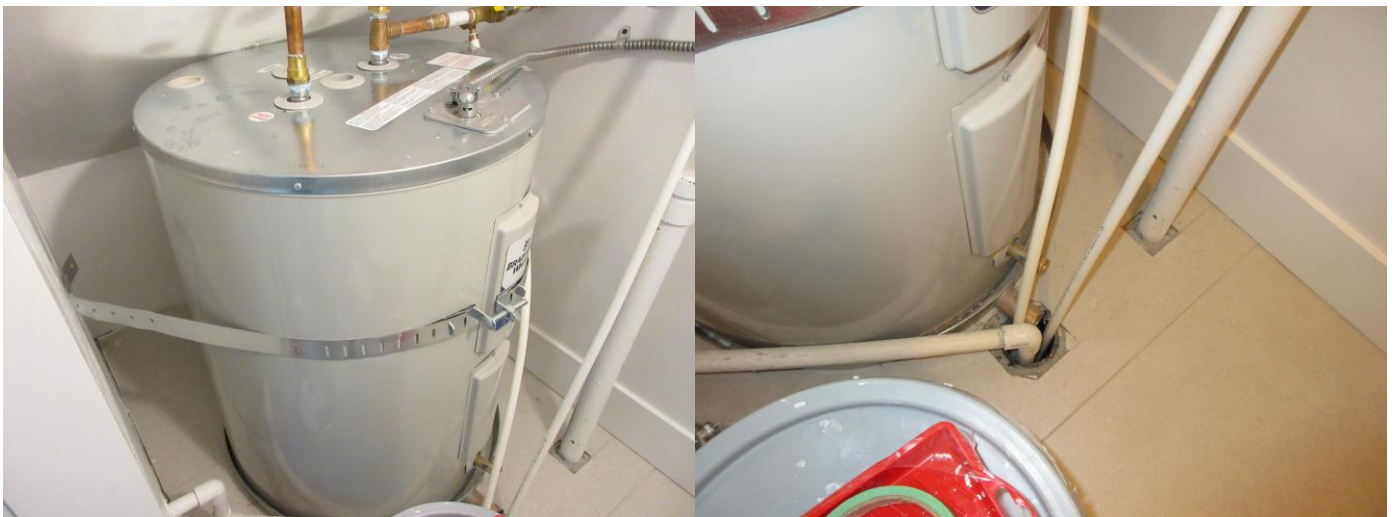
## 4.3 Hot Water Tank

The hot water tank was manufactured in Feb/ 2025, indicating it is approximately one years old. The typical lifespan for a hot water tank is between 7 and 12 years. At the time of inspection, the tank showed no signs of leaks and was functioning properly.

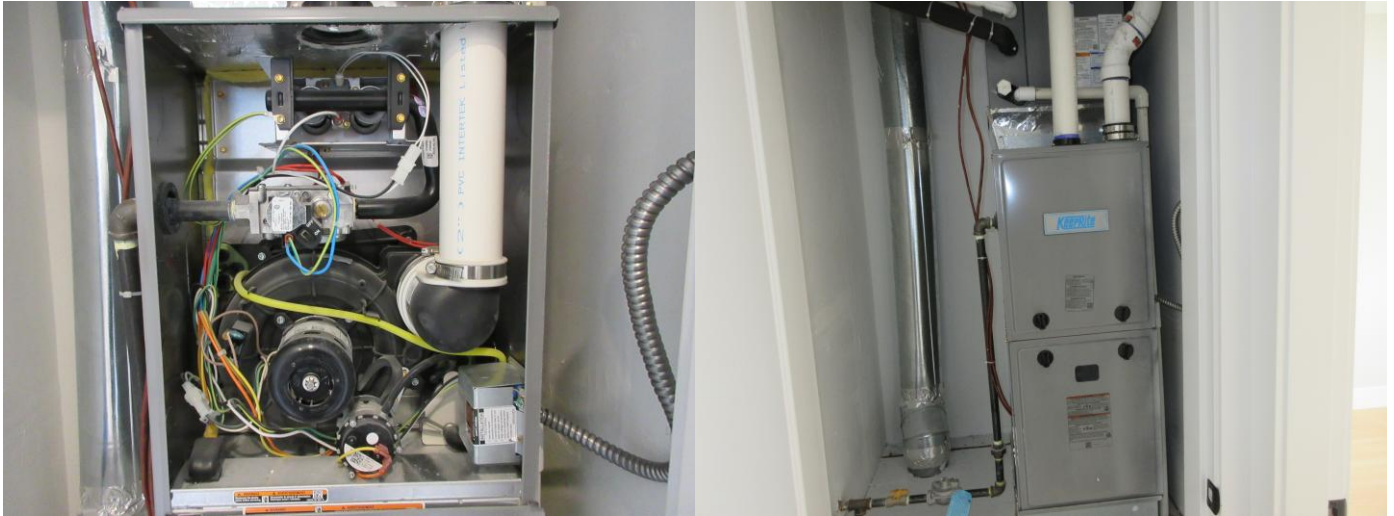
### 5.1 Furnace & A/C (Standard combo)

The house is equipped with a combined heating and cooling system, including a high-efficiency gas furnace with an input of 60,000 BTUs. The furnace was manufactured in 2024, making it 2 years old. While the typical lifespan for a furnace is 15-20 years, this unit is currently functioning properly with no deficiencies observed during the inspection.

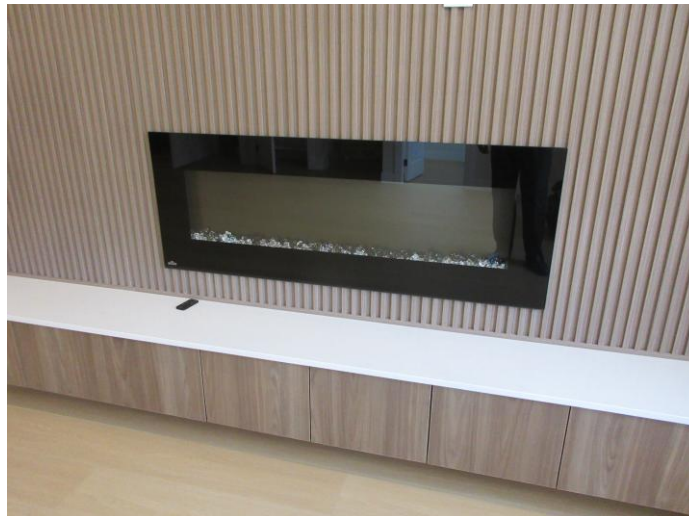
### 5.2 Fireplace

The electrical fireplace located in the ground floor. The built-in linear electric fireplace located in the living area was found to be insecurely anchored and loose within its wall framing cavity. Furthermore, when tested using normal operating controls, the fireplace failed to produce heat; the internal blower fan operated continuously but only discharged unheated (cold) air. No room for heat discharge causing the grill to become obstructed by the surrounding wood slats or drywall structure was noted as well. If the heating element is repaired and runs without **enough clearance (room) to discharge heat**, it will cause rapid heat buildup within the wall cavity, posing a serious fire hazard or melting internal components.

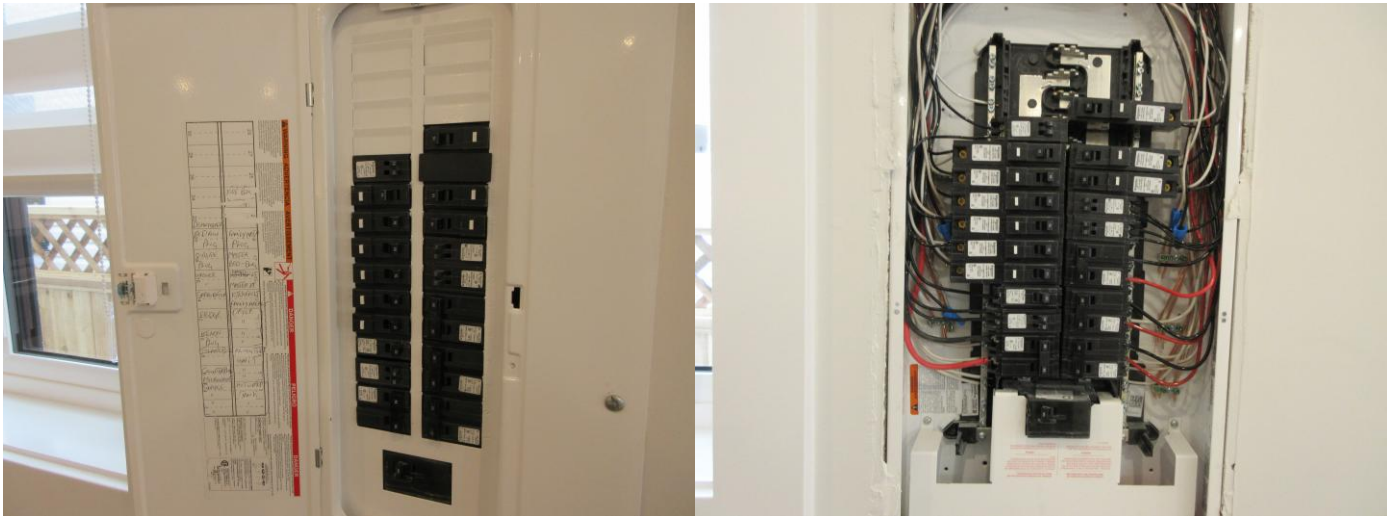
### 6.1 Main Electrical Panel

The main electrical panel was located in the northeast corner of the family room and was professionally installed. The electrical panel is 125 Amp, with a 60 Amp breaker for sub panel. The wiring in the house is copper, showing no signs of burnt, scorched, damaged, or corroded wires. The breakers are labelled. Appropriate circuit breakers and properly sized wires were used for specific circuits (e.g., 30 amp for the dryer, and 15 amp for general circuitry).

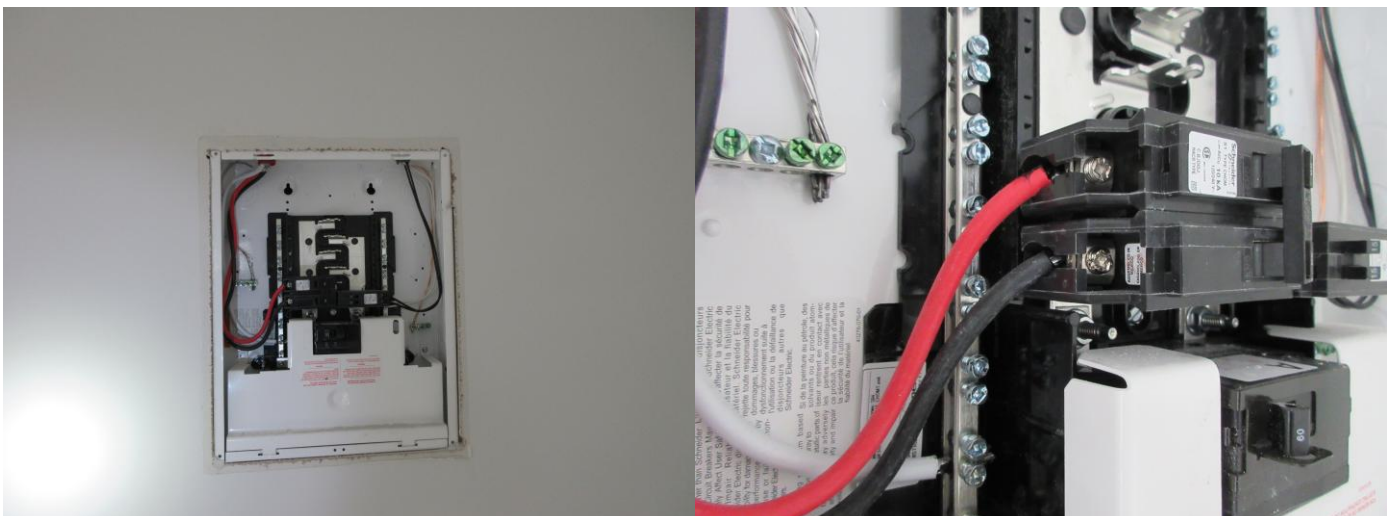
### 6.2 Subpanel

The sub-electrical panel was rated at 60 amps, with a 60-amp main breaker. The 60 amps breaker wiring in the sub-electrical panel was stranded aluminum, with no visible signs of burning, damage, or corrosion. The breakers were labeled.

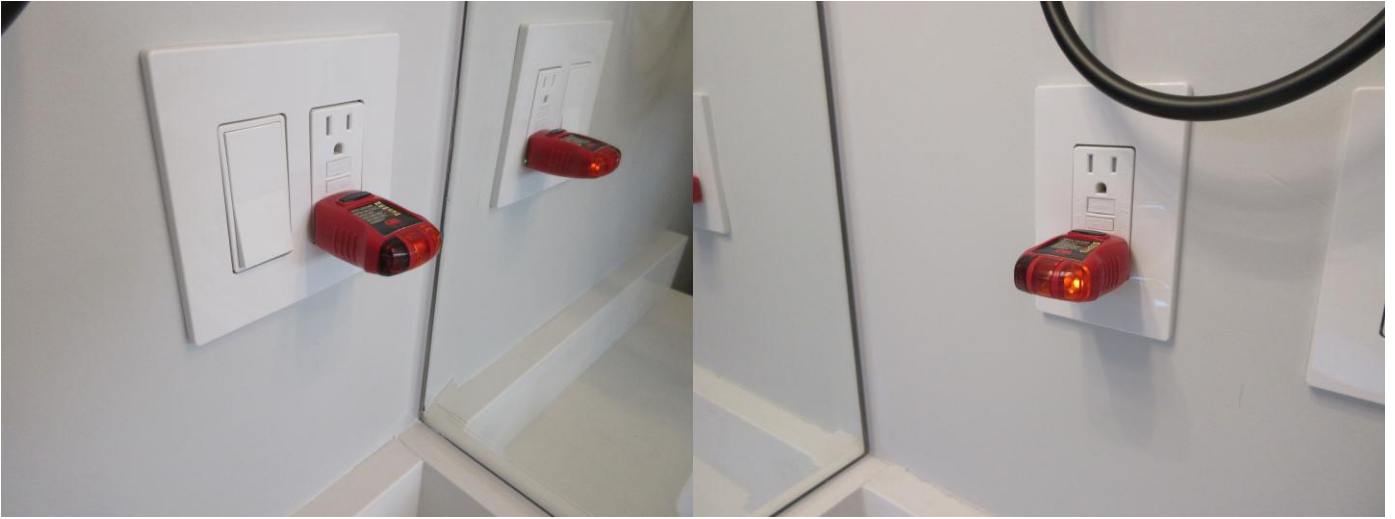
## 6.3 Outlet and Switch

There were GFCI outlet outlets were present in the bathrooms and washroom of the house. The GFCI outlets that were tested appeared to be in serviceable condition on the day of the inspection.

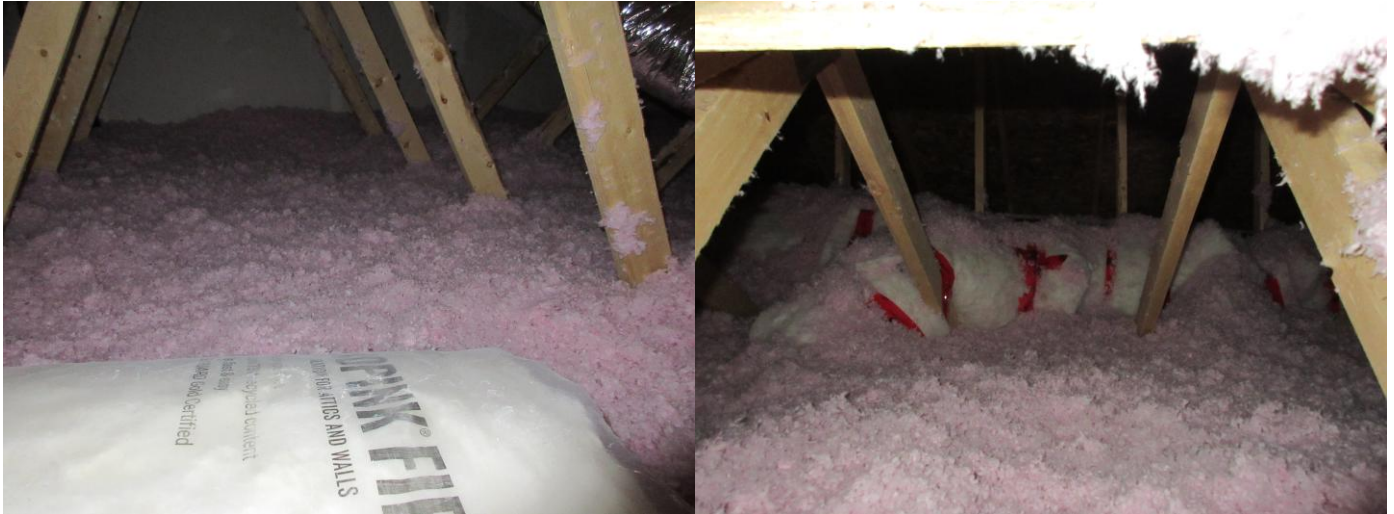
### 7.1 Attic insulation

The attic insulation consists of blown-in fibreglass types. The blown fibreglass insulation measured approximately 10-12 inches in depth, with an R-value of 40, which is close to current standards. A vapor barrier was also present on the attic floor.

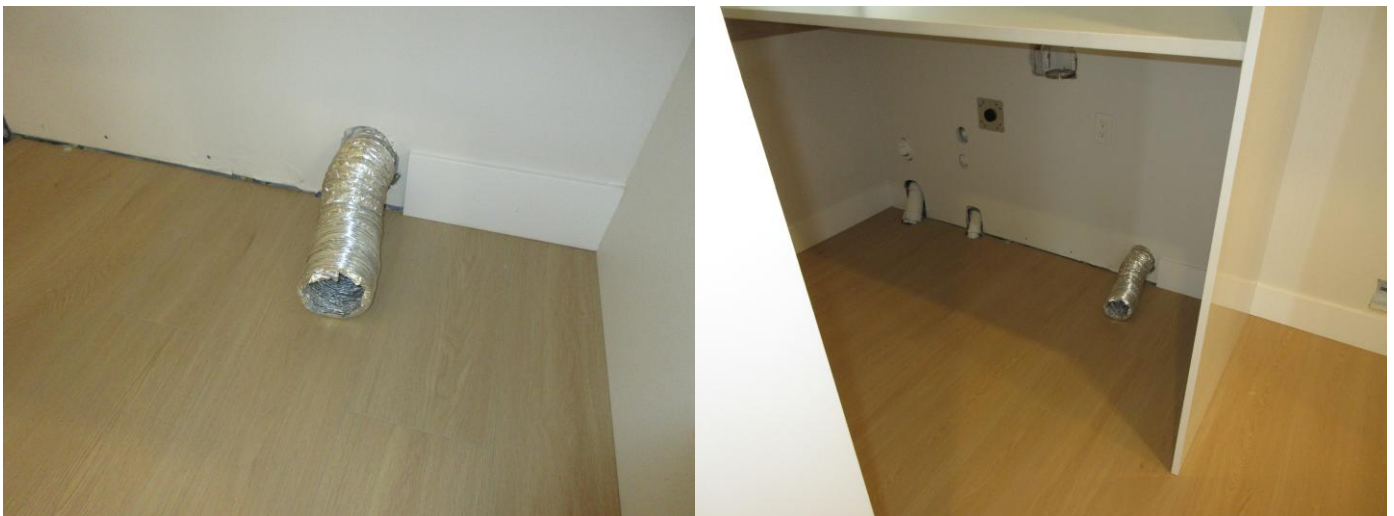
### 7.2 Laundry duct

The dryer location was designed with a foil duct, which is not recommended for use. Only hard metal or aluminum ducts are acceptable for dryer connections. It is strongly recommended to install a hard metal or aluminum duct for the dryer to ensure safety.

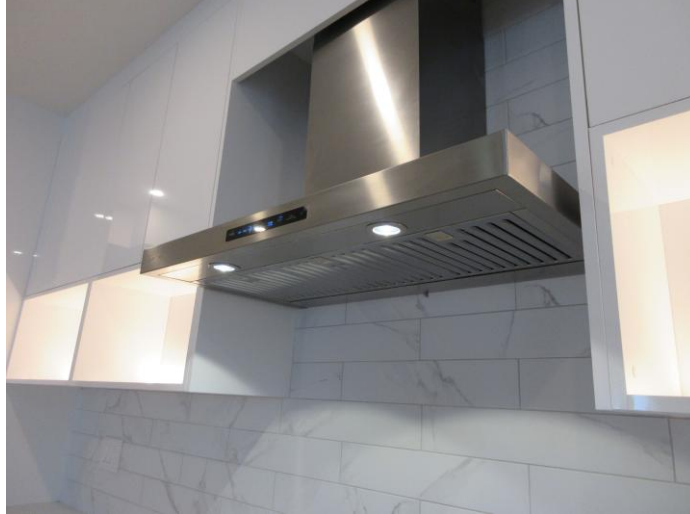
## 7.3 Rang Hood

There was a range hood over the stove in the kitchen. The electrical exhaust fan was tested and was functional at the time of this home inspection.

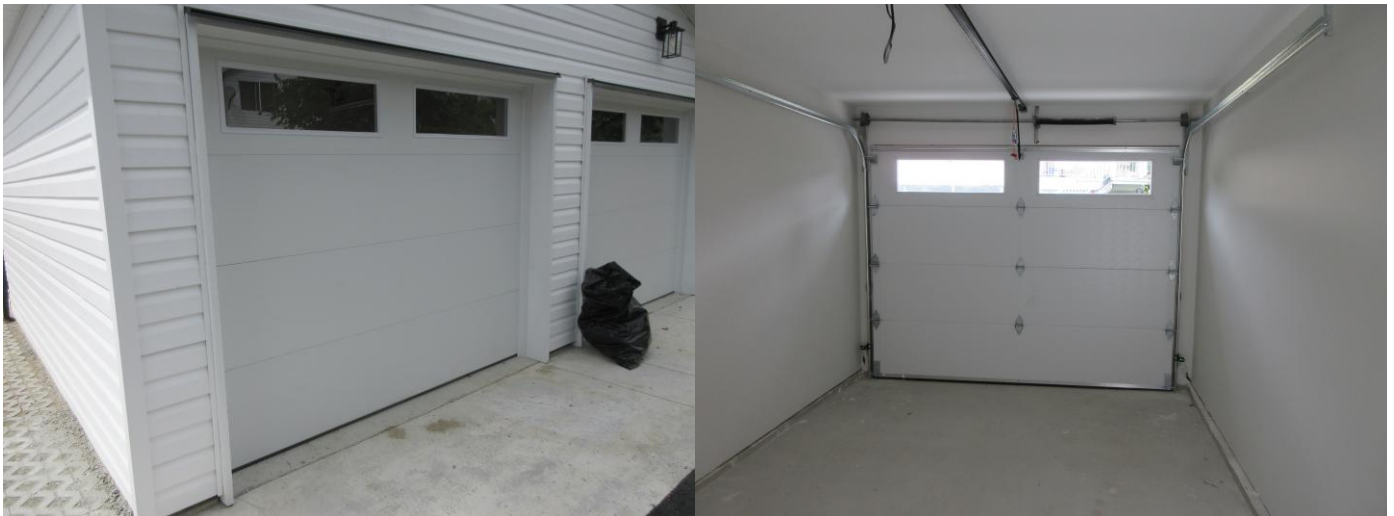
### 8.1 Garage

The garage door was operational and moved smoothly. The sensors were in place and successfully reversed the door at the time of inspection.

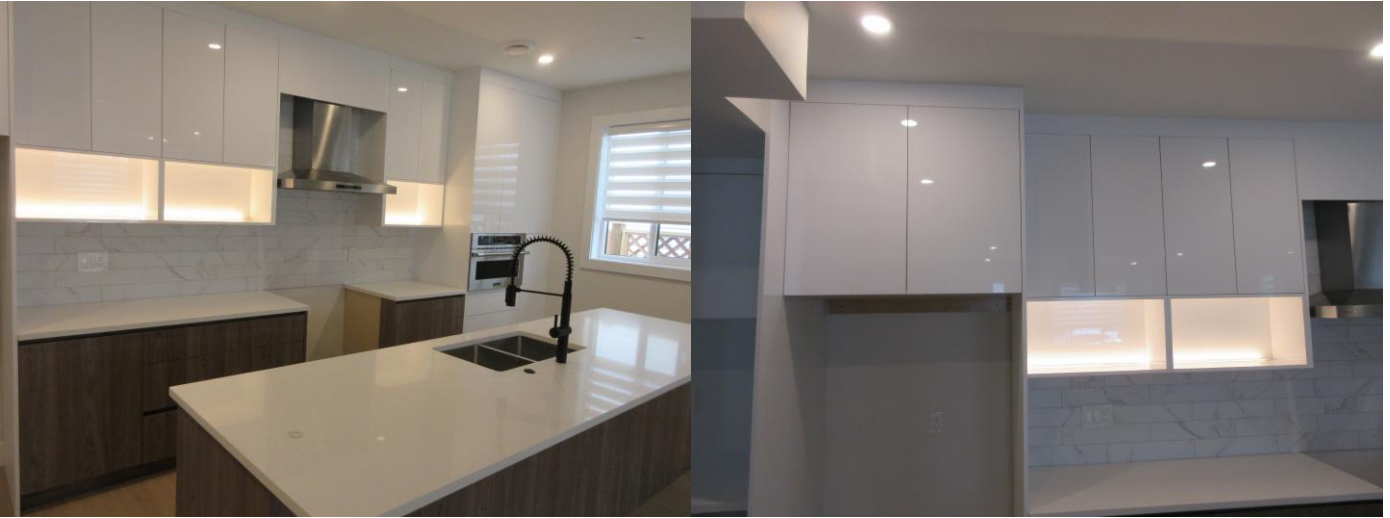
## 8.2 Counter and Cabinet

The house had types of countertop quartz. The cabinet doors were made of MDF. The kitchen cabinets and countertops were functional, with no deficiencies noted at the time of inspection.

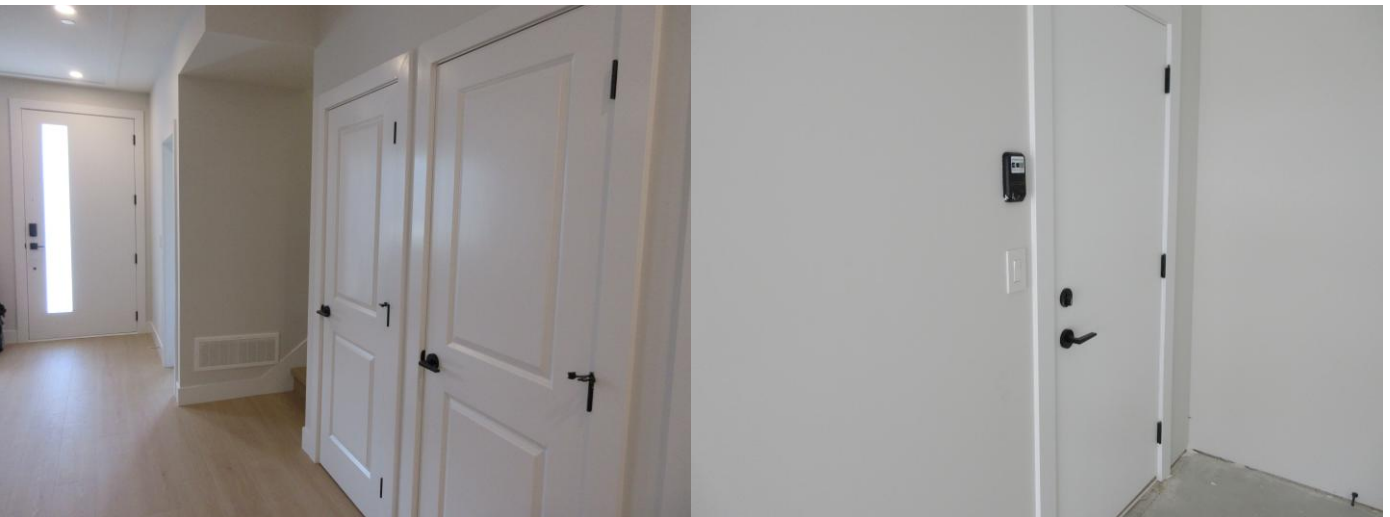
## 8.3 Door & Closet door

The house had interior doors made of vinyl including closet doors, The interior and closet doors, along with their hardware, were functional with no observed deficiencies.

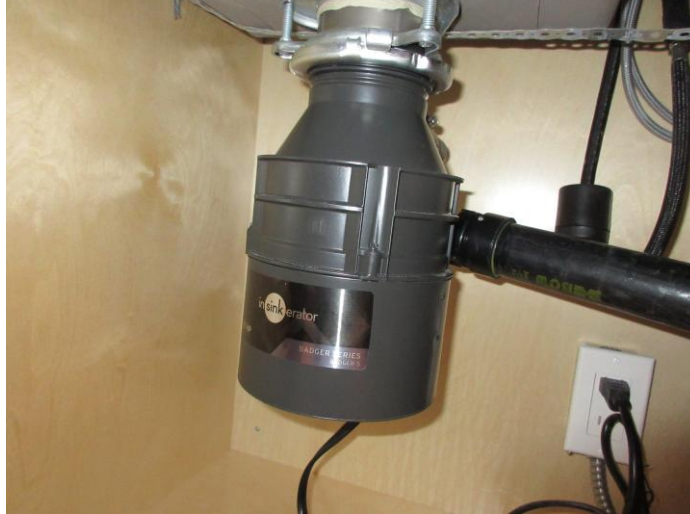
## 8.4 Garbage disposal

A garbage disposal was observed under the kitchen sink. It made some noise during the inspection.

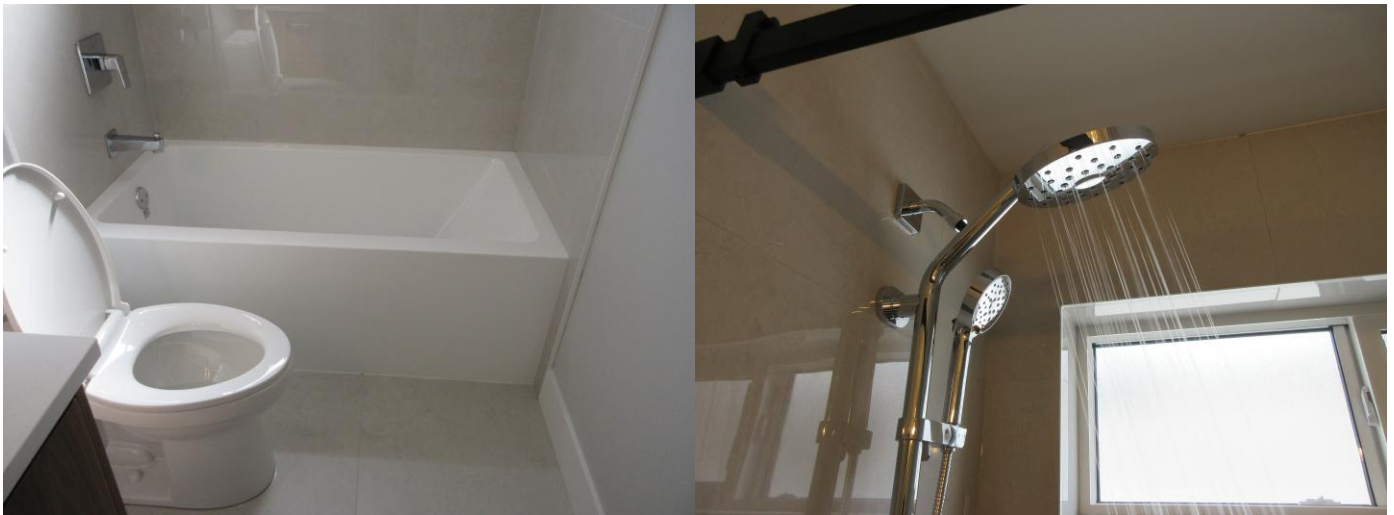
## 8.5 Bathroom

The bathtub, faucet, and shower were functional with no visible deficiencies at the time of inspection.

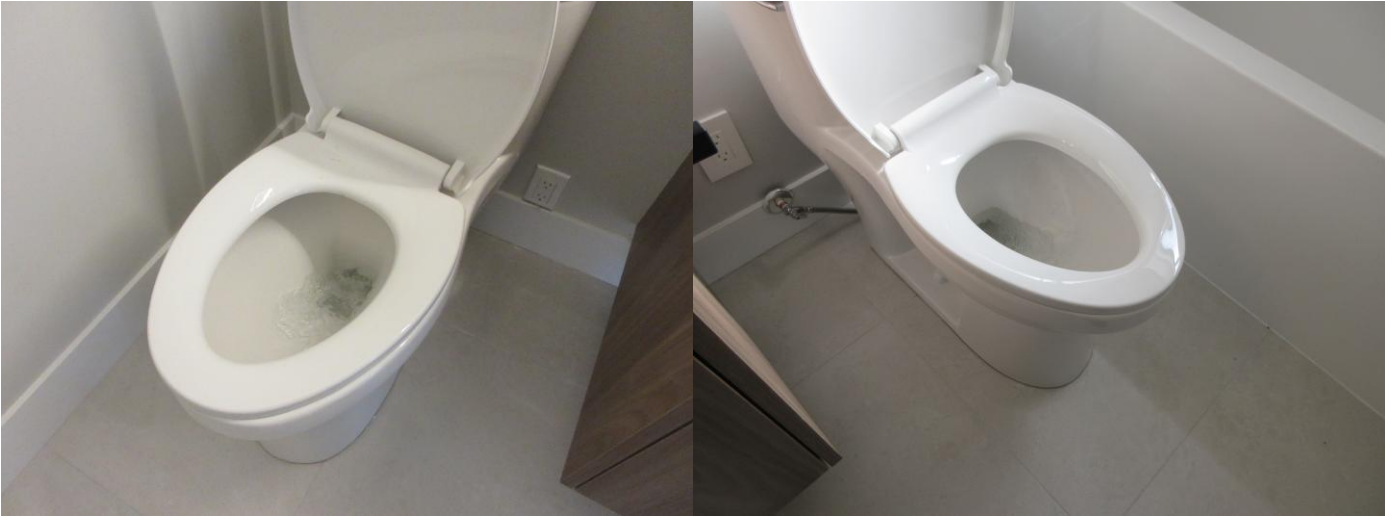
All toilets in the house were tested and found to be functional and appropriately installed with no deficiencies at the time of inspection. No movement, cracks, or leaks were observed in the flush tanks or toilets.

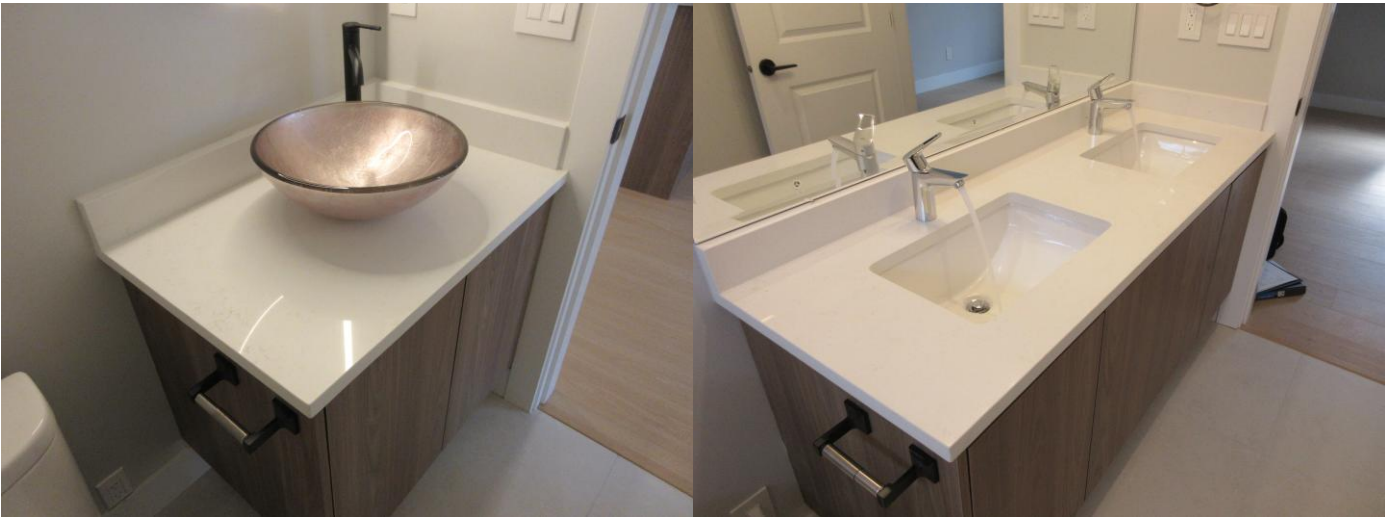
All basins and faucets in the master and main bathrooms were tested and found to be functional with no deficiencies at the time of the inspection. The basin bowls were secure, and the faucets were working properly, with adequate water pressure and drainage.

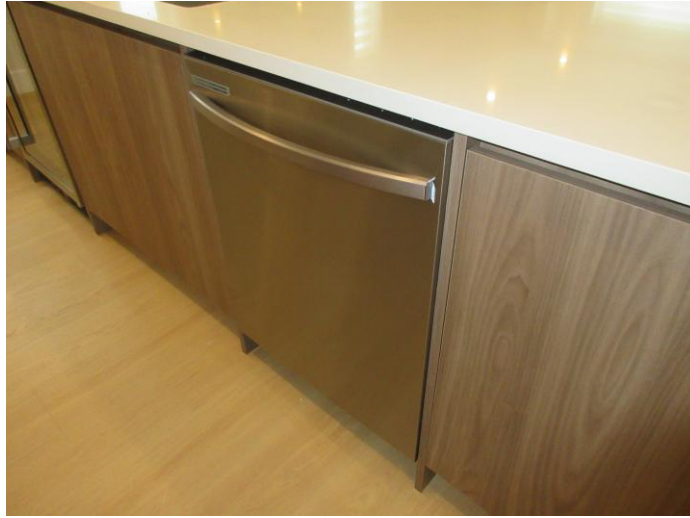
## 8.7 Dishwasher

The dishwasher was tested. There was no apparent water leakage at the time of this home inspection.

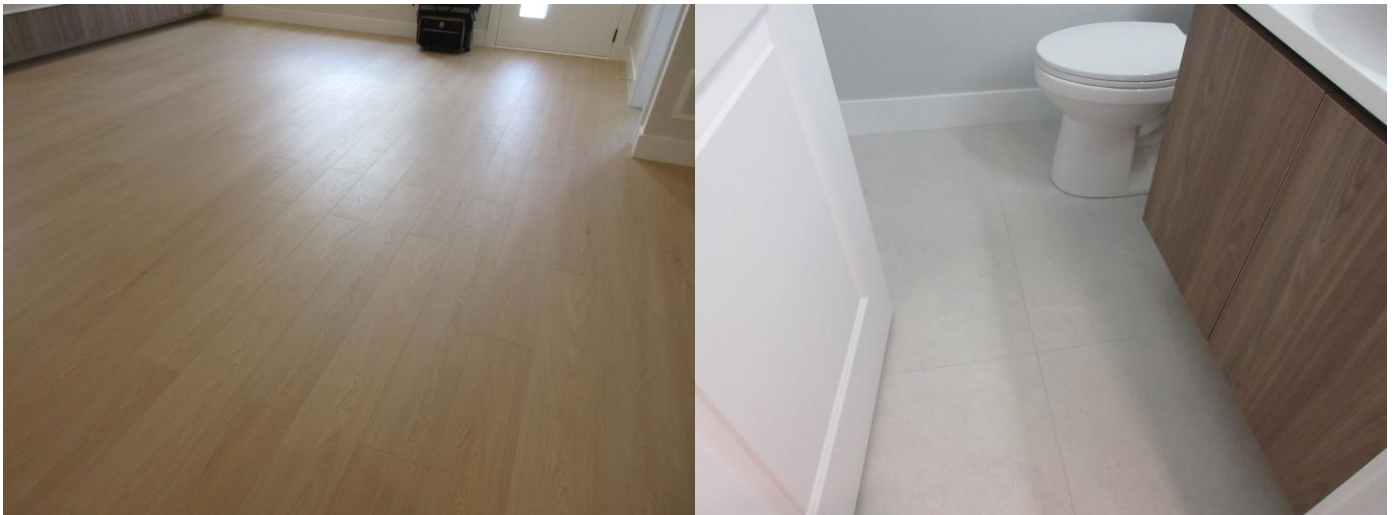
## 8.8 Floor cover

The house floor was covered with laminate, and tile. No deficiencies were observed at the time of this home inspection.

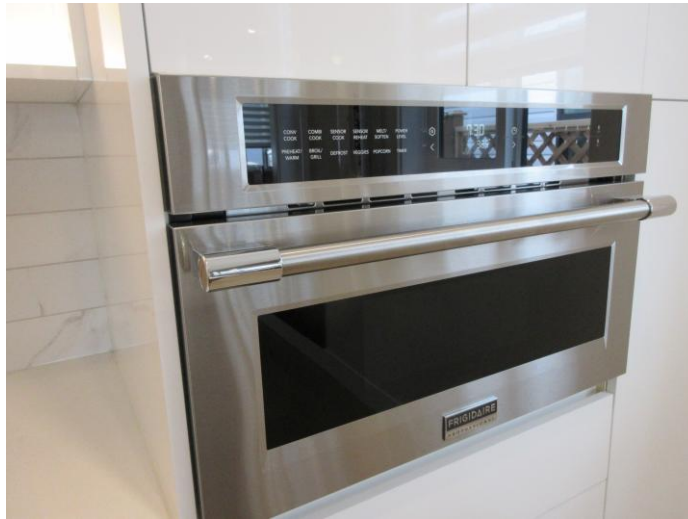
## 8.9 Wall oven

The built-in microwave oven was inspected and tested using normal operating controls. The digital display panel, interior lighting, control buttons, and door handle mechanism are all intact with no deficiency.
