# Home Inspection Report

Prepared exclusively for  
Surrey, BC

Property Address: Surrey, BC  
Date of home inspection: July 9, 2021  
Inspection start time: 10:00 AM  
Inspection end time: 1:00 PM  
MLS#: not available  
Year Built: 2017  
Construction: Concrete / Metal  
Furnished: Yes  
Occupied: Yes  
Floor Area Total: 1313 sq. Ft.

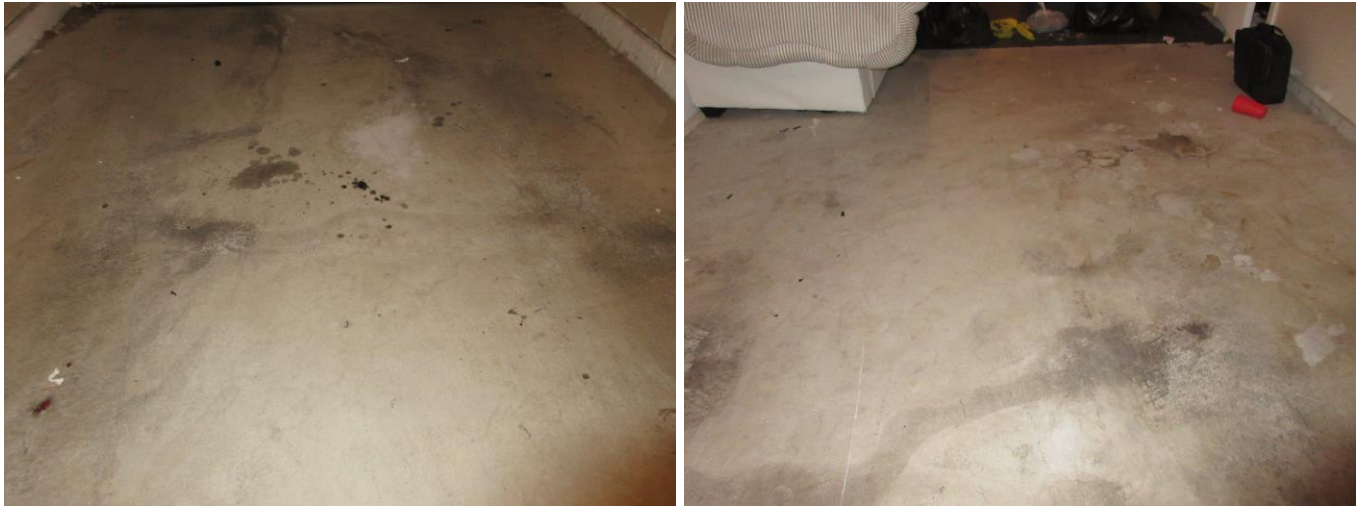
## 1.1 Floors

The house featured a poured concrete floor, which was inspected and found to have no visible deficiencies or structural concerns at the time of this home inspection.

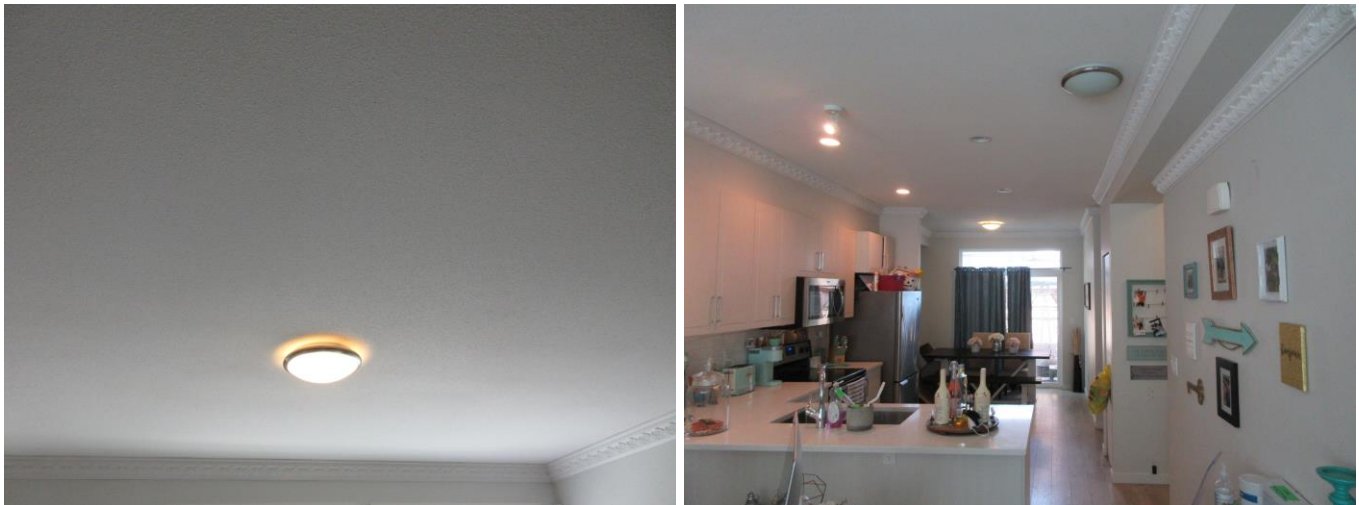
## 1.2 Ceiling

The interior ceiling assembly consists of drywall panels. Ceilings throughout the home were visually inspected and found to be in overall satisfactory condition, with no evidence of structural movement, severe cracking, or active moisture staining noted at the time of inspection.

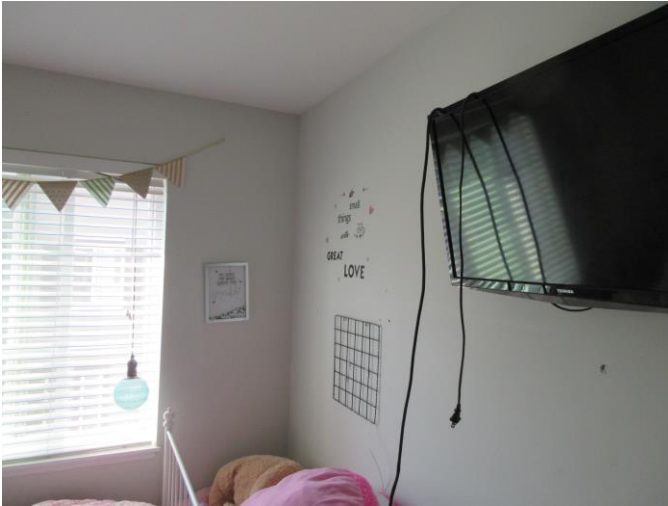
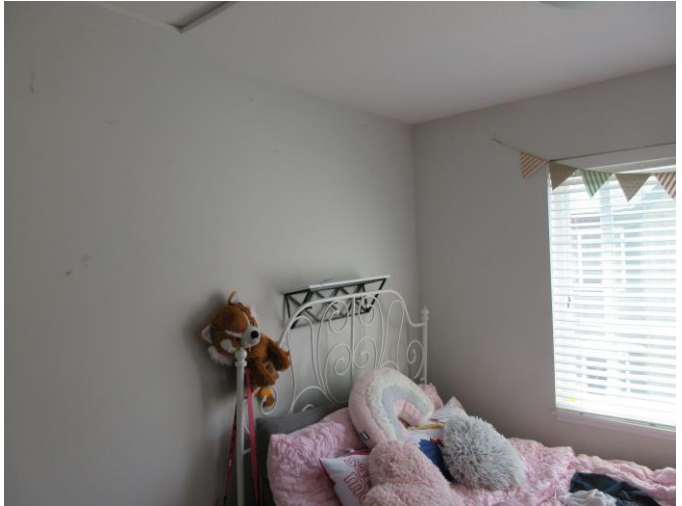
### 1.3 Wall

The structural wall framing consists of a combination of poured concrete and wood framing. At the time of inspection, interior wall surfaces, ceilings, and floor structures were visually evaluated where accessible, showing no major defects, significant cracking, or signs of structural deficiency.

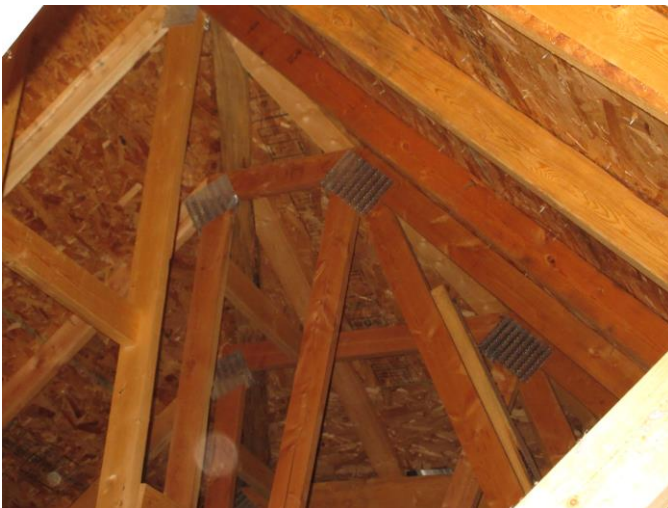
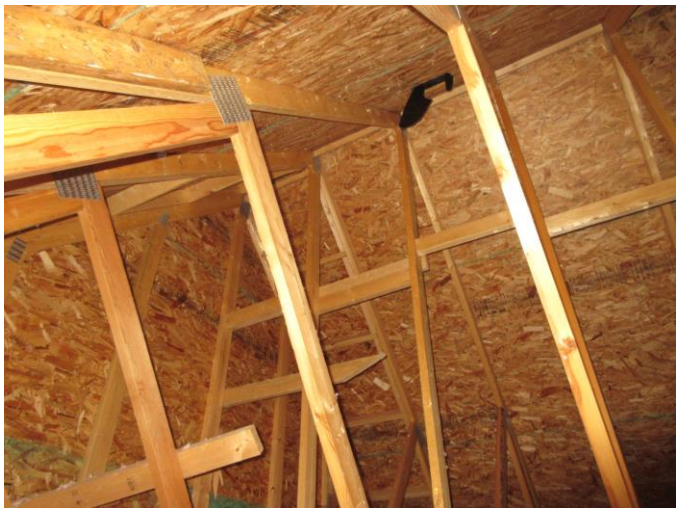
### 1.4 Roof

The visible roof framing was constructed of engineered wood trusses. The roof structure appeared to be performing its intended function with no signs of structural deflection, sagging, or major deficiencies observed at the time of inspection.

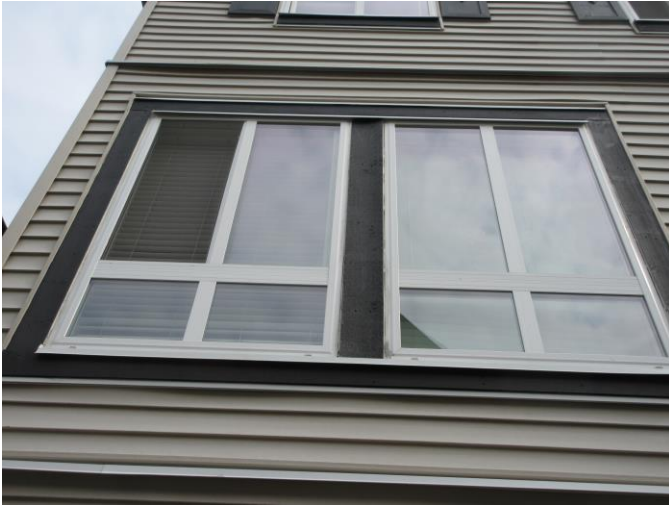
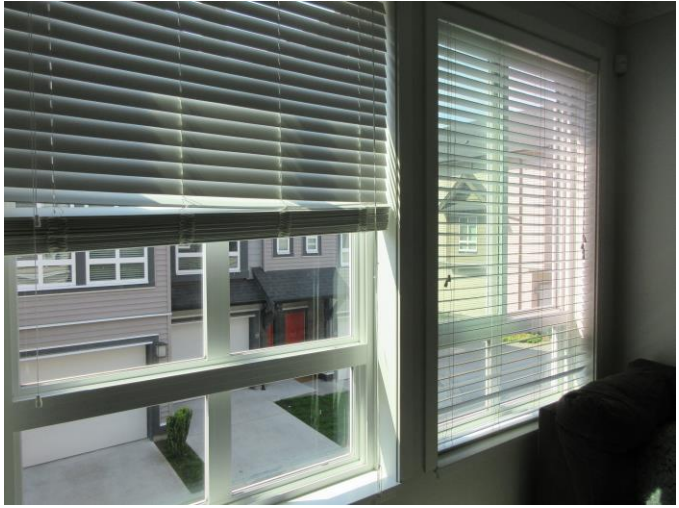
### 2.1 Windows

The building features vinyl-framed windows equipped with double-pane insulated glass units. All accessible windows were tested and found to be functional, operating smoothly with no thermal seal failures or physical deficiencies observed at the time of inspection.

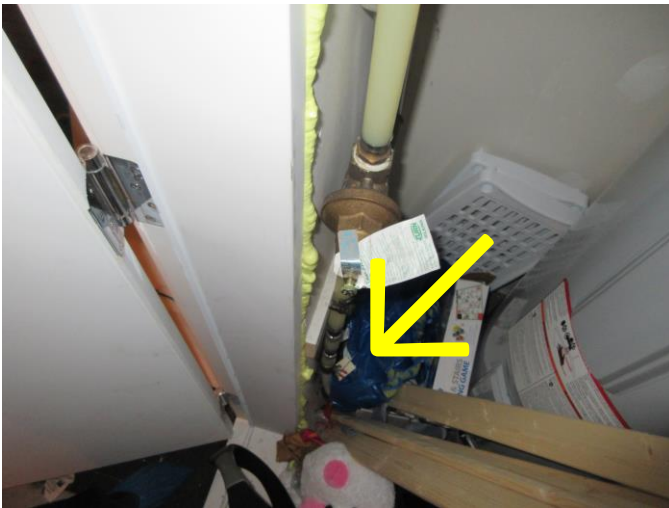
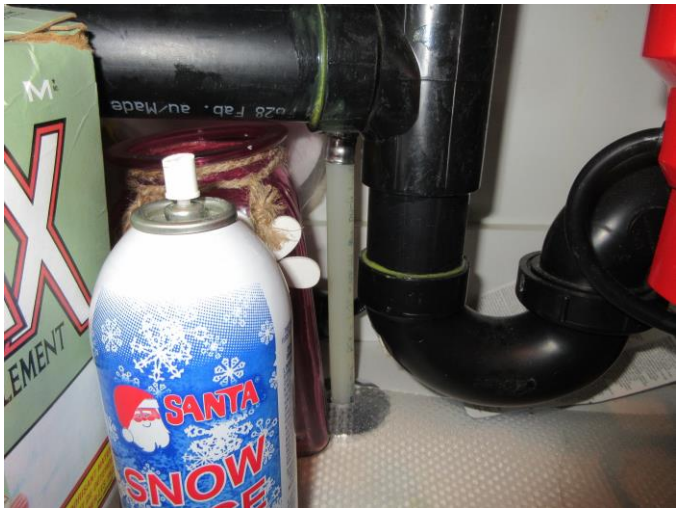
## 3 . Plumbing Water Supply System

The visible supply plumbing is a combination of copper and Uponor PEX piping. The system was functional with adequate pressure and no active leaks, corrosion, or severe condensation observed at the time of inspection. The main water shut-off valve and a pressure-reducing valve (PRV) are located in the hot water tank room. Both copper (typical lifespan 20–50 years) and PEX (typical lifespan 40–50 years) materials appear to be performing as intended."

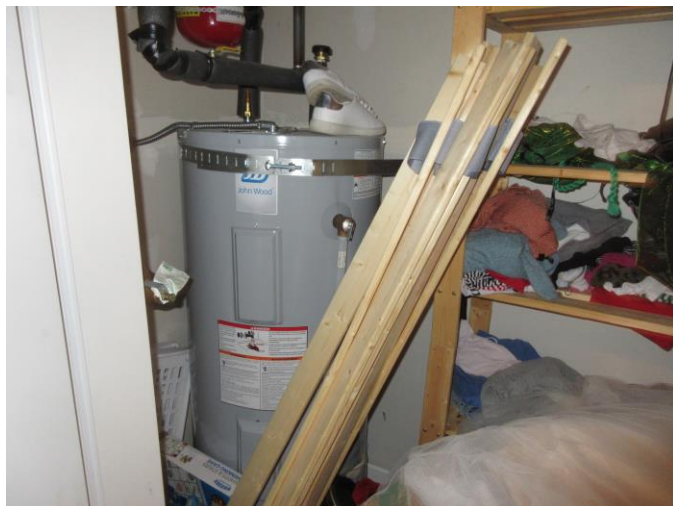
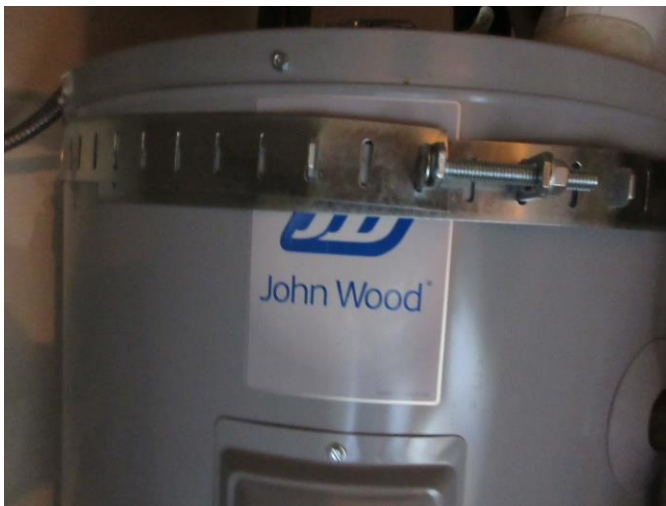
## 3.1 Hot Water Tanks

The hot water tank was manufactured in December 2017. The unit was functional with no visible signs of leaking or active corrosion observed during testing. Given its age relative to the typical 8–12 year lifespan for standard water heaters, budget planning for future replacement should be considered

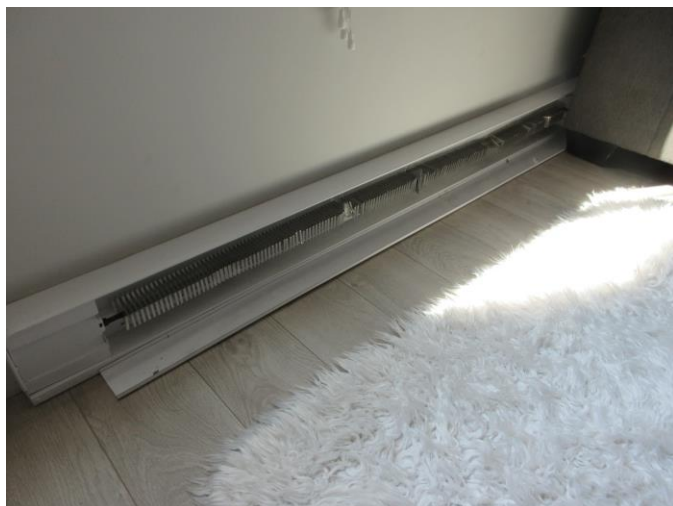
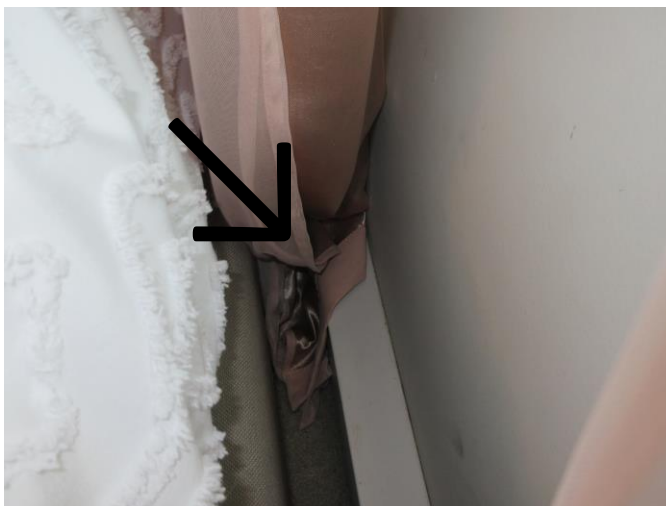
### 4.1 Electrical baseboard heater

The front protective cover was missing/separated on the living room electric baseboard heater, exposing hot heating elements. Furthermore, furniture and drapery were situated directly against heaters in both the living room and bedroom. Combustible items contacting heating equipment reduce system efficiency and pose a severe fire safety risk. Prompt repair of the heater cover and clearing all surrounding clearances is recommended

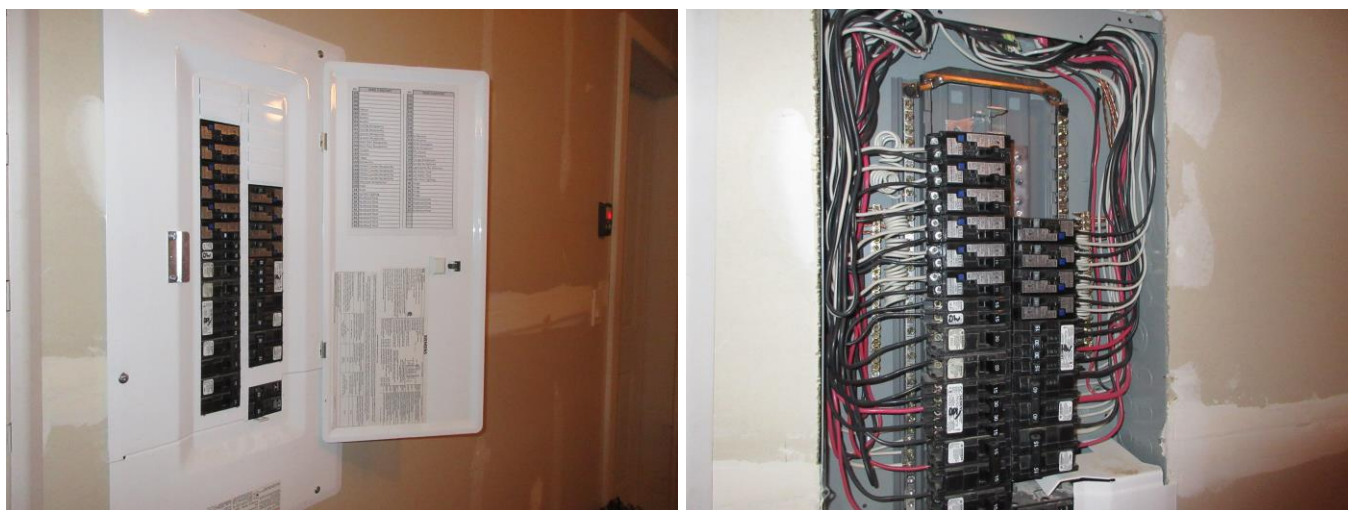
### 5.1 Main Electrical Panel

The 100-amp main electrical panel is located in the garage and was fully accessible at the time of inspection. Branch wiring consists of copper conductors. The panel circuit directory was labeled, and internal components showed no evidence of overheating, physical damage, or corrosion. Circuit breakers and conductor gauges appear properly matched across tested circuits (including 15-amp general branch circuits, a 30-amp dryer circuit, and a 40-amp range circuit).

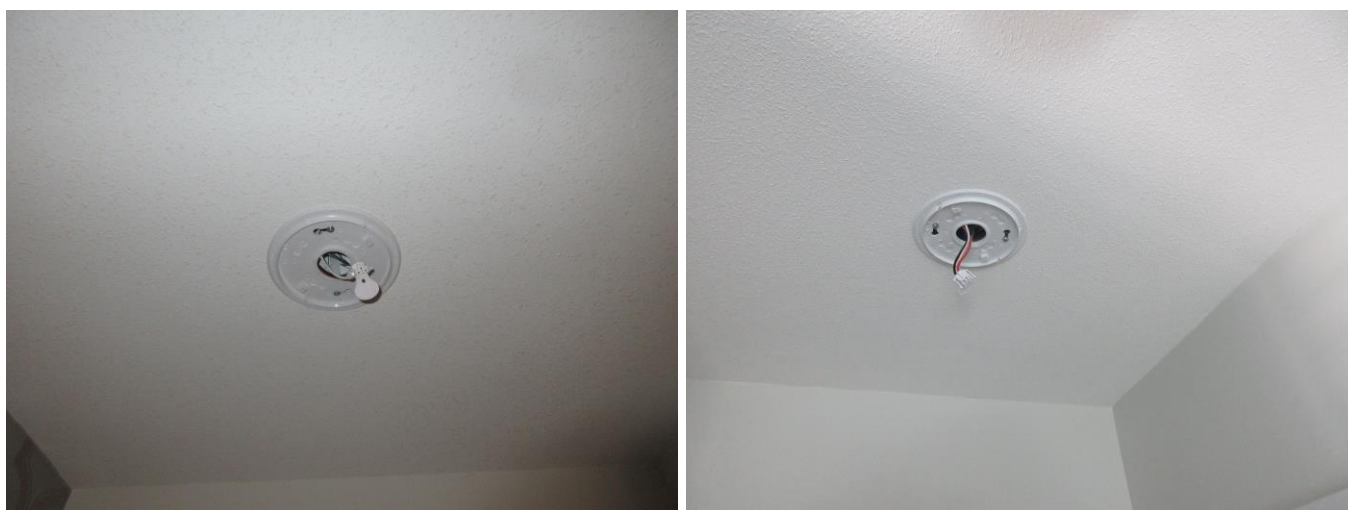
### 5.2 Smoke Detector & Carbon monoxide

Damaged and incomplete smoke alarms were observed in bedroom areas. Smoke detectors are a primary life safety device; damaged or missing components compromise their ability to detect fire. Immediate replacement or proper repair of all non-functional smoke alarms by a qualified individual is recommended.

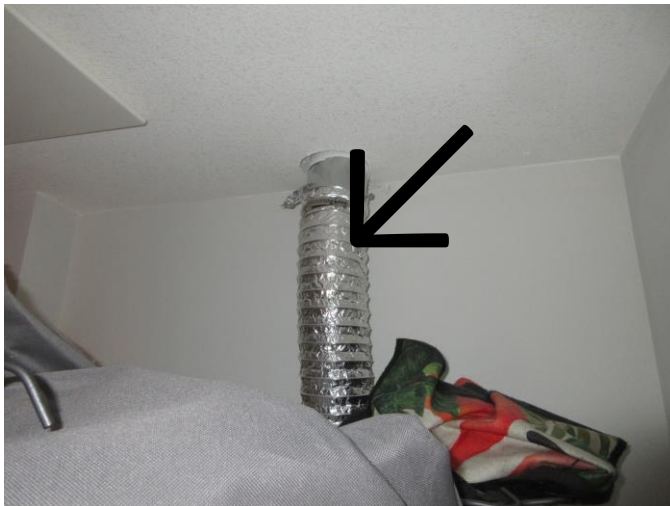
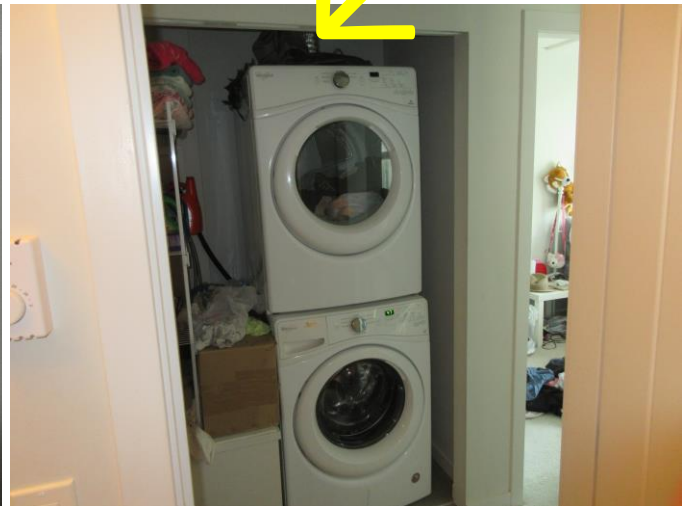
### 6.1 Laundry Vent

The clothes dryer is connected using a flexible foil transition duct. Flexible foil and plastic ducts are prone to crushing, tearing, and trapping lint, posing a potential fire hazard. It is recommended to replace the flexible foil duct with an approved rigid or semi-rigid metal (aluminum/galvanized) vent pipe for safety and optimal performance.

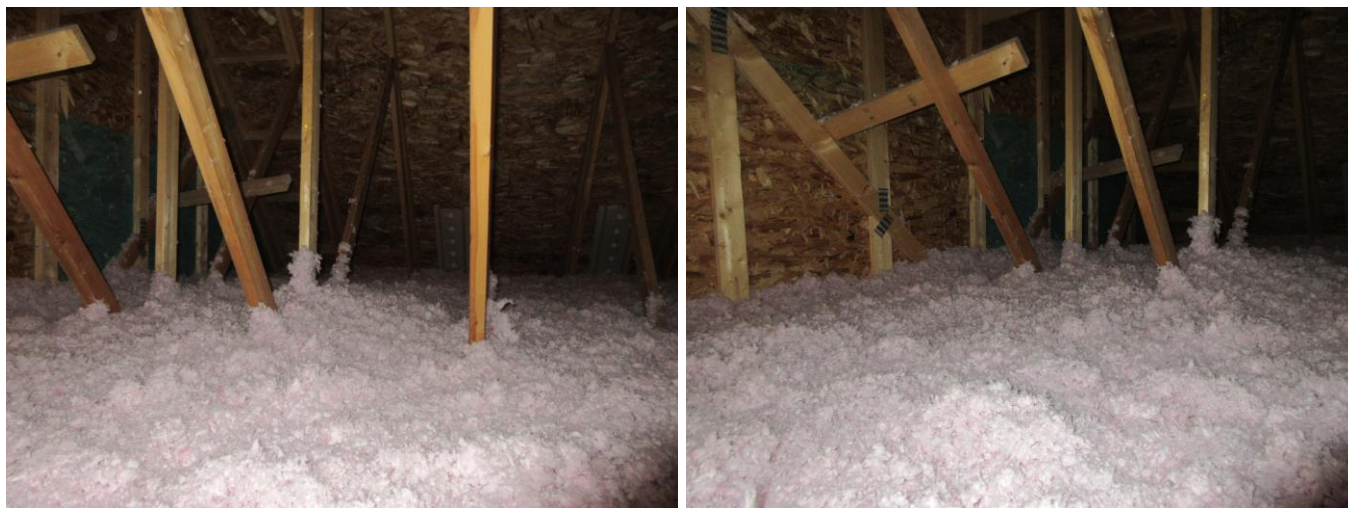
The attic space was insulated with blown-in fiberglass insulation, averaging approximately 10 to 12 inches in depth (estimated R-38 to R-40), which aligns closely with current residential energy standards. A vapour barrier was present on the attic floor beneath the insulation.

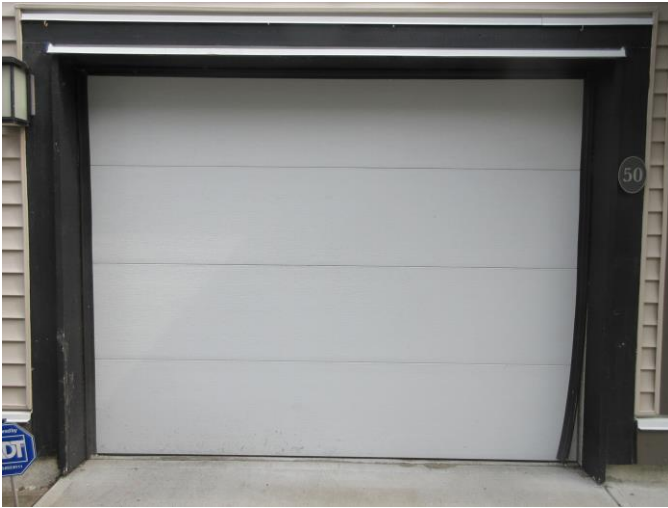
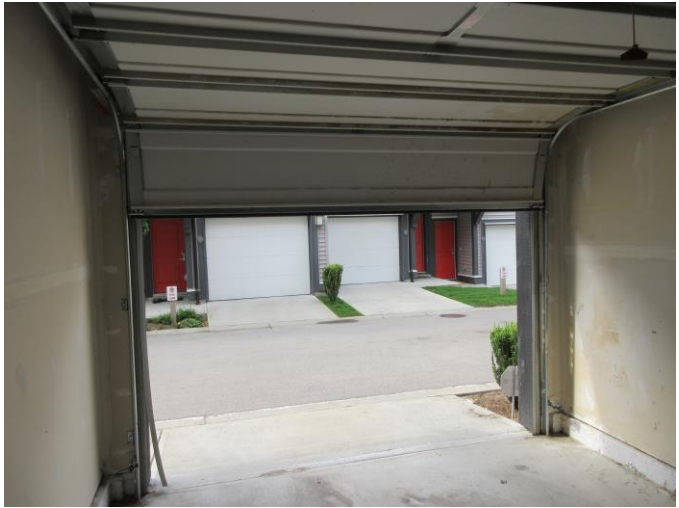
### 7.1 Garage

The garage door and automated opener were tested and performed as intended. The door moved smoothly, and the photoelectric safety sensors successfully reversed the door when obstructed during testing.

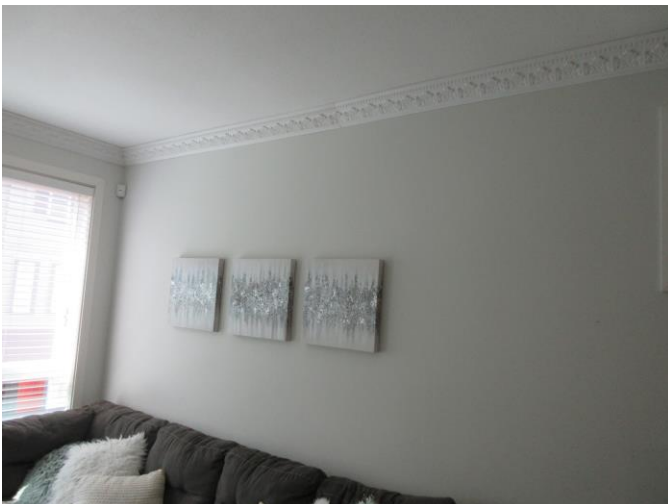
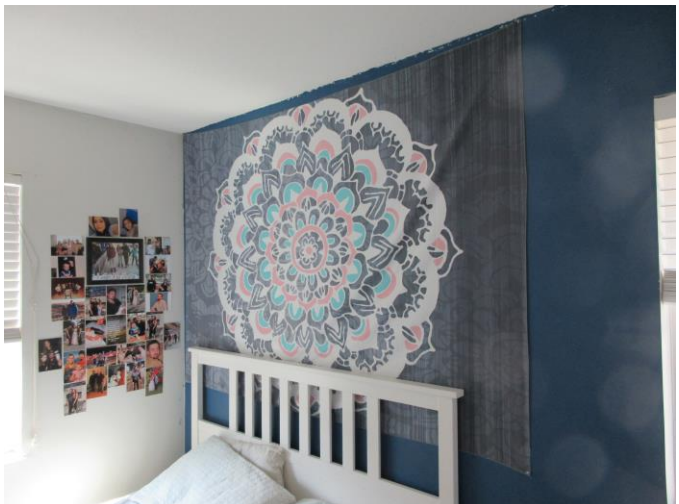
### 7.2 Walls and Materials

Interior drywall/gypsum wallboard was inspected and appeared to be in overall satisfactory condition, functioning as intended at the time of inspection. Gypsum board wall surfaces throughout the home were found to be in serviceable condition with no significant defects observed at the time of inspection.

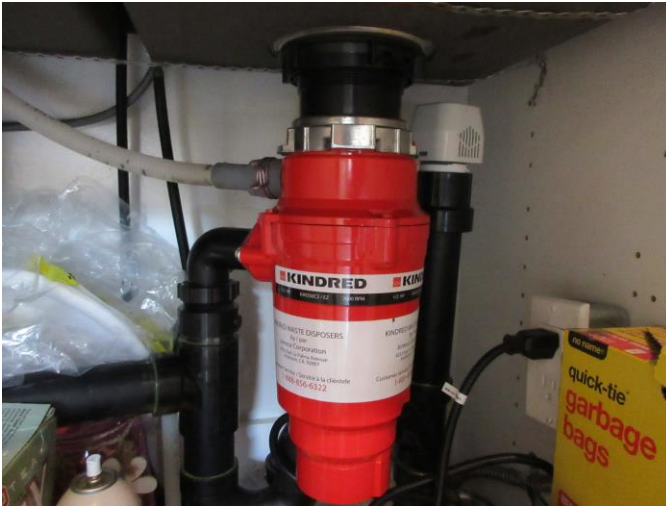
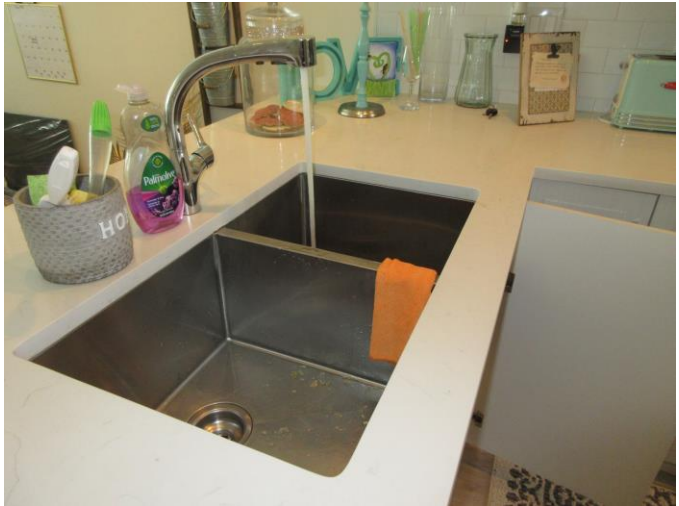
### 7.3 Kitchen sink & Garbage disposal

The kitchen is equipped with a steel sink. At the time of this home inspection, the faucets and sink were functioning properly with no leaks. The water fixtures appeared to be in satisfactory condition, and both water pressure and drainage were adequate for the kitchen sink. A garbage disposal was installed beneath the kitchen sink. The unit was operated using normal controls and was found to be functional with no active leaks, abnormal noise, or visual defects observed at the time of inspection.

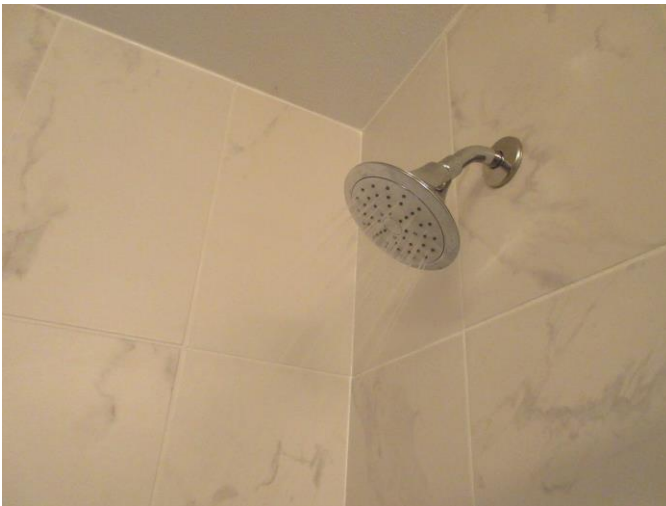
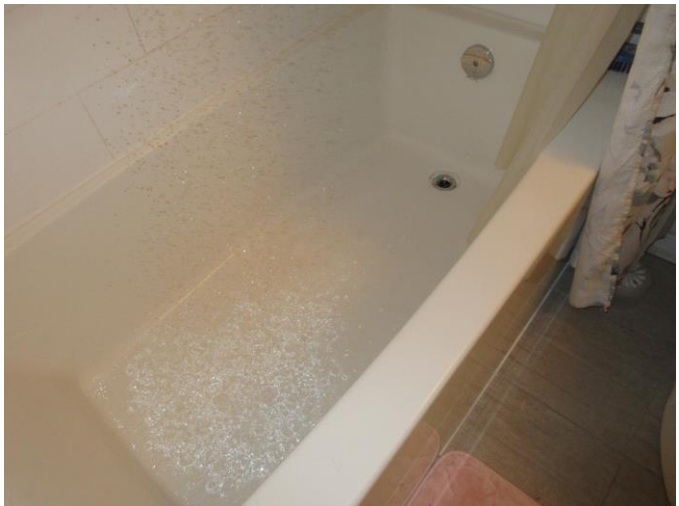
### 7.4 Bathroom

The bathtub, faucet, and shower head assembly were operationally tested and appeared to be in good working condition with no leaks or visible deficiencies observed at the time of inspection.

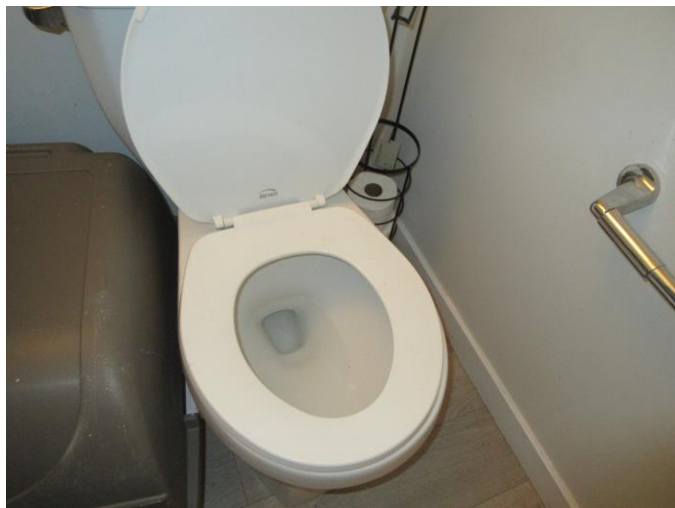
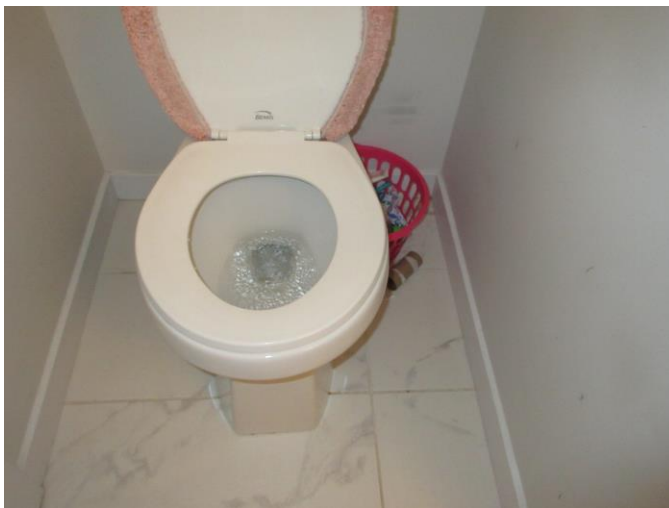
## 7.5 Washroom

All toilets were operationally tested and found to be functional and properly secured. No cracks, movement, or water leaks were observed at the toilet bases or flush tanks during the inspection.

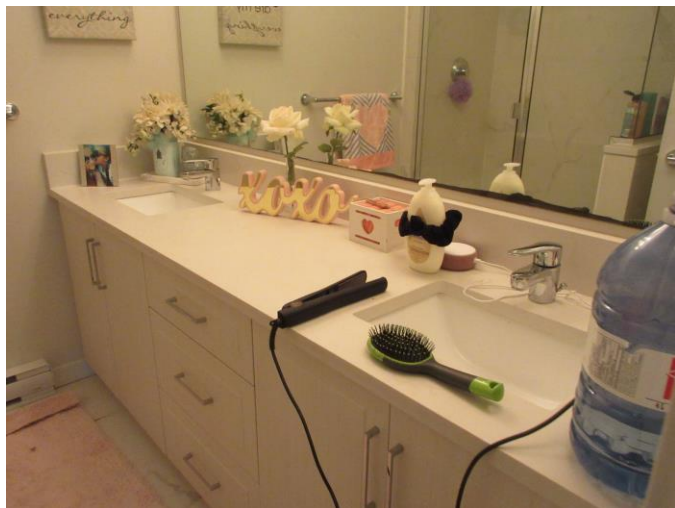
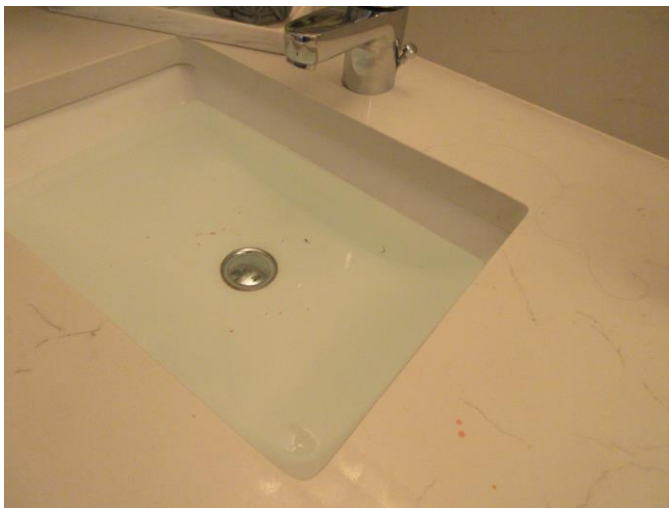
The sink basin stoppers in both the master bathroom and main bathroom were observed to be non-functional during testing. Repair or adjustment of the stopper mechanisms by a qualified plumber or handyman is recommended to restore normal operation.

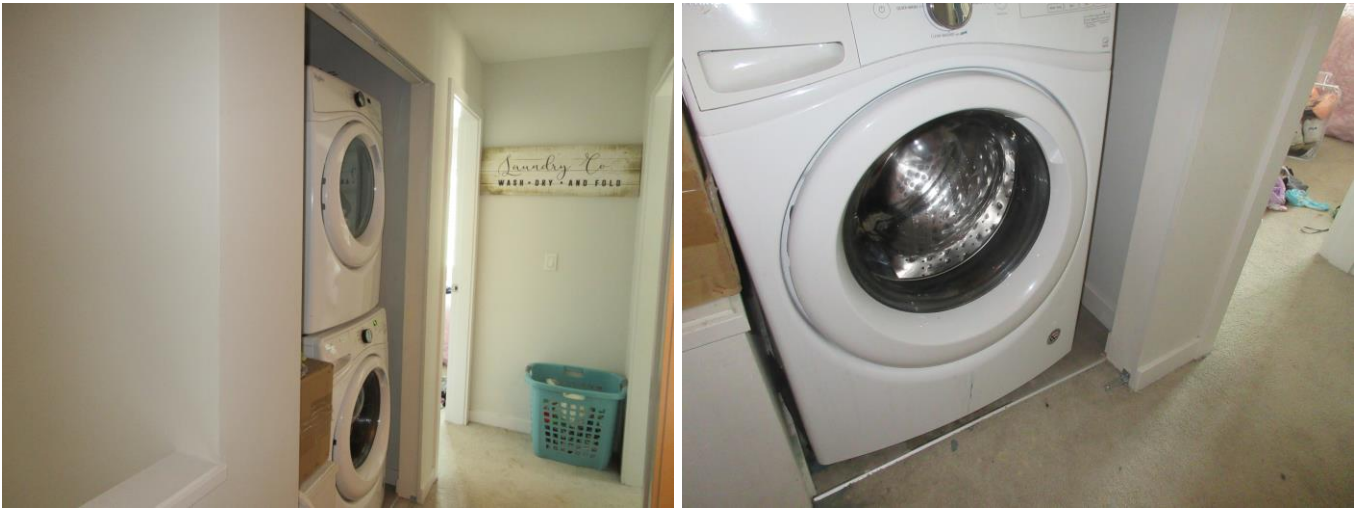
## 7.6 Washing machine & Dryer

The washing machine and dryer located in the laundry room were visually inspected and operationally tested. Both units were functioning properly with no water leakage observed from the washing machine at the time of inspection.

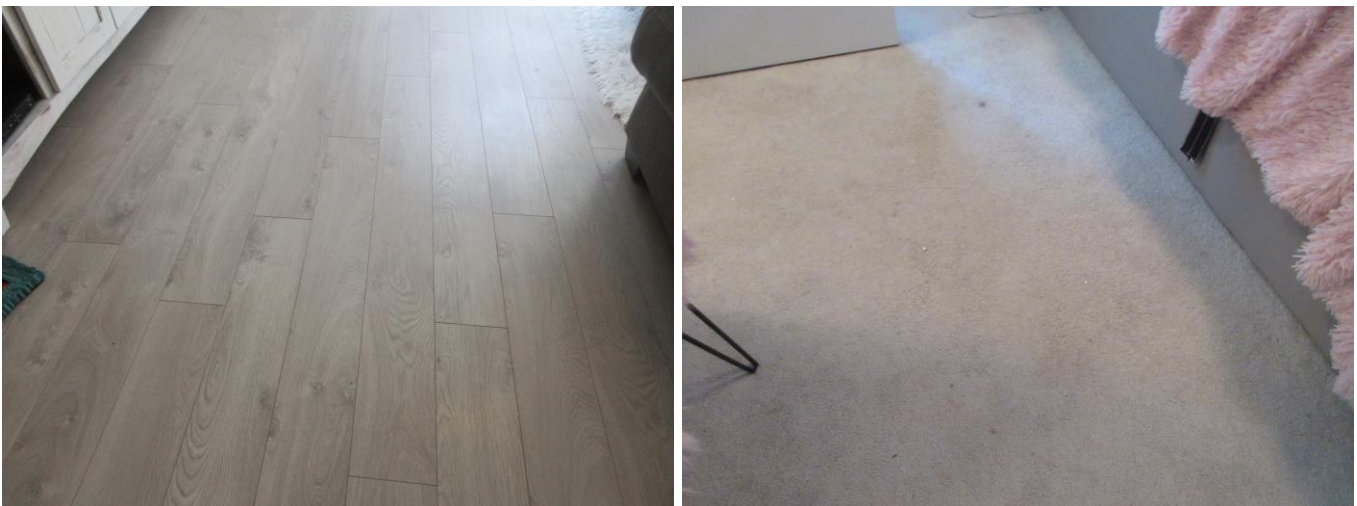
## 7.7 Floor cover

The interior floors throughout the home were finished with tile, carpet, and laminate flooring. The floor coverings were visually inspected and appeared to be in good/functional condition with no major deficiencies observed at the time of inspection.

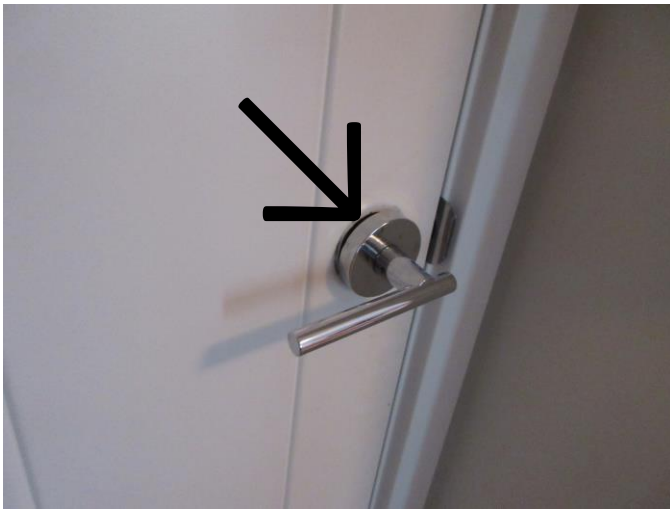
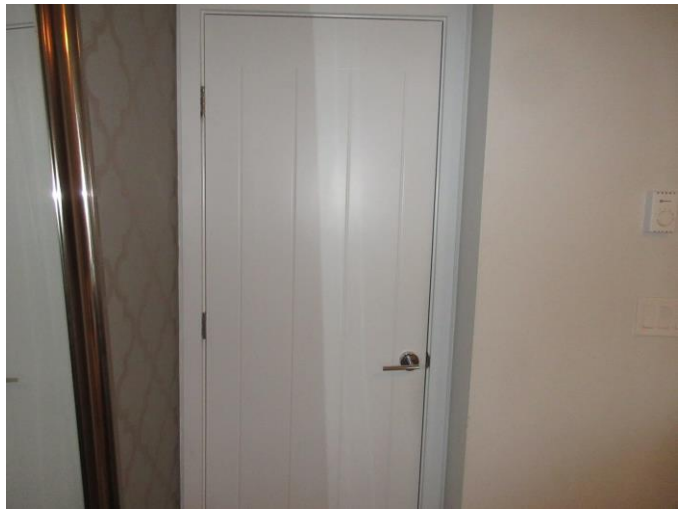
## 7.1 Doors & Closet door

The master bedroom door handle and lever lock set were observed to be loose. Continued operation without servicing may lead to further hardware loosening, latch misalignment, or failure. Repair or tightening by a qualified handyman or contractor is recommended to restore secure operation.

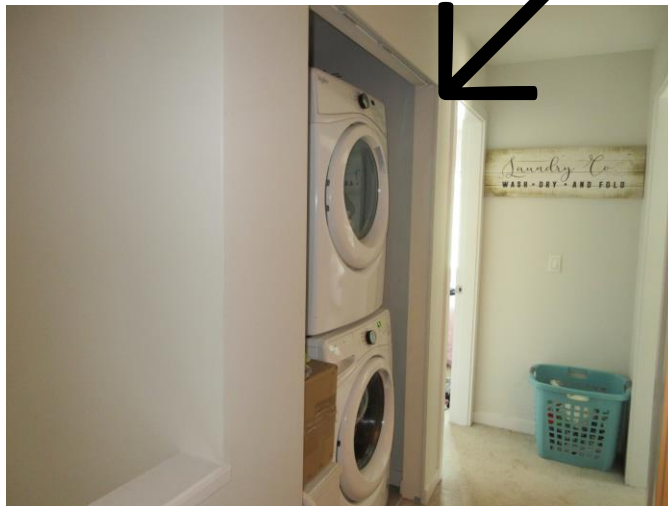
The top floor laundry room was observed to be missing its panel door. Installing a properly sized interior door panel with complete hardware is recommended to improve sound damping, privacy, and visual finish.
