# Home Inspection Report

Prepared exclusively for customer  
Vancouver, BC

Property Address: Vancouver, BC  
 Date of home inspection: May 18, 2020  
 Inspection start time: 9:00 AM  
 Inspection end time: 12:30 PM  
 MLS# not available  
 Year Built: 1999  
 Construction: Concrete  
 Furnished: Yes  
 Occupied: Yes  
 Floor Area Total: 674 sq. Ft.

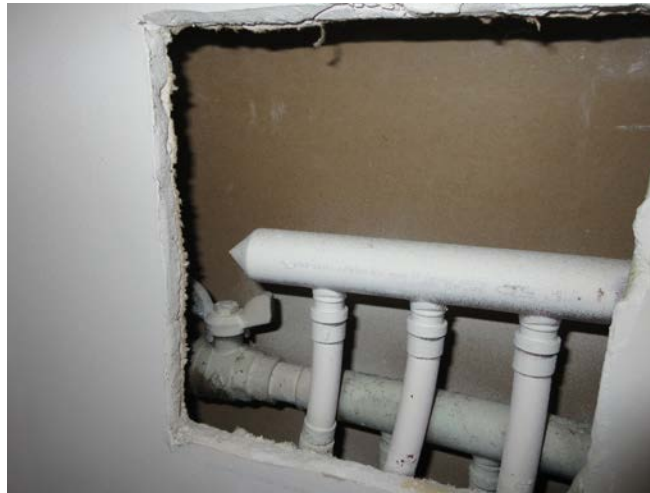
Type: PEX

The house original supply pipes is PEX. The life expectancy of PEX piping is 40-50 years. The main water shut off valve is located in the closet of the suite entrance space.

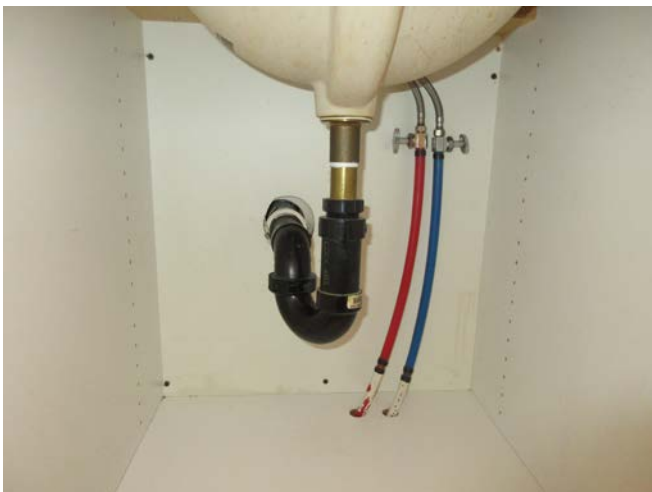
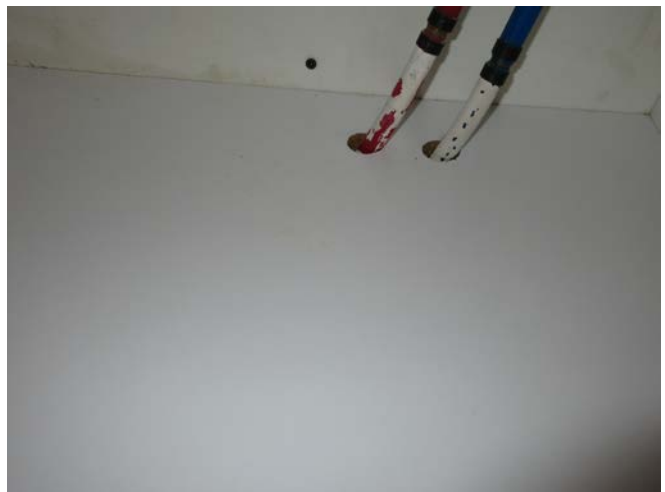
The water leakage was noted under the basin faucet. I recommend fixing the water leakage.

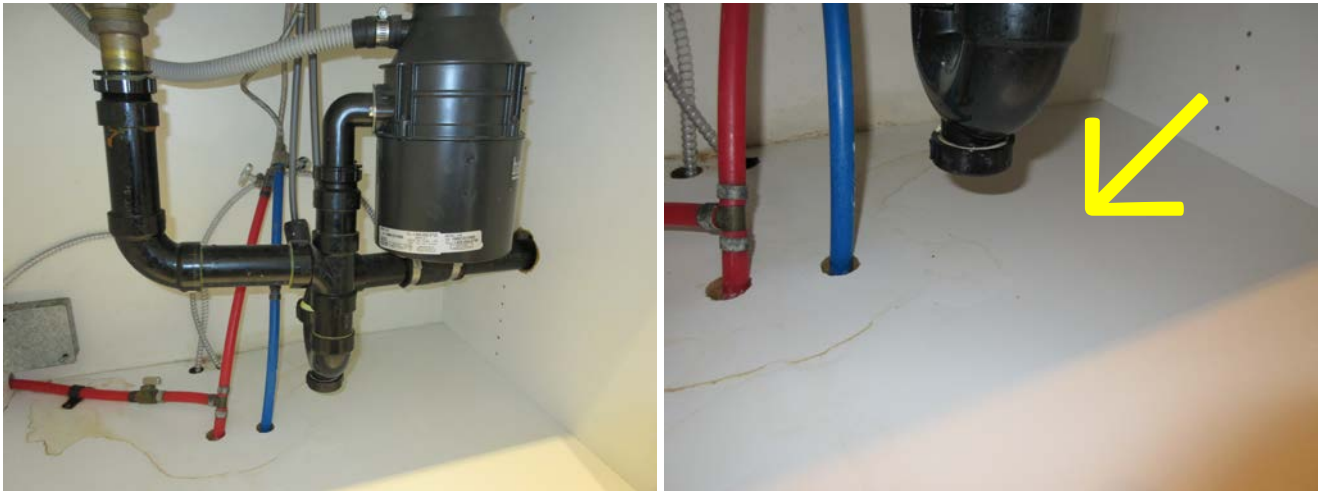
The water leakage was noted under the kitchen sink sewage pipe of the house. I recommend fixing the water leakage.

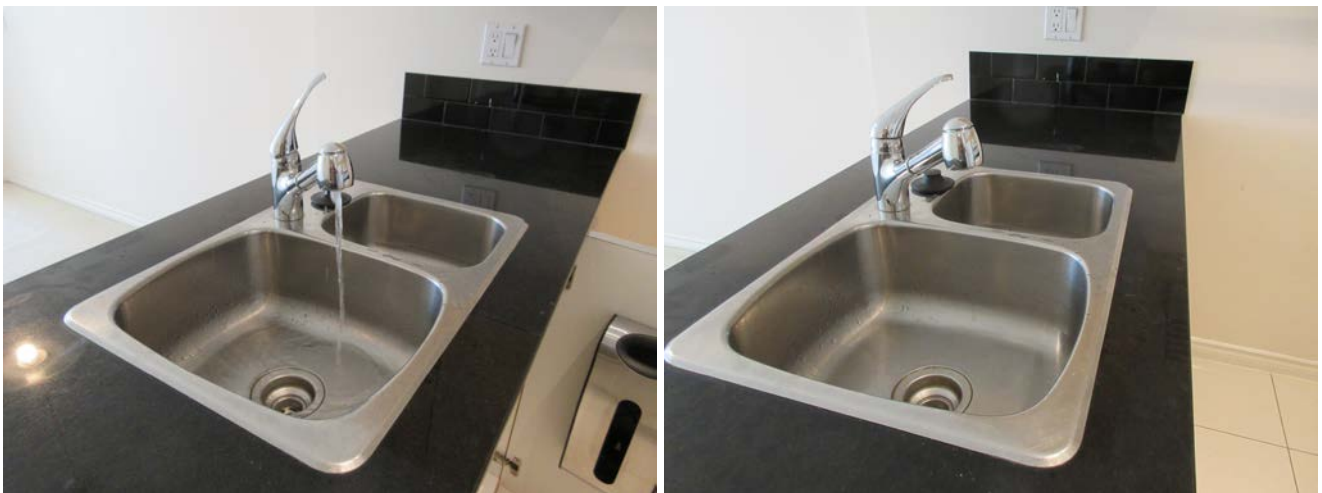
The water pressure was low for the kitchen sink. Monitor the water pressure change to fix by a qualified plumber is recommended.

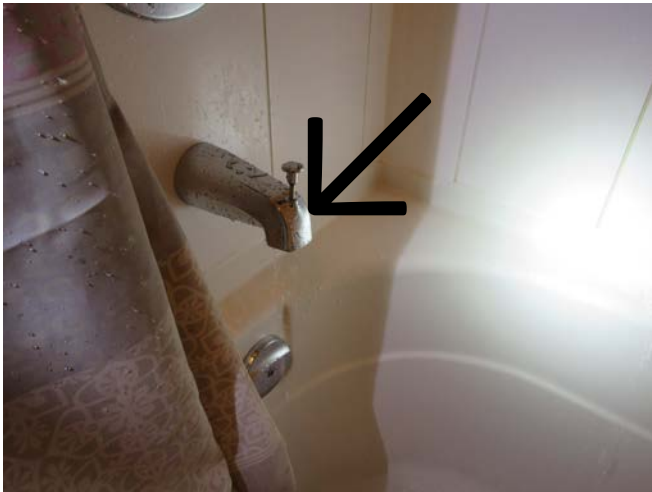
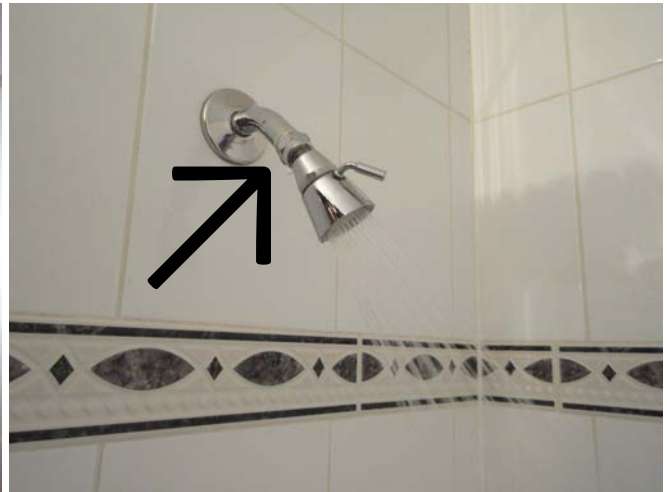
The water leakage was observed on the faucet's spout and shower head at the bathroom. Fixing the water leakage by qualified plumber is recommended.

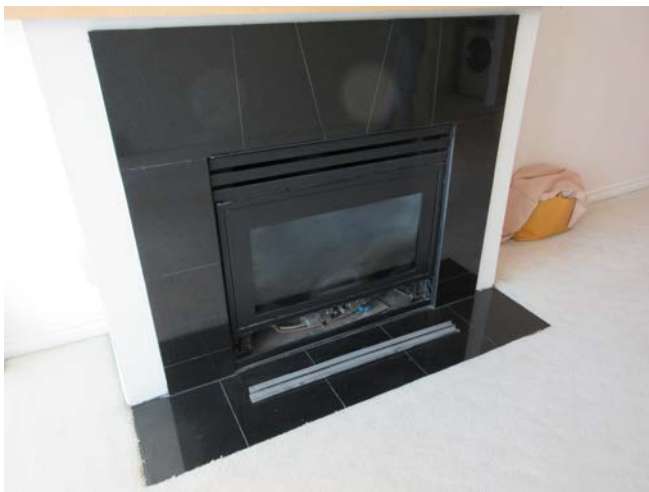
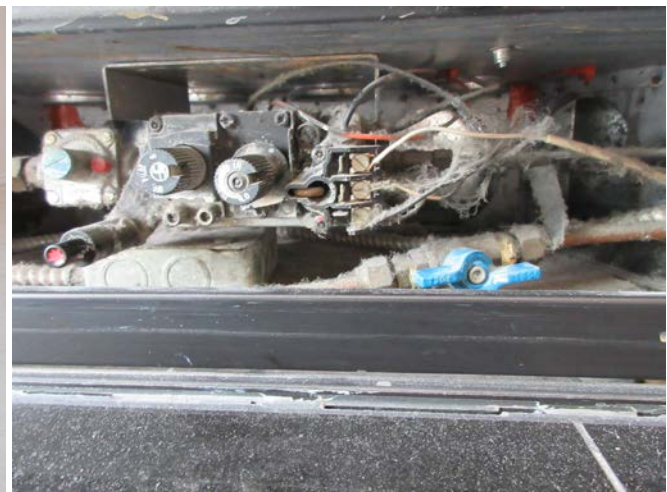
Type: Gas

The fireplace was gas type. I was not able to turn on the fireplace at the time of this home inspection.

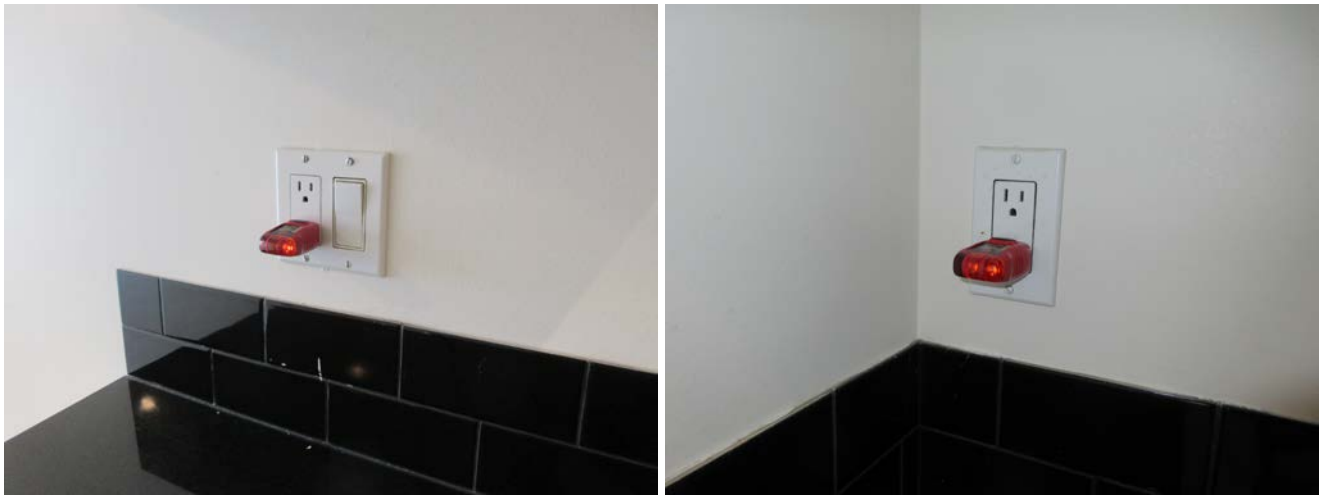
There was no GFCI type outlet in the kitchen. It is safety concern. The outlet needs to be GFCI type in the kitchen to protect users from any electrical shock and unsafe situation. Ground Fault Circuit Interrupter (GFCI) outlets are recommended for installation at kitchen outlets.

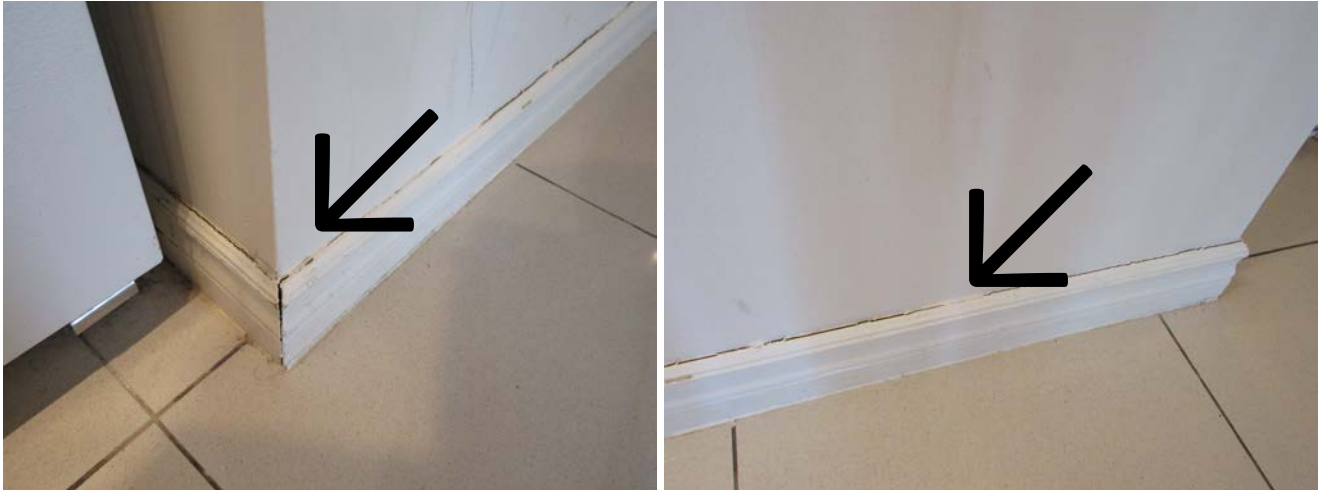
The wood baseboard had cracks and was separated in the kitchen and entrance space of the house. Repairing the wood baseboard is recommended.

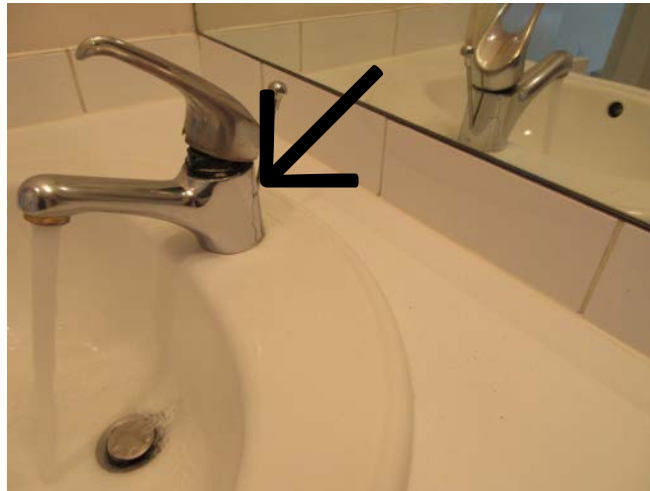
The water leakage was noted on the washroom basin faucet. Fixing the faucet leakage is recommended.
