# Home Inspection Report

Prepared exclusively for  
Vancouver, BC

Property Address: 87 Nelson St, Vancouver, BC Date  
of home inspection: Thursday, July 25, 2024  
Inspection start time: 10:00 AM  
Inspection end time: 12:15 AM  
MLS#: not available  
Year Built: 2019  
Construction: Concrete / Metal  
Furnished: No  
Occupied: No  
Floor Area Total: 534 sq. Ft.

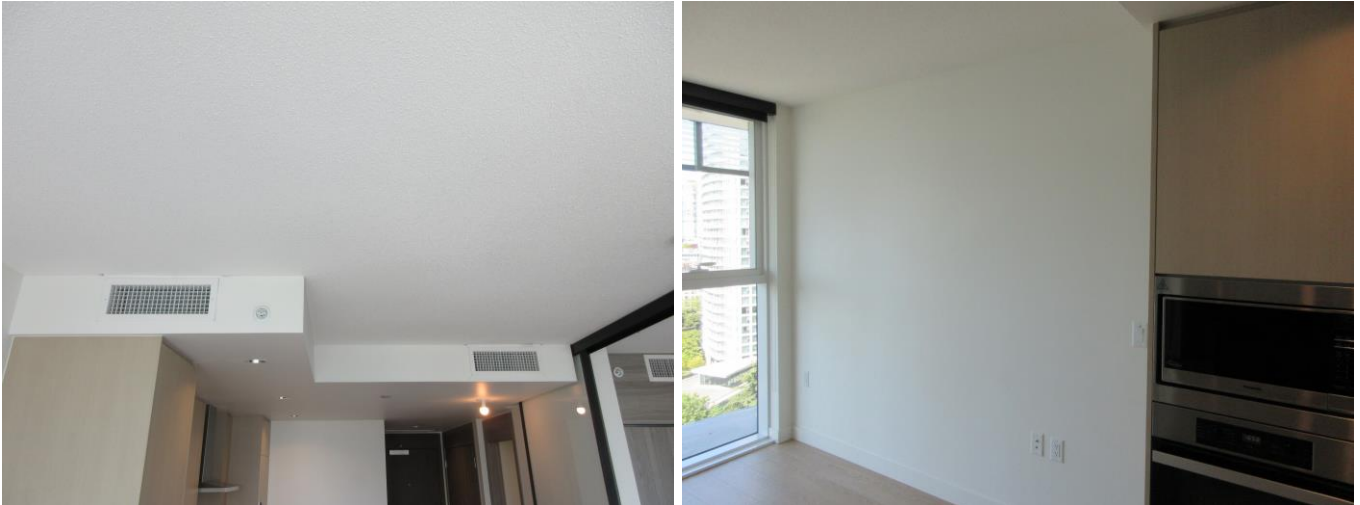
## 1.1 Main

**Type:** Concrete

The house features concrete floors, drywall ceilings, and metal-framed walls. The interior walls, ceilings, and floors showed no signs of defects or structural deficiencies at the time of this inspection.

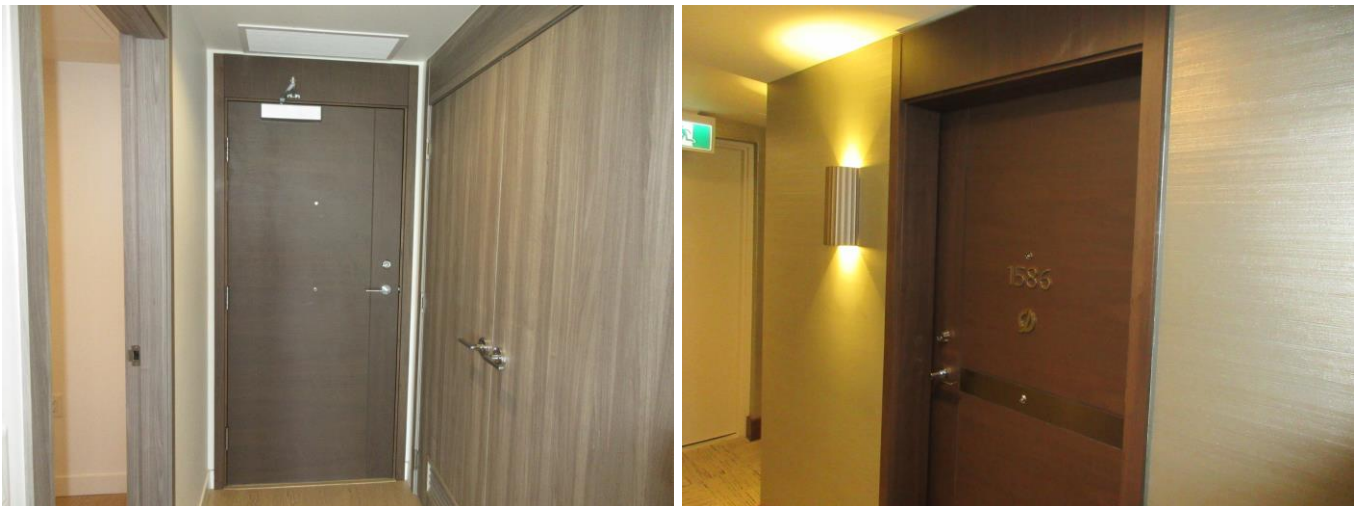
## 2.1 Exterior Door

The house features a wooden main entrance door. At the time of this inspection, the door was fully operational with no observed deficiencies. All interior doors, closet doors, and associated hardware were functional and in good condition.

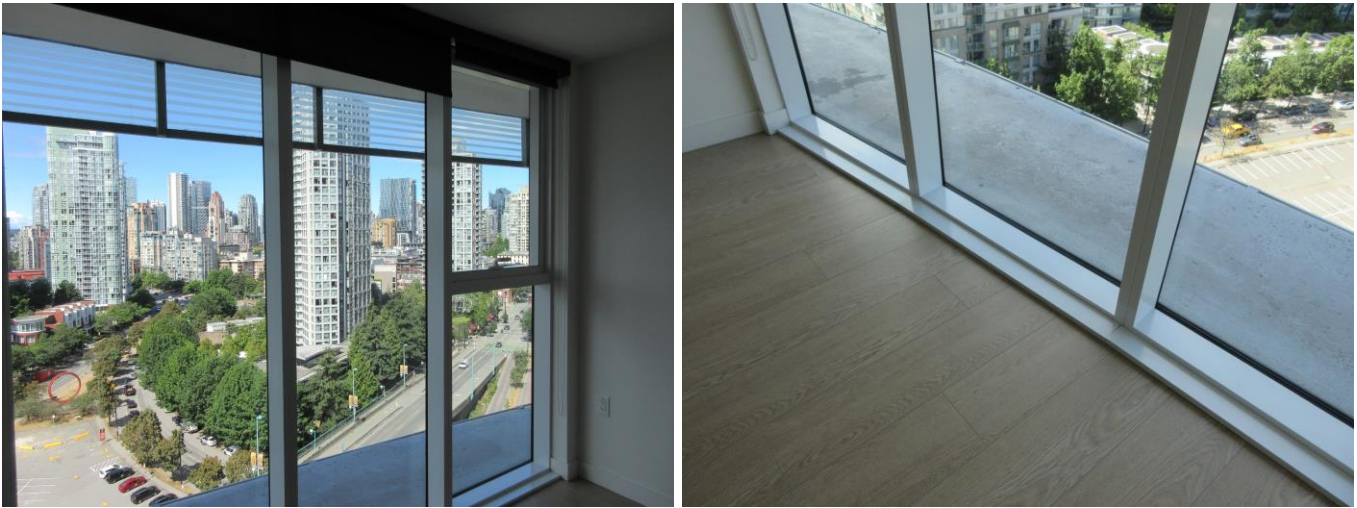
## 2.2 Window

The house is equipped with aluminum-framed, double-pane windows. At the time of this inspection, the windows were fully functional with no observed deficiencies in their operation or seals.

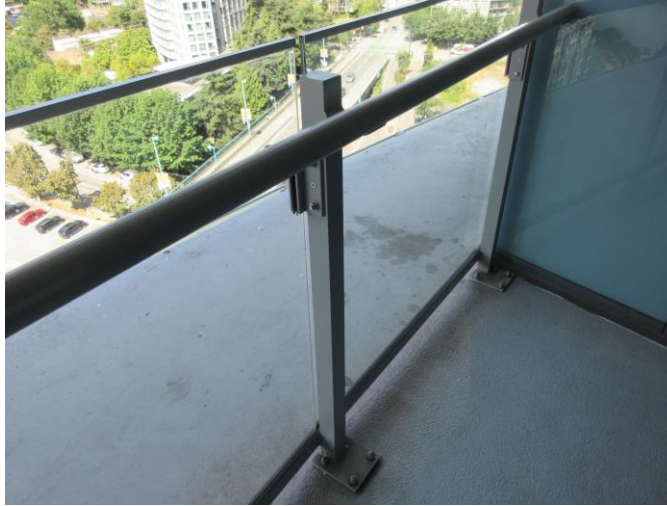
## 2.4 Guard and Handrail

The balcony features a metal-framed glass guard system. Both the handrail and the guard were found to be securely anchored and functional, with no observed deficiencies at the time of this inspection.

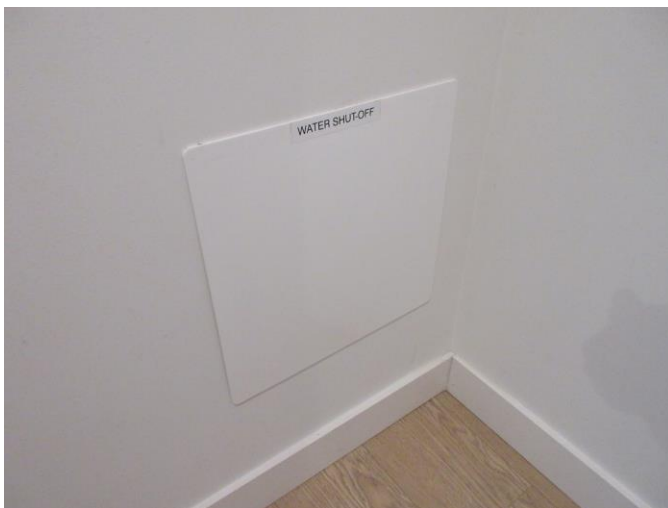
### 3.1 Water Supply System

The original water supply lines are Uponor PEX piping. The system was functional with no observed deficiencies at the time of this inspection. The typical life expectancy for PEX piping is 40 to 50 years. The main water shut-off valve is located in the den.

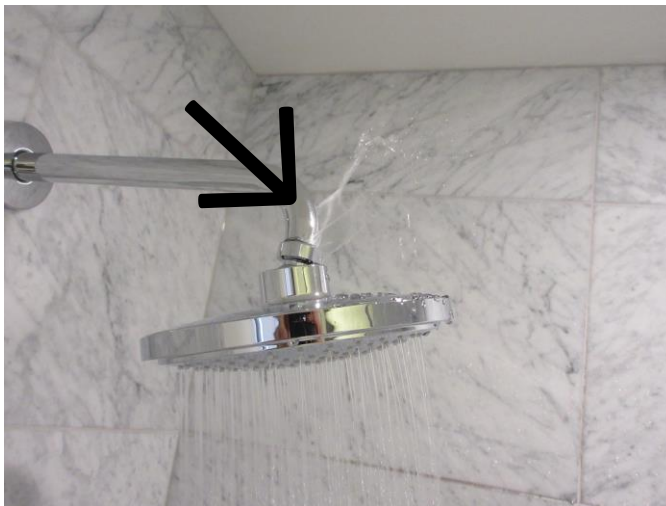
## 3.2 Bathtub

Active leakage was observed at the master bathroom shower head. It is recommended that a qualified individual repair or replace the fixture to prevent water waste and potential moisture issues.

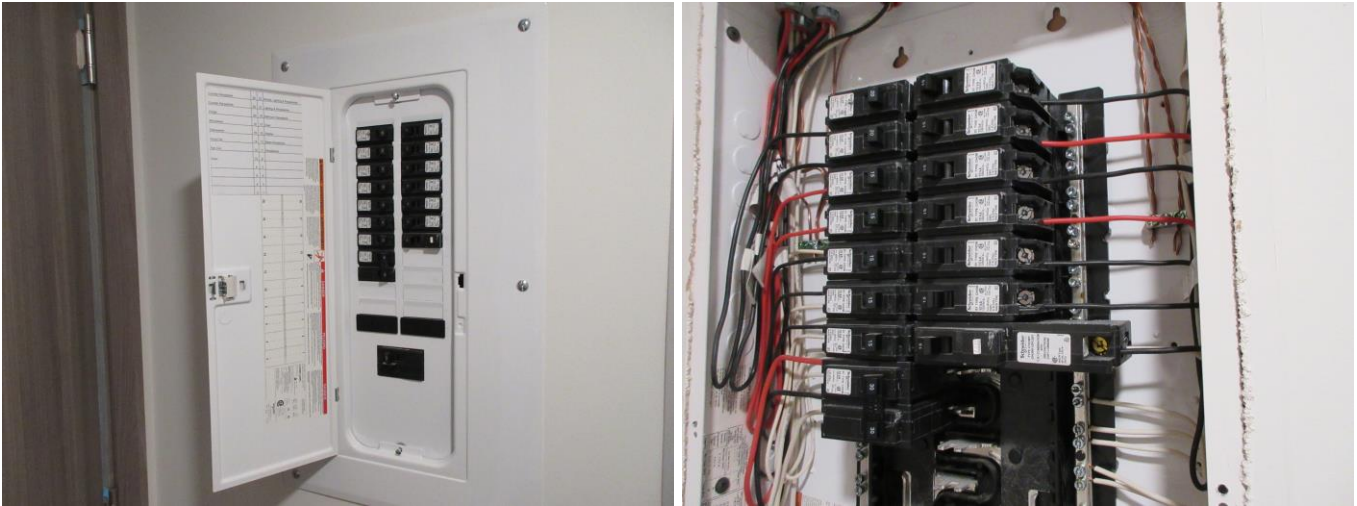
### 5.1 Main Electrical Panel

The 100-amp main electrical panel is located in the den and was professionally installed. The house is wired with copper, and no signs of burnt, damaged, or corroded wiring were observed. All breakers were clearly labeled. Appropriate circuit breakers and wire gauges were used for specific circuits (e.g., 30-amp for the dryer and 15-amp for general circuitry).

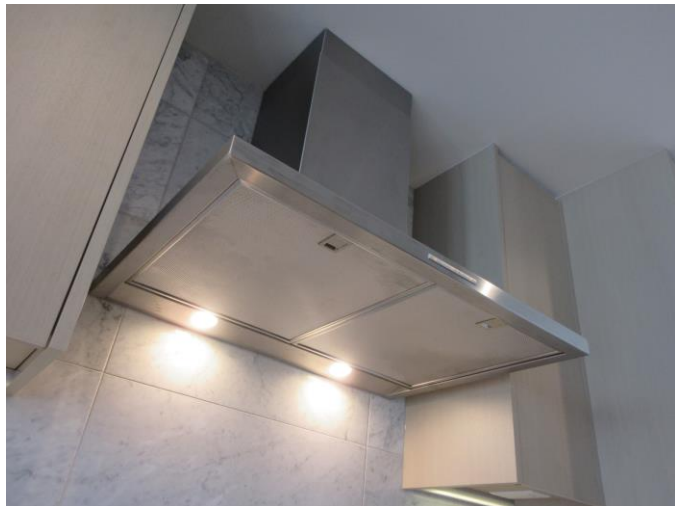
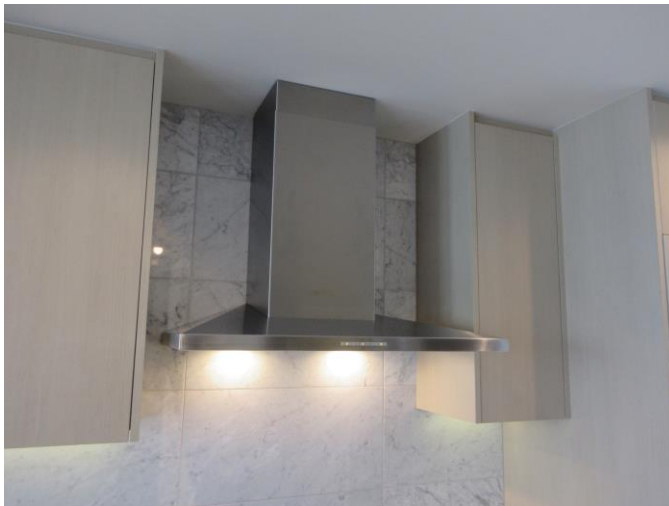
## 6.2 Rang Hood

The kitchen is equipped with an electric range hood. The exhaust fan and light were tested and found to be fully functional with no observed deficiencies at the time of inspection.

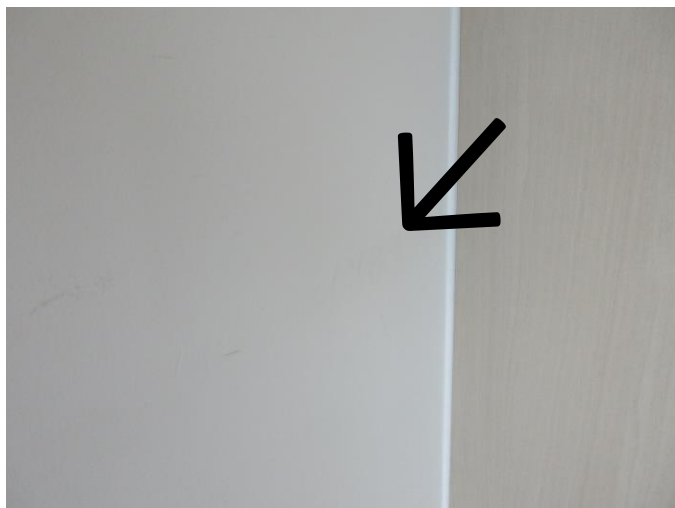
### 7.1 Wall and Material

The living room wall finish was observed to be damaged or missing in several areas. These appear to be strictly cosmetic issues and do not indicate underlying structural concerns. Surface preparation and repainting are recommended to restore the wall's appearance.

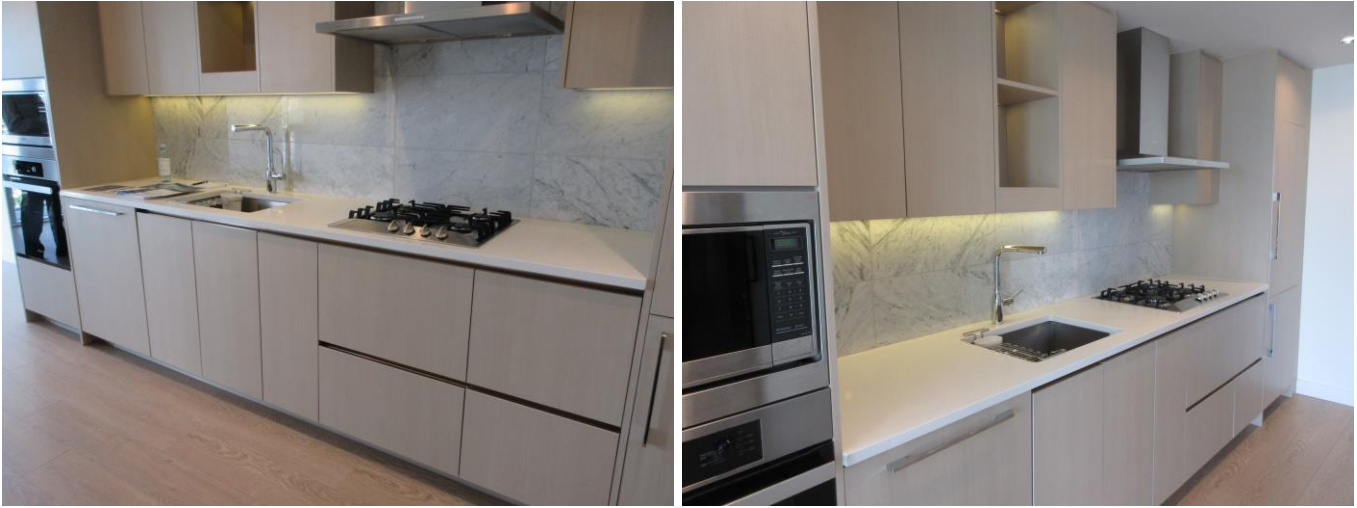
## 7.2 Counter and Cabinet

The kitchen features quartz countertops and MDF-core cabinet doors. Both the cabinetry and the countertops were inspected and found to be in serviceable condition, with no observed deficiencies in alignment or finish at the time of inspection.

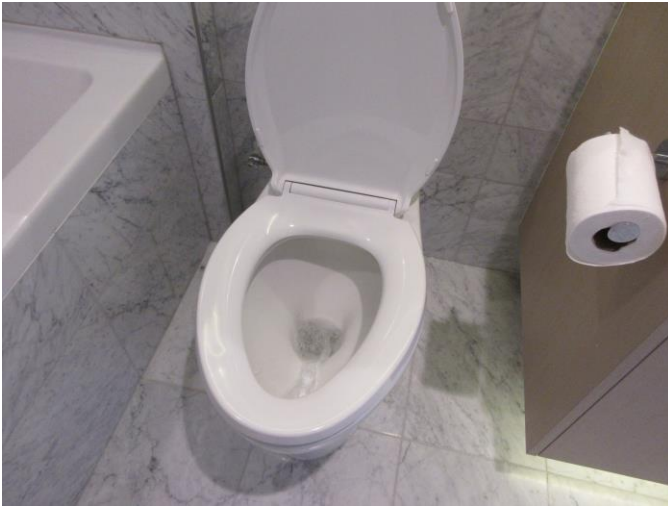
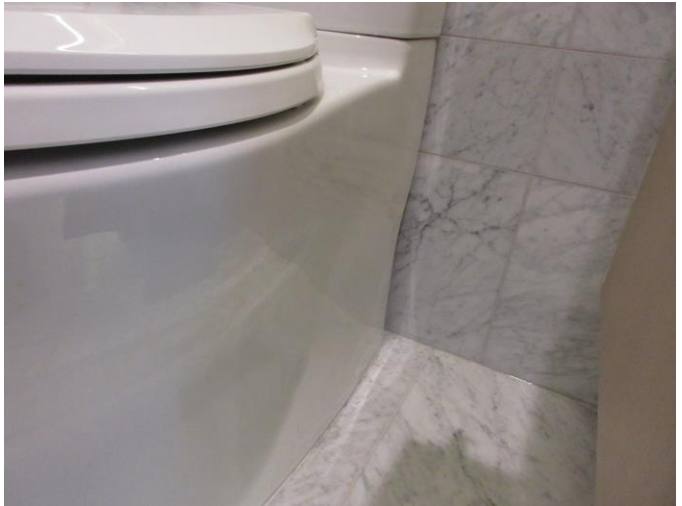
## 7.5 Washroom

All toilets were tested throughout the home. They were found to be properly installed and fully functional, with no observed deficiencies. The units were firmly secured to the floor, and no cracks or active leaks were noted at the tanks or bowls at the time of inspection.

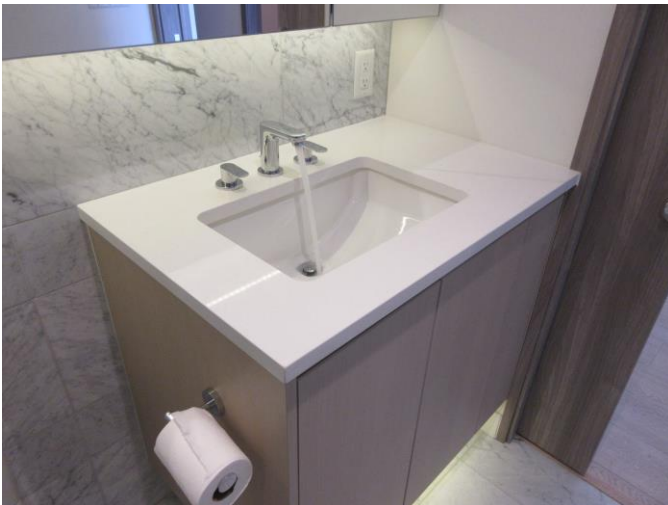
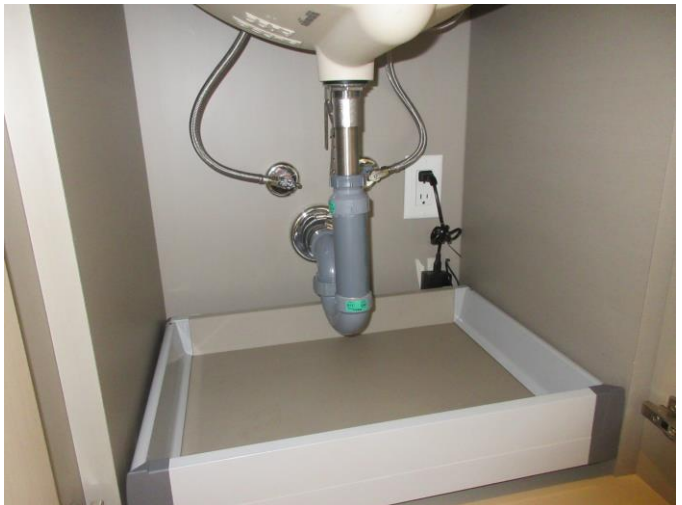
The bathroom lavatory and faucet were tested. The basin was securely mounted, and the faucet was fully functional with no observed deficiencies. Water pressure and drainage were both adequate and performing as intended at the time of this inspection.

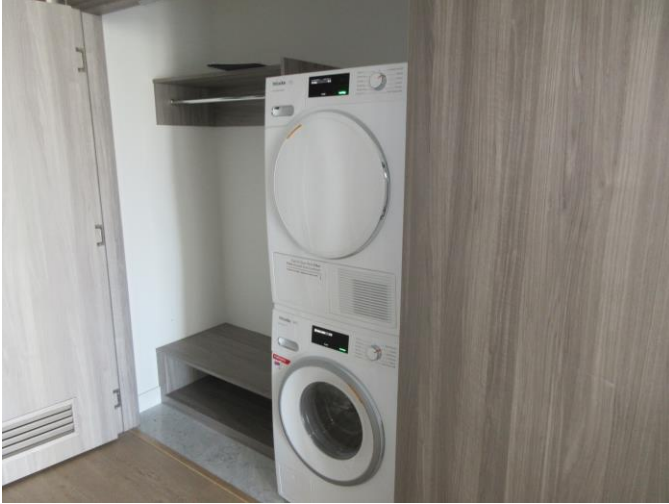
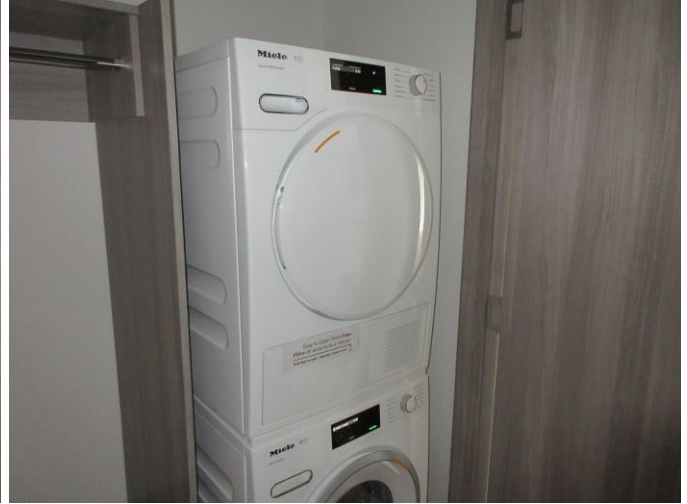
## 7.6 Washing machine & Dryer

The washing machine and dryer were tested in the laundry room and found to be fully functional at the time of inspection. No active water leaks were observed at the washer's supply or drain lines. Both appliances appeared to be in serviceable condition.

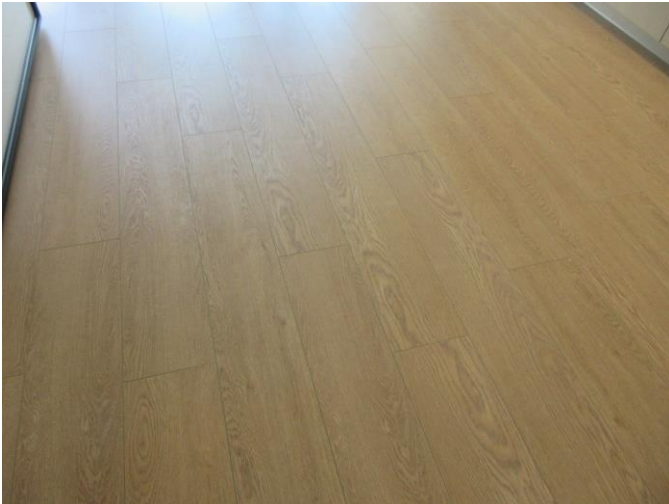
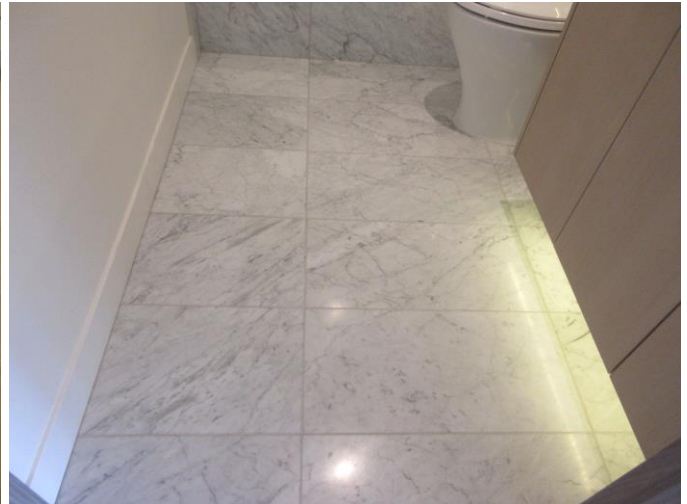
## 7.7 Floor cover

The home's flooring consists of laminate and stone surfaces. The flooring was inspected throughout and found to be in serviceable condition with no observed deficiencies in installation or finish at the time of this inspection.

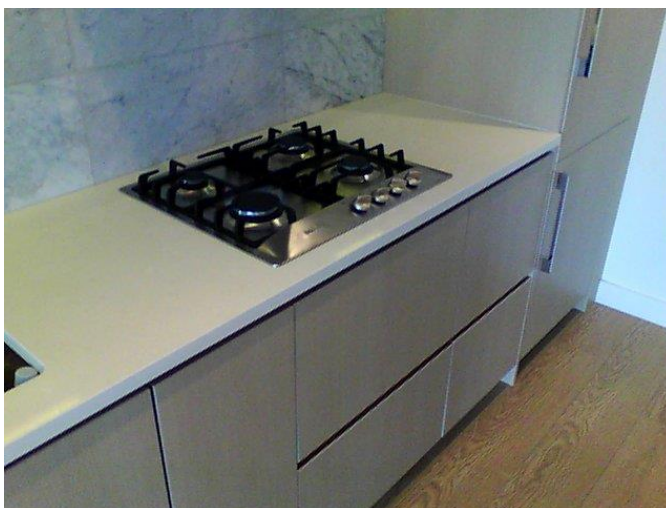
## 7.8 Range & Oven

The house is equipped with a gas range. The unit was operated and tested; all burners and the oven were found to be fully functional and in serviceable condition with no observed deficiencies at the time of inspection.

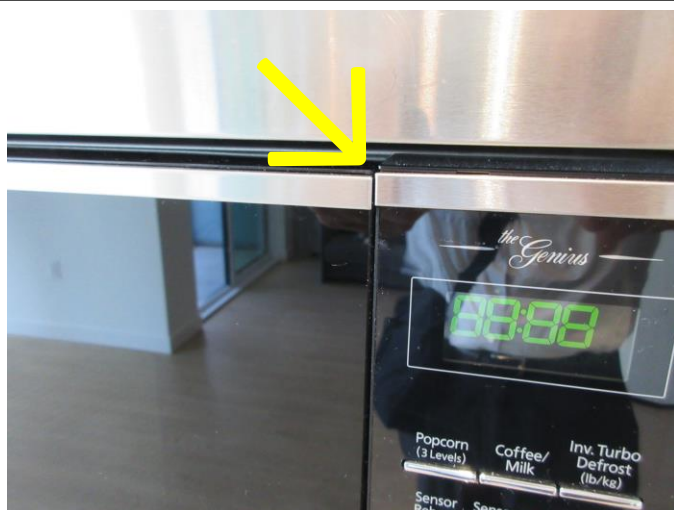
The microwave door was observed to be misaligned with the surrounding trim panel, showing a minor sag. This appears to be a cosmetic issue and did not affect the unit's ability to latch or operate at the time of inspection. Adjusting the door hinges is recommended for aesthetic uniformity.

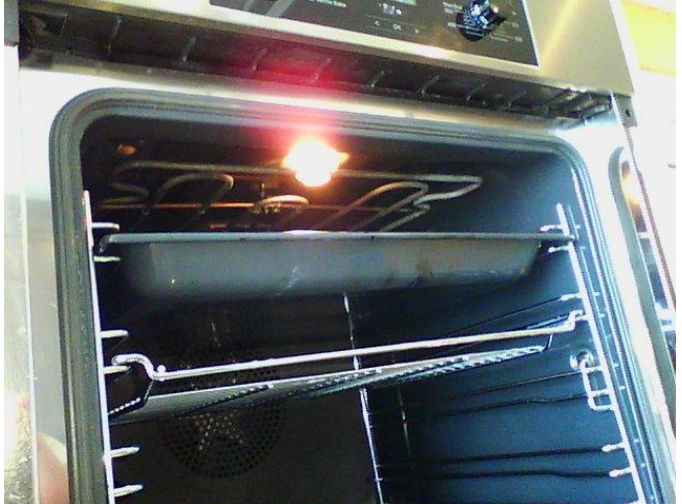
## 7.9 Wall oven

The kitchen features a gas-fired oven with an electronic ignition system. The unit was tested and found to be fully functional, reaching target temperatures during the heating cycle with no observed deficiencies at the time of inspection.

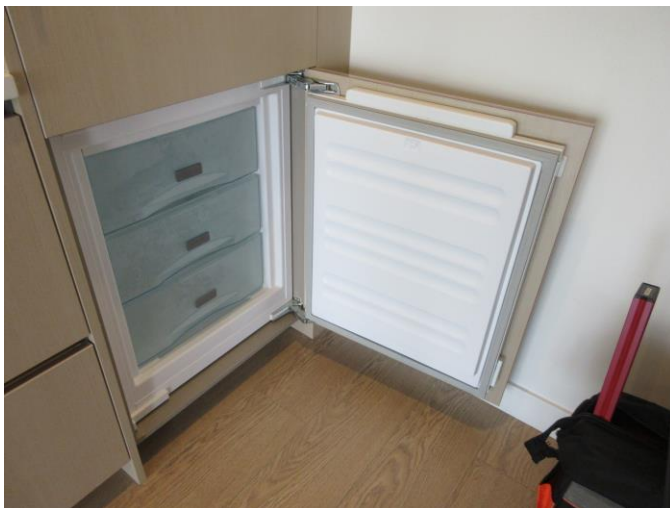
## 7.10 Fridge

The refrigerator and freezer doors were observed to be misaligned with the left cabinet side panel (gable). This appears to be a cosmetic issue related to the leveling of the appliance or hinge adjustment and does not affect the unit's seal or function. Adjustment is recommended for aesthetic uniformity.
